Division of Water Pollution Control ANNUAL FACILITY INSPECTION REPORT

for NPDES Permit for Storm Water Discharges from Separate Storm Sewer Systems (MS4)

Report Period: From March, 2019 To March, 2020

Name: Village of Tilton Mailing Address 1: 1001 Tilton Road
Mailing Address 2: _____ County: Vermilion
City: Tilton State: IL Zip: 61833 Telephone: 217-477-0800
Contact Person: David Phillips, Mayor Email Address: dphillips@tilton.com
(Person responsible for Annual Report)

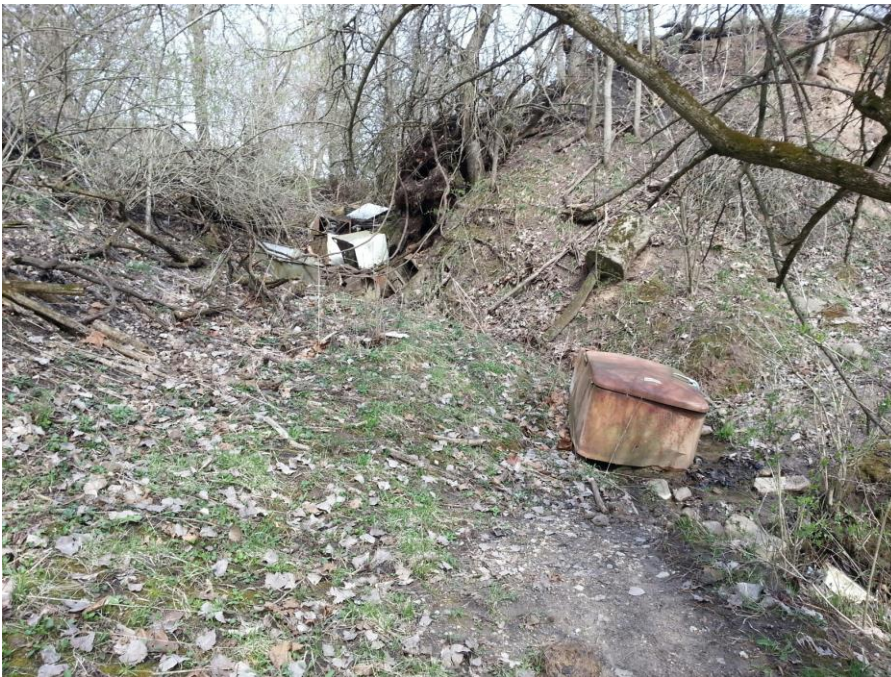
**Look April 10th 2019 at appliance fill in ravine at bend in Grape Creek approximately 500 ft. downstream of Herschel Lake discharge.
Communicate and coordinate to safely remove appliances and legally dispose of.**

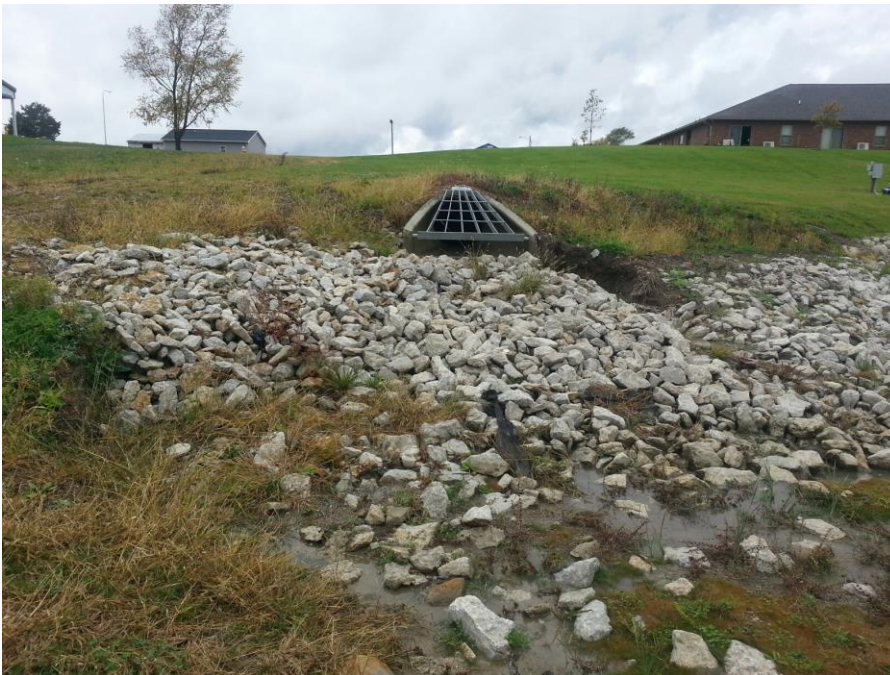
Storm Structure Q4

Look October 21st 2019 at erosion east of Herschel Lake Drive. Engineer plan, specification and cost estimate to force water into grated storm sewer manhole, repair ruts and establish turf. Delineate property line. Recommend grading be mow & pedestrian safe turf.

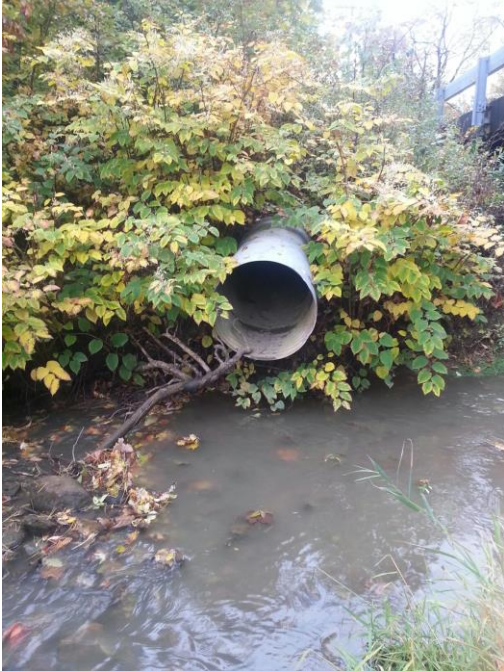
Storm Structure M1

Look West at storm sewer discharge into Herschel Lake October 21st 2019. Engineer plan, specification and estimate to stabilize rip rap and erosion.

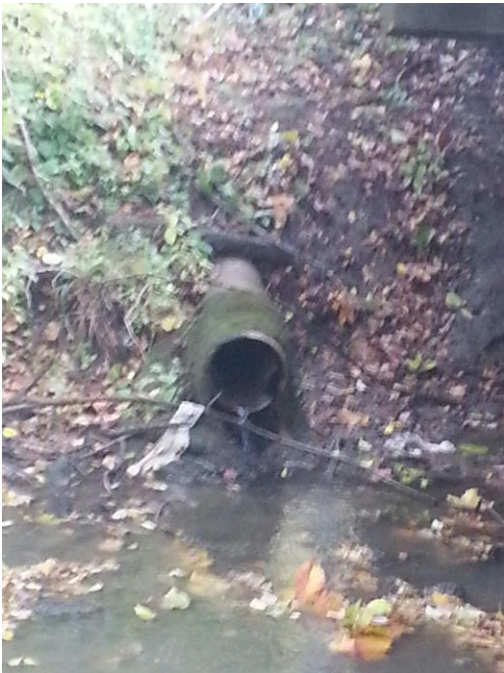
Look south October 21st 2019 at pipe near the southeast corner of King Street Bridge over Grape Creek. No water observed discharging from pipe after rain events. **Consider robotic video inspection of pipe.**

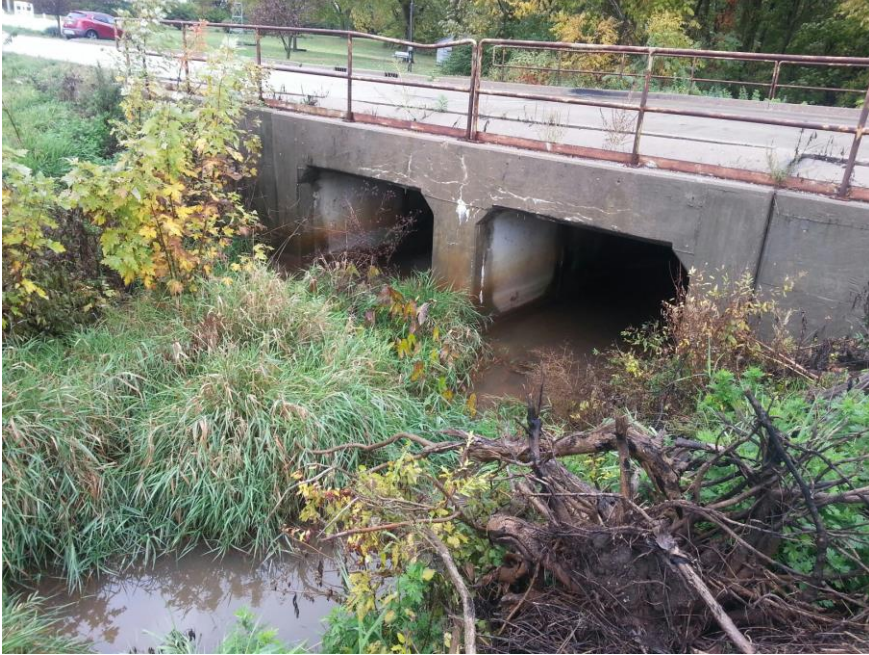
Storm Structure R16

Look toward upstream through West barrel of culvert under West Ross Lane over Grape Creek October 21st 2019. Appears water is cloudy discharging from storm sewer. Use mapping to inspect drainage from upstream of discharge. Test, communicate plan and eliminate condition.

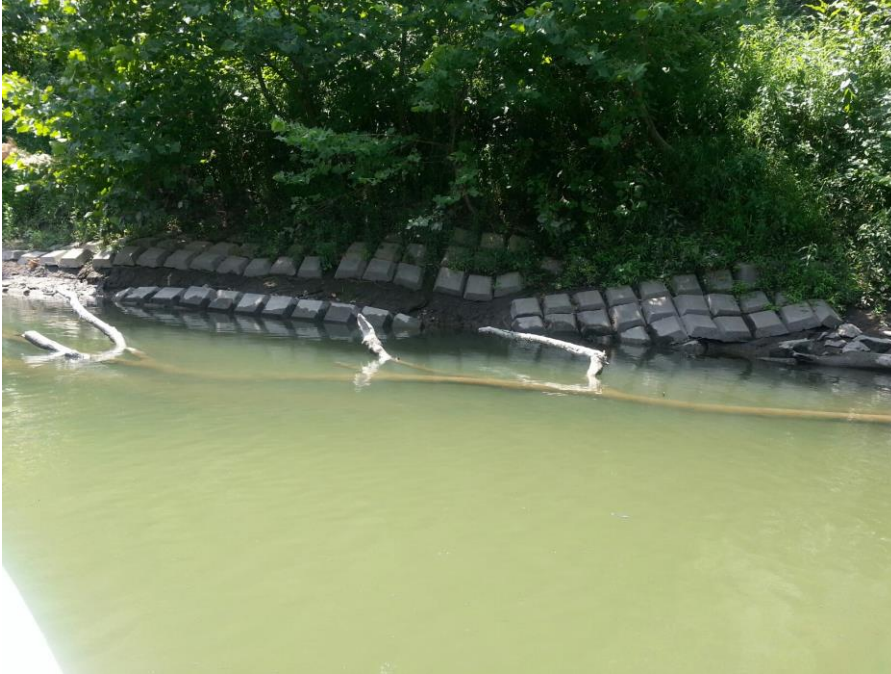
Look July 24th 2019 southerly at the south bank of Vermilion River near abandoned General Motors site upstream of CSX Railroad at black high density polyethylene pipe discharging liquid into stream and PVC attachment loose in river bank. Communicate with property owner regarding purpose of pipe.

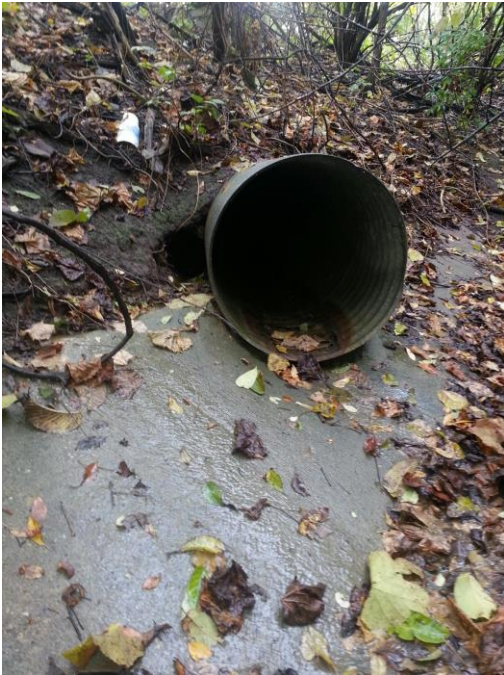
Storm Structure B3

Look at sinkhole near brick block manhole on IDOT Right-of-Way October 21st 2019 near Tilton ball fields. **Communicate and coordinate with the Illinois Department of Transportation to inspect and remediate conditions.**

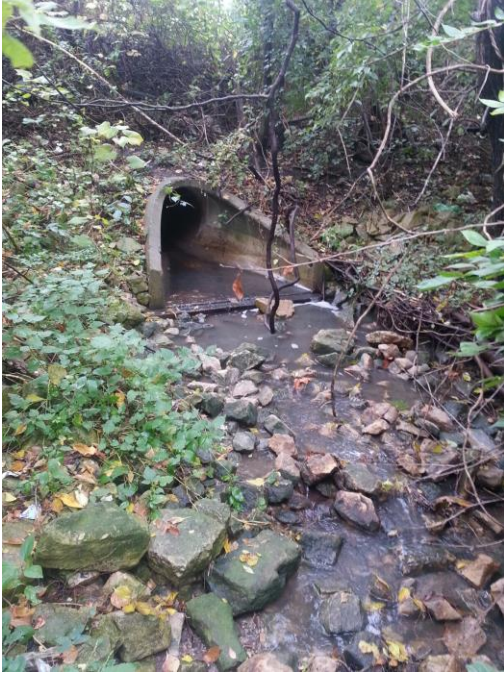
Storm Structure A71

Look at storm sewer discharge north of I-74 in ravine near Tilton Ballfields October 21st 2019. Sinkhole exists next to pipe and behind that manhole. **Notify Illinois Department of Transportation of conditions.**

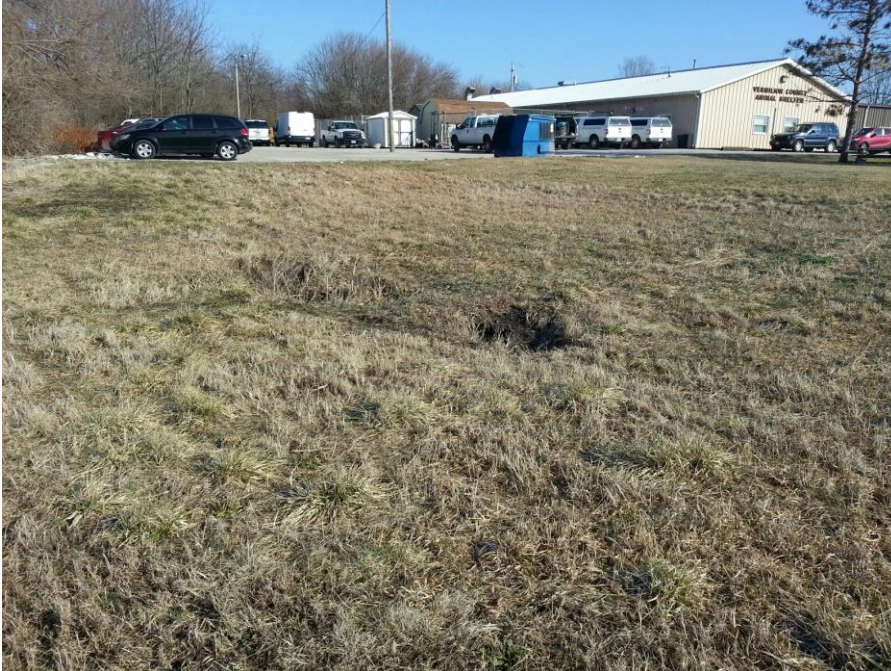
Look at tile from west near farm crossing west of Vermilion County Animal Shelter February 19th 2020. Consider video inspection of pipes & communication with County, IDOT, Village and owner. Engineer a plan, specifications and estimate to improve conditions.

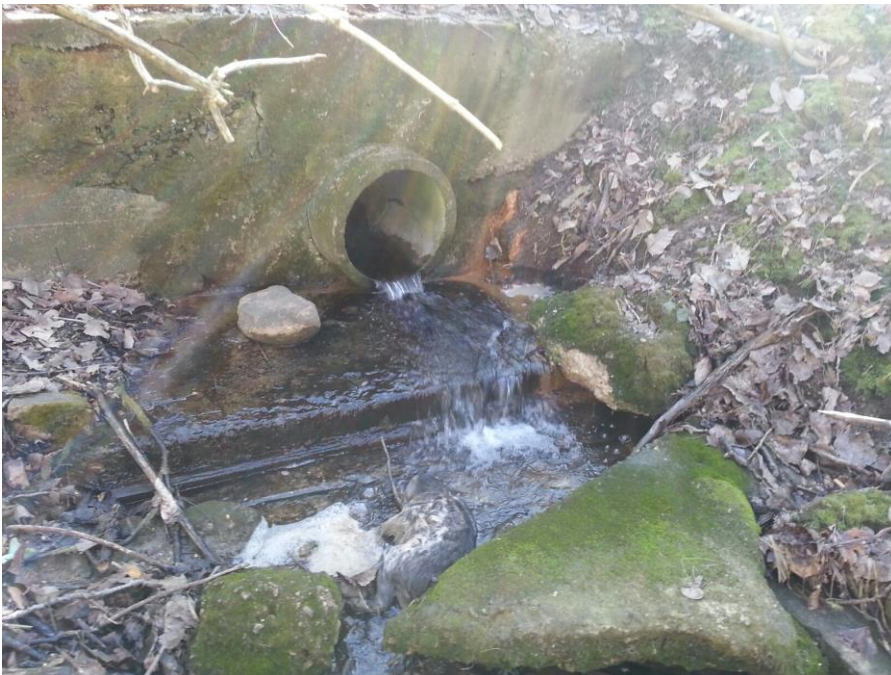
Look northeasterly at sinkholes above storm sewer from Catlin Tilton Road West of County Animal Shelter February 19th 2020. Consider video inspection of pipes & communication with County, IDOT, Village and owner. Engineer a plan, specifications and estimate to improve conditions.

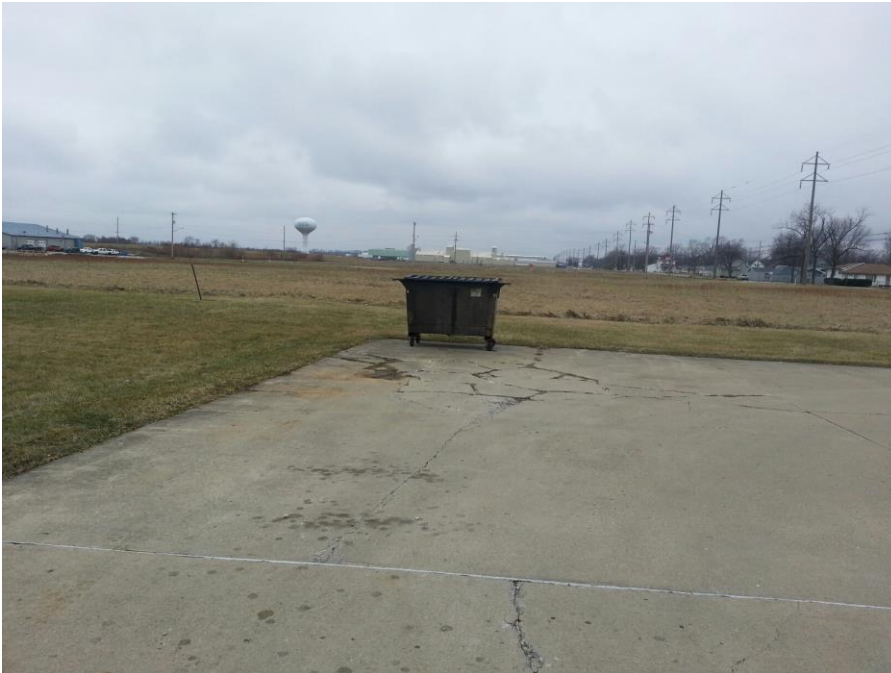
Look west January 28, 2020 at solid waste containers on the northwest side of Truscelli Collision Repair. Ensure lids are closed on dumpsters and solid waste is contained in accordance with Village ordinances.

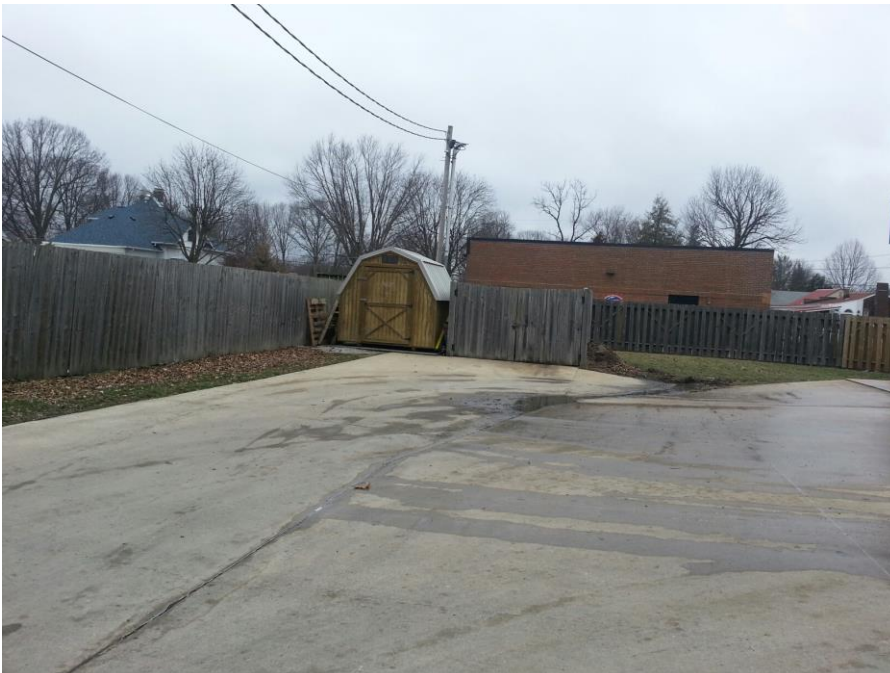
Look west January 28th 2019 at solid waste containment area on the north side of Casey's General Store. There appears to be stain on pavement from container area. **Ensure dumpster is leak proof, lids are closed and solid waste is contained in accordance with Village ordinances.**

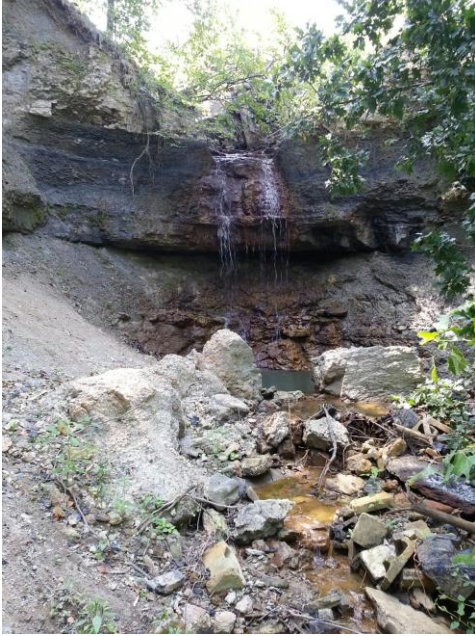
Look toward downstream on Vermilion River July 24th 2019 at overhead utility structures. **Communicate with utility company to inspect condition of bank near structures to ensure structural stability. Give notice to Army Corps of Engineers to obtain permission prior to discharge of erosion stabilization material onto bank**

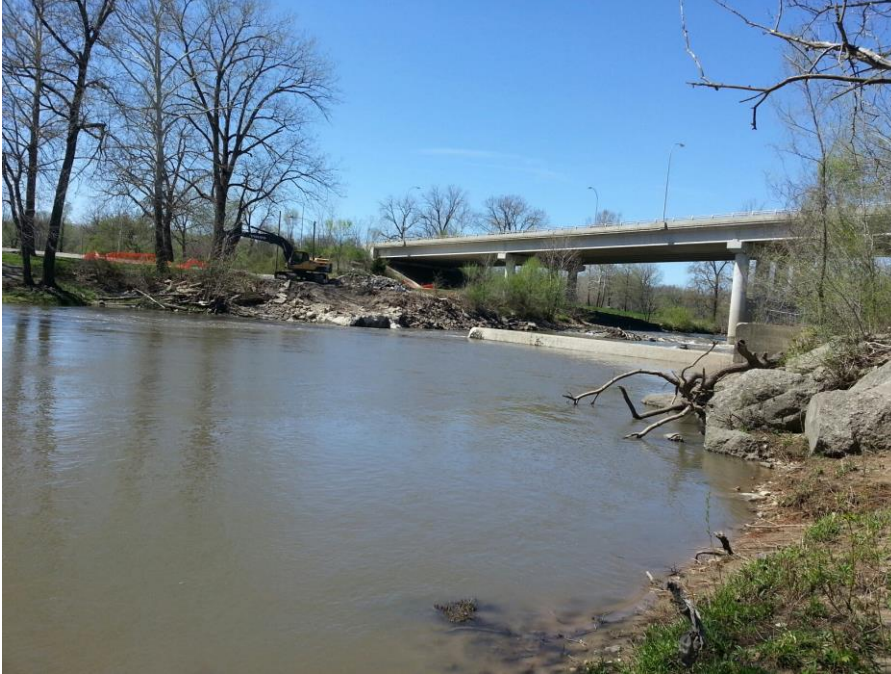
Look April 6th 2019 from the west bank of the North Fork River upstream of dam removal project in Ellsworth Park at the U.S. 150 Bridge over the North Fork River. Water flowing towards and under center pier also demolition debris exposed due to lower water elevation. **Remedy conditions.**

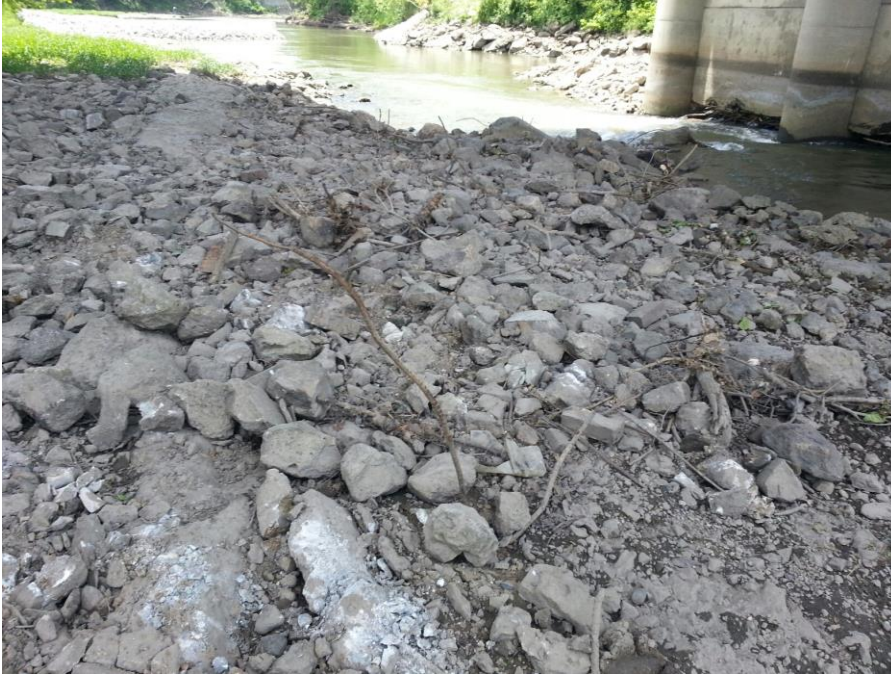
**Look June 14th 2019 at stream flow diverted underneath center pier concrete wall of Martin Luther King (US150) bridge over North Fork River).
Communicate and remedy condition.**

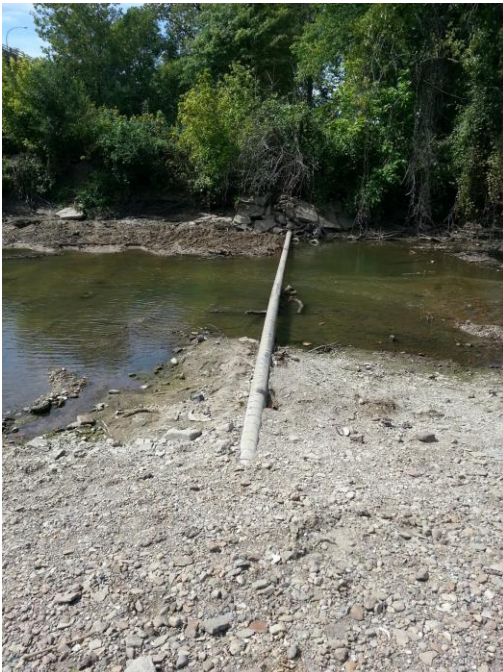
Look northerly September 13th 2019 from east bank of North Fork River at pipe exposed across North Fork River. **Determine purpose of pipe and eliminate hazard.**

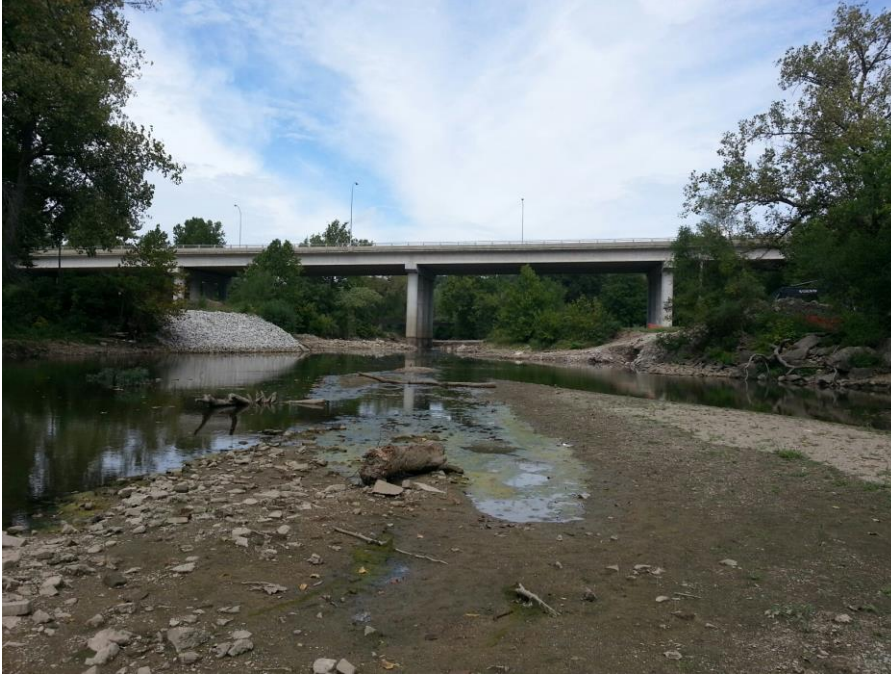
Look September 13th 2019 at pipe line across North Fork River exposed upstream of us 150 Martin Luther King Drive Bridge. **Dam removals exposed hazard. Communicate to determine pipe owner and eliminate hazard of exposed pipe obstructing water way.**
