Division of Water Pollution Control ANNUAL FACILITY INSPECTION REPORT

for NPDES Permit for Storm Water Discharges from Separate Storm Sewer Systems (MS4)

Report Period: From March, 2019 To March, 2020

Name: Village of Tilton Mailing Address 1: 1001 Tilton Road
Mailing Address 2: _____ County: Vermilion
City: Tilton State: IL Zip: 61833 Telephone: 217-477-0800
Contact Person: David Phillips, Mayor Email Address: dphillips@tilton.com
(Person responsible for Annual Report)

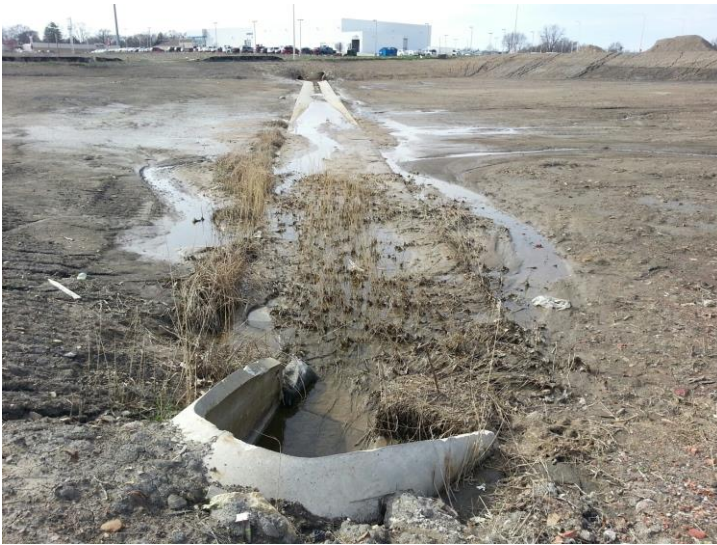
Storm Structure P4

Look April 10th 2019 toward northwest at detention basin and inlet to 36 inch storm sewer that discharges into Grape Creek near Southgate Drive. Reinforce erosion control. Consider staking straw bales along edges of concrete storm water flow pad. Final grade detention basin & establish turf as soon as possible!

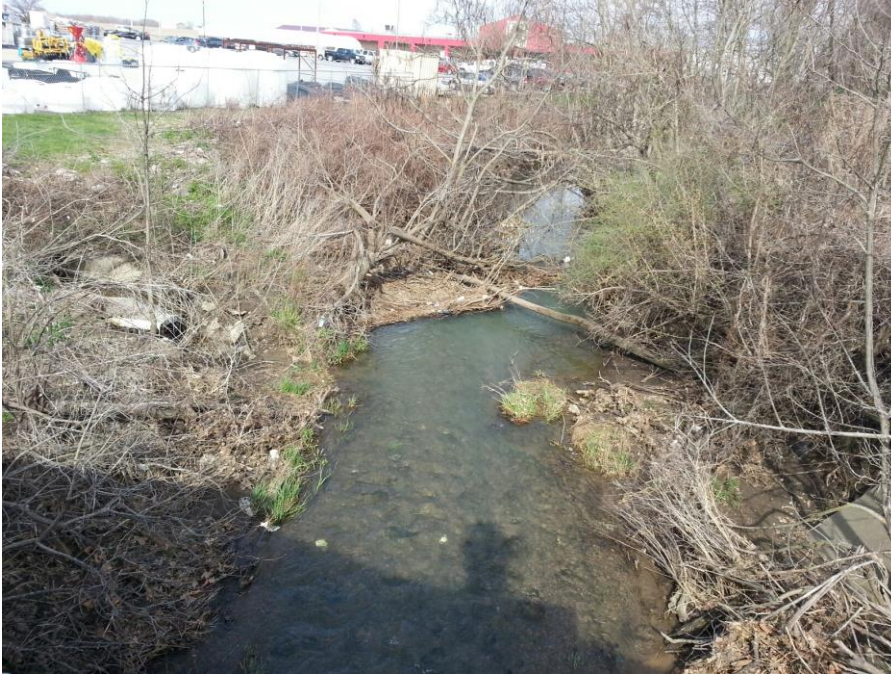
Look easterly April 10th 2019 from Illinois Route 1 box towards downstream at log jam along Grape Creek approximately 75 feet downstream. **Communicate, coordinate and implement operation to remove trash from stream and banks.**

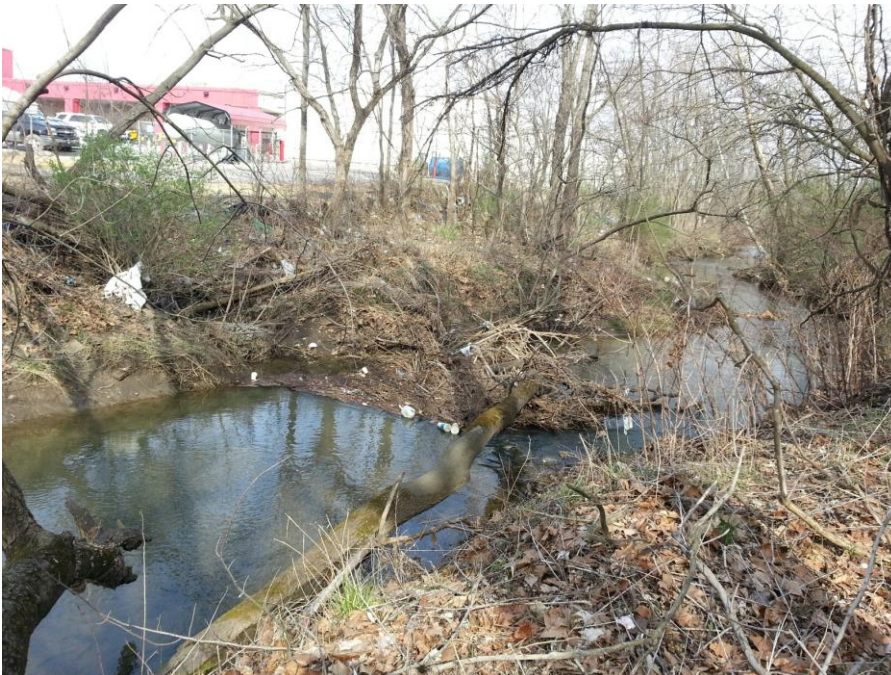
Look April 10th 2019 at debris jam and solid waste buildup along the northern bank 300 feet downstream Illinois Route 1 along Grape Creek. **Use pool leaf rake with pole to remove solid waste from stream & pick up litter on banks and legally dispose of.**

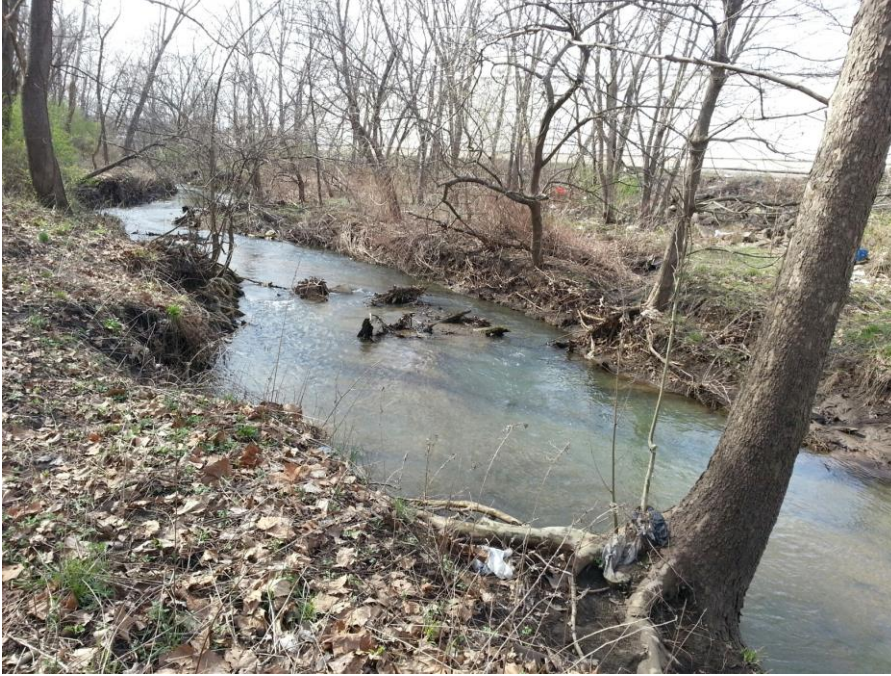
Look westerly toward upstream April 10th 2019 downstream of Illinois Route 1. Devise operation to safely remove debris and garbage from stream and stream banks then dispose of legally also prevent from further migrating into the stream.

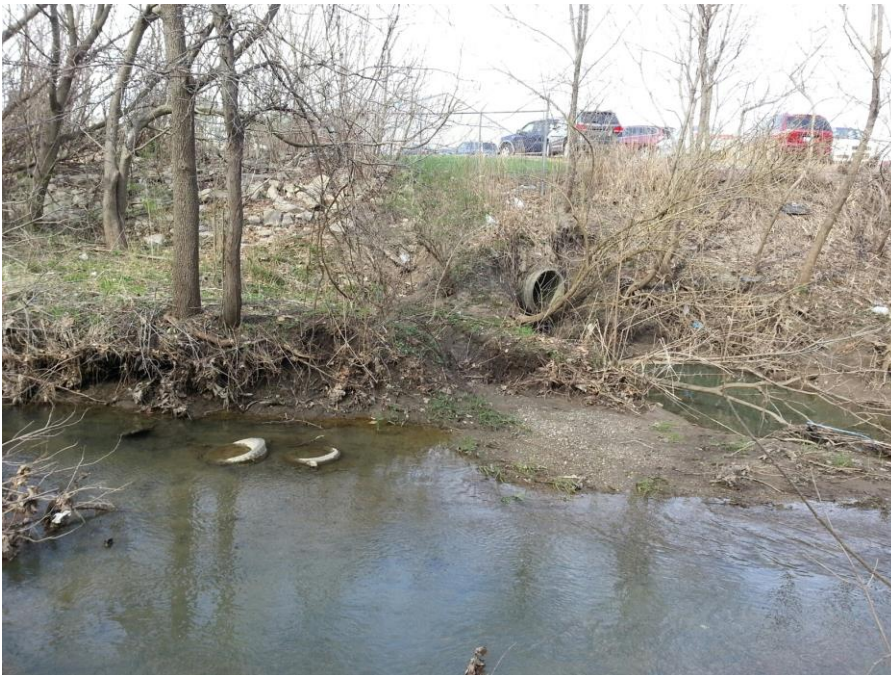
Storm Structure P1

Look towards Northwest at erosion near 36-inch Southgate Drive storm sewer discharge April 10th 2019 from the south side of Grape Creek. Remove tires from stream and coordinate with Army Corp of Engineers regarding erosion stabilization and discharge.

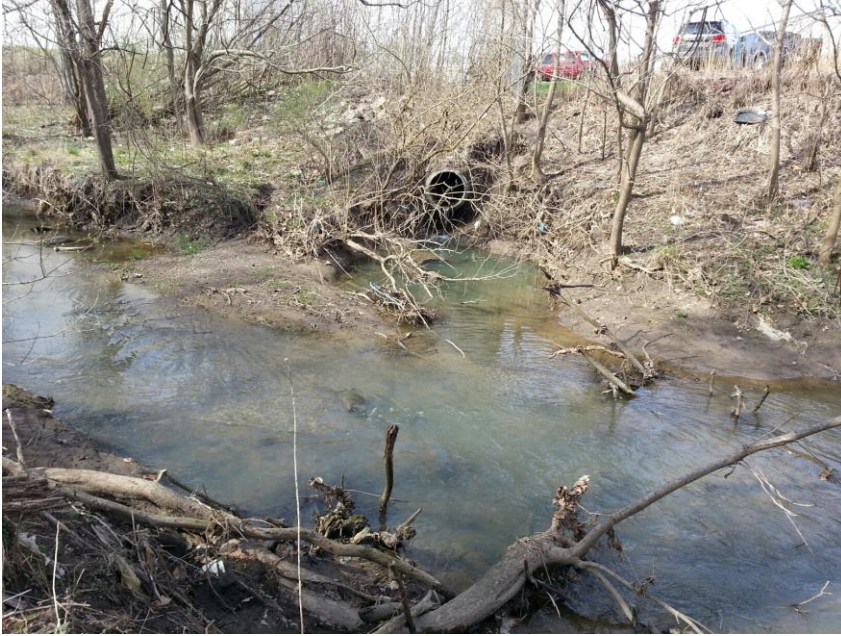
Storm Structure P4

Look April 10th 2019 from the south side of stream towards the north across Grape Creek at erosion near 36 inch diameter storm sewer discharge from Southgate Drive. **Coordinate with Army Corp of Engineers regarding erosion stabilization and discharge.**

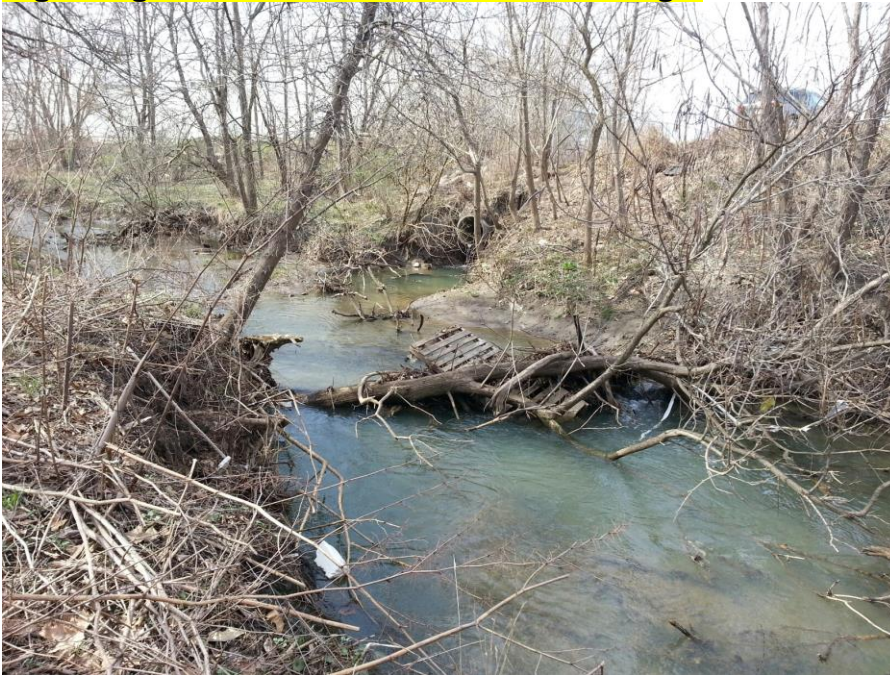
Look April 10th 2019 toward the northwest and upstream along Grape Creek from the south side of stream at log jam downstream of the 36 inch diameter Southgate Drive storm sewer discharge. **Remove debris from stream.**

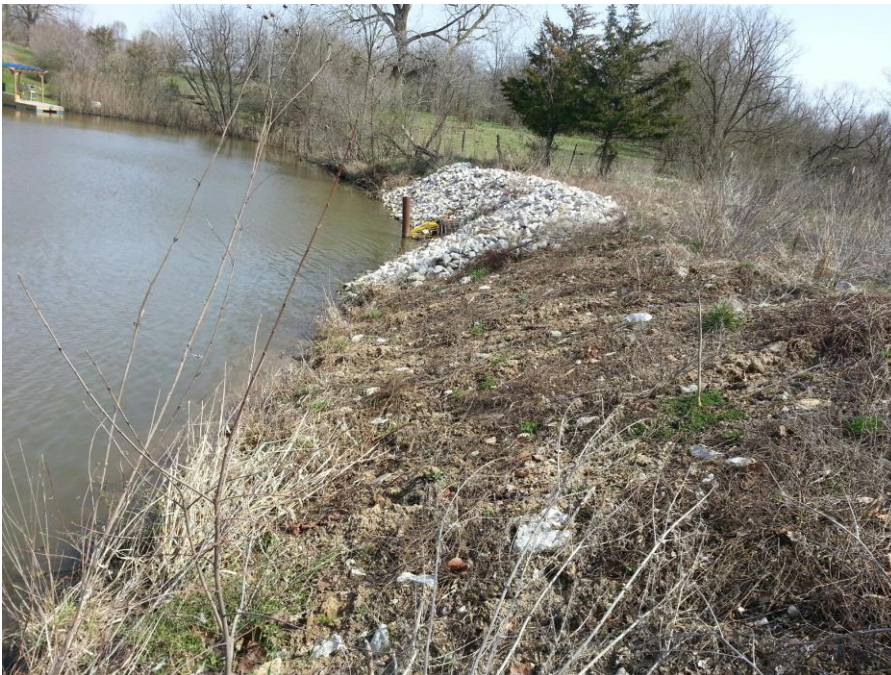
Storm Structure Q2

Look southeasterly at screened culvert inlet and dam on Herschel Lake April 10th 2019. Coordinate with Engineer to establish vegetation and prevent erosion of exposed soil.

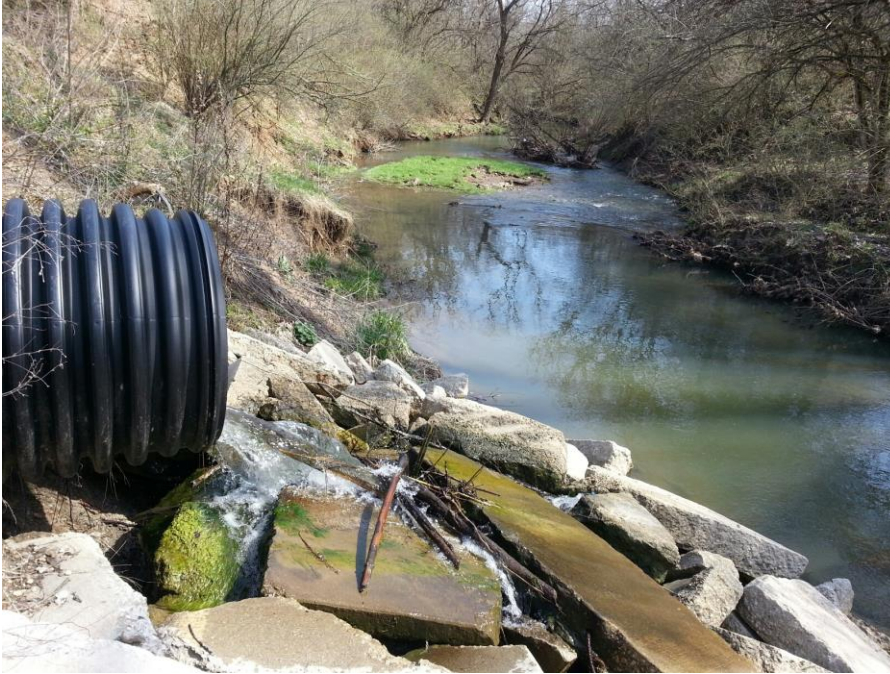
Storm Structure Q2

Look April 9th 2019 at sediment bar directly downstream of Herschel Lake discharge along Grape Creek

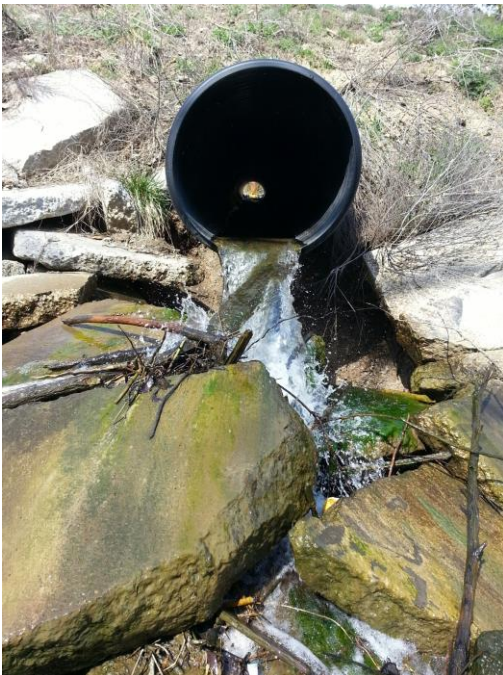
Storm Structure Q1

Look at water discharging from Herschel Lake into Grape Creek April 10th 2019. Add riprap under end pipe discharge to eliminate erosion.

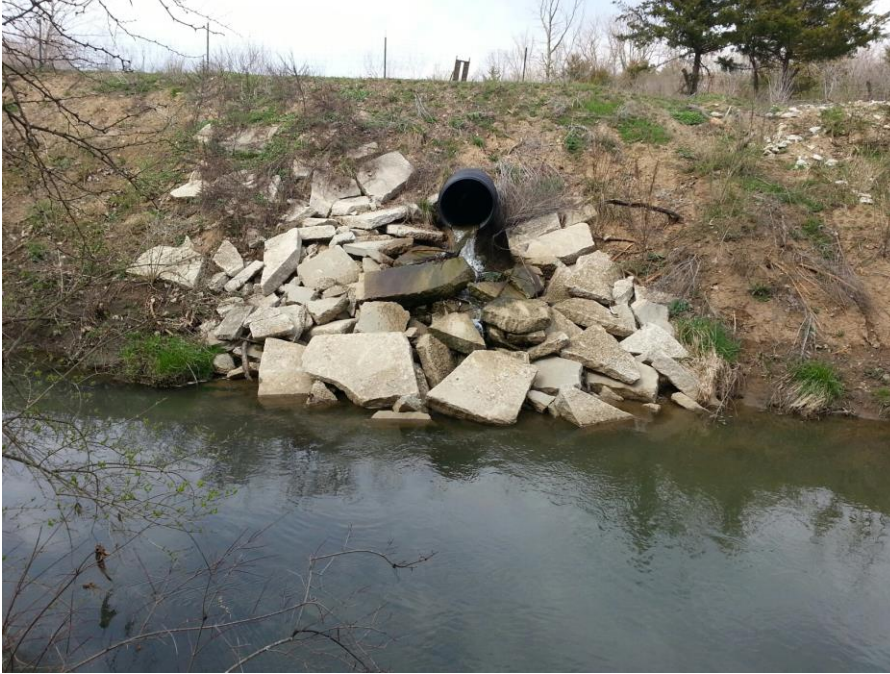
Storm Structure Q1

Look from south side of Grape Creek at Herschel Lake discharging April 10th 2019. Coordinate with Engineer to establish vegetation and prevent erosion of exposed soil.

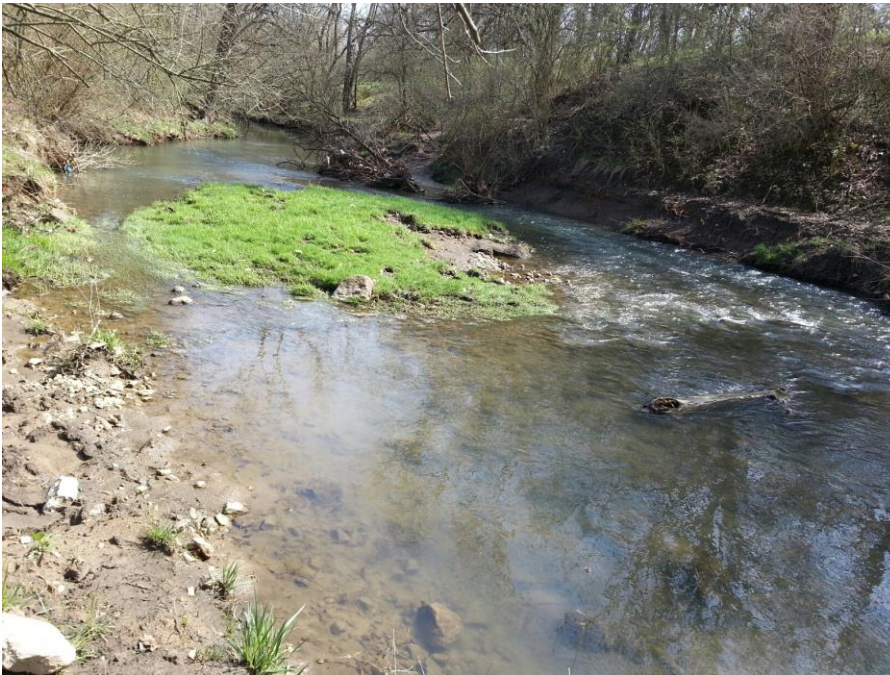
Look April 10th 2019 toward downstream at sediment deposit in Grape Creek approximately 35 to 80 feet downstream of Herschel Lake discharge

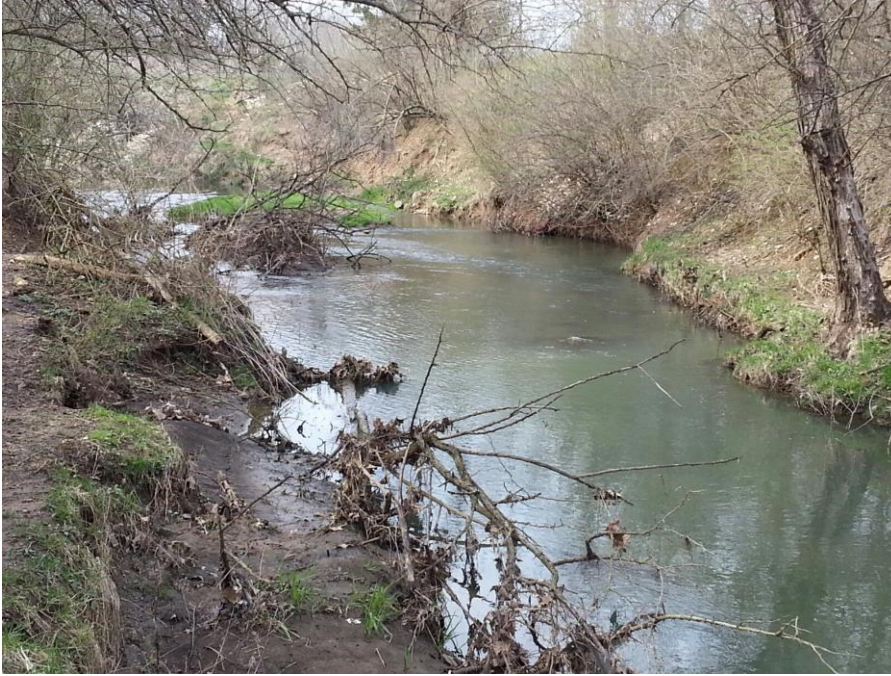
Look toward upstream at sediment bar and erosion along the bank approximately 100 feet downstream of Herschel Lake discharge April 10th 2019.

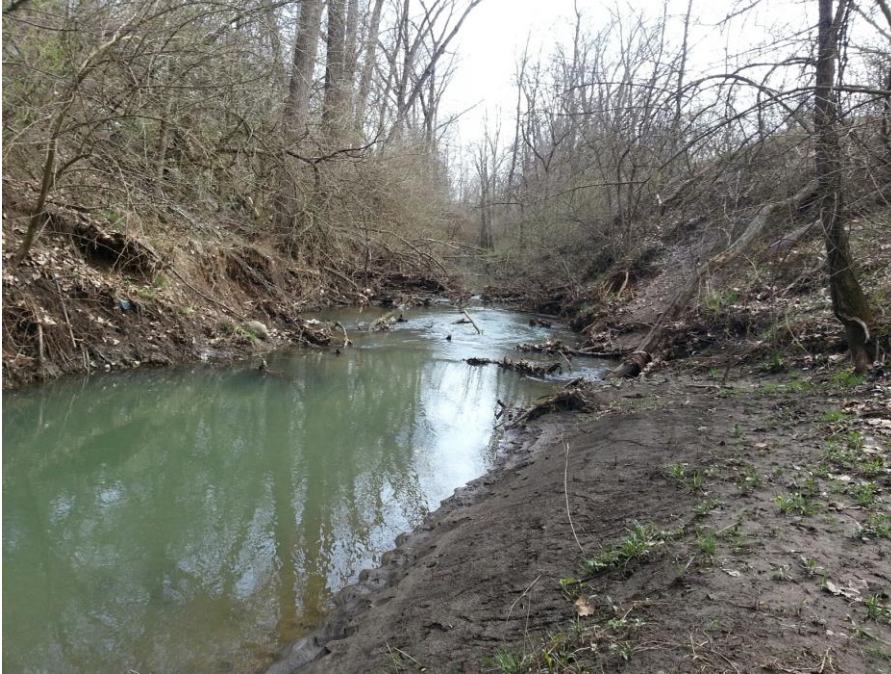
Look April 10th 2019 toward downstream at debris jam across Grape Creek approximately 1,000 feet downstream of Herschel Lake discharge

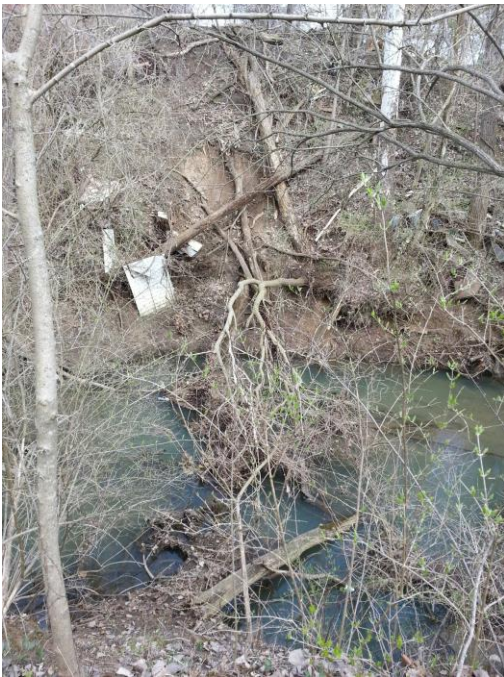
Look at debris jam along Grape Creek approximately 1,000 feet downstream of Herschel Lake discharge April 10th 2019. Communicate and coordinate to safely remove solid waste debris from stream bank and legally dispose of.

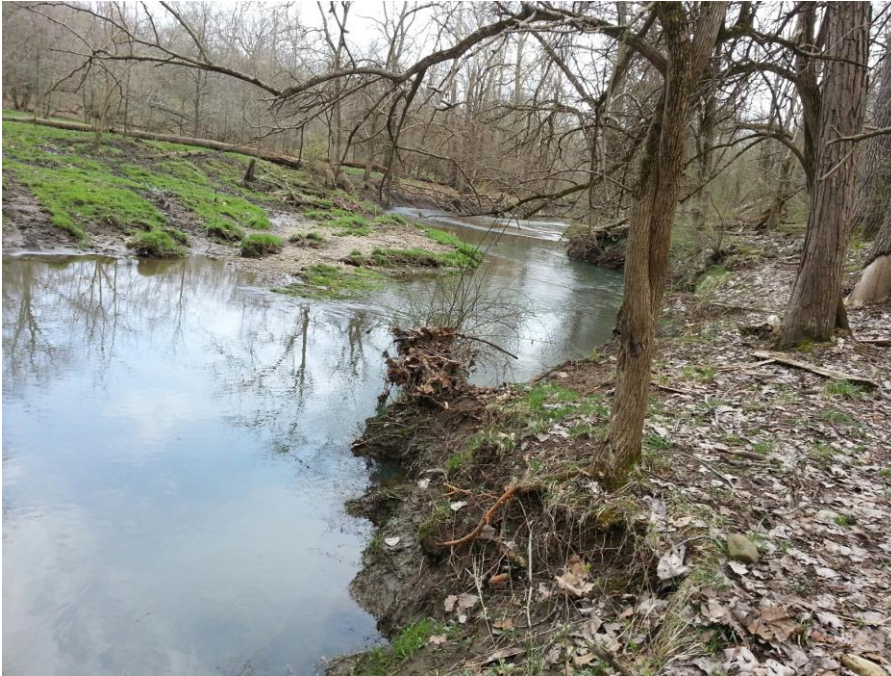
Look toward downstream at gravel sediment bar approximately 2500 feet downstream of Herschel Lake discharge April 10th 2019

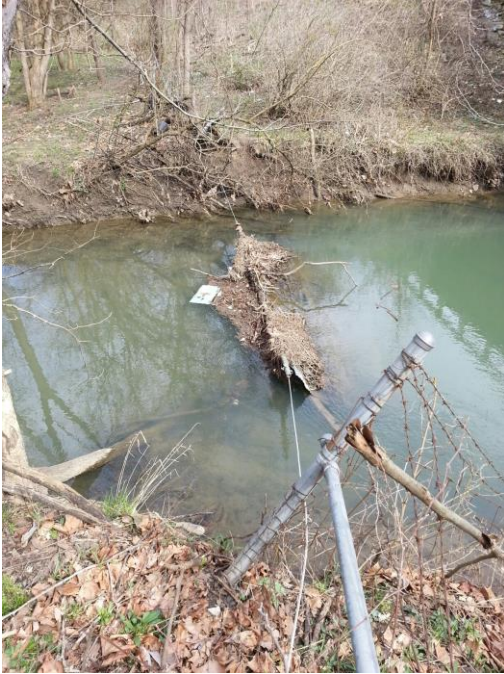
Look from the west bank of Grape Creek on the upstream side of East Ross Lane Bridge at cattle guard status April 10th 2019. **Communicate with Engineer and property owner to plan operation to implement regular debris removal.**

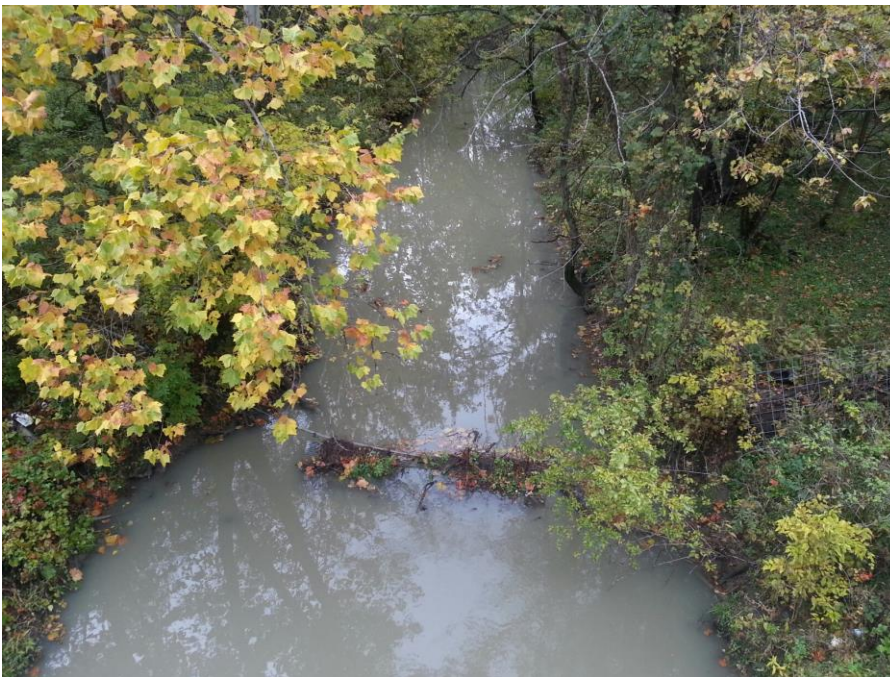
Look northerly from East Ross Lane Bridge October 21st 2019 at status of cattle guard upstream of bridge over Grape Creek. Determine source of cloudy stream water and eliminate.

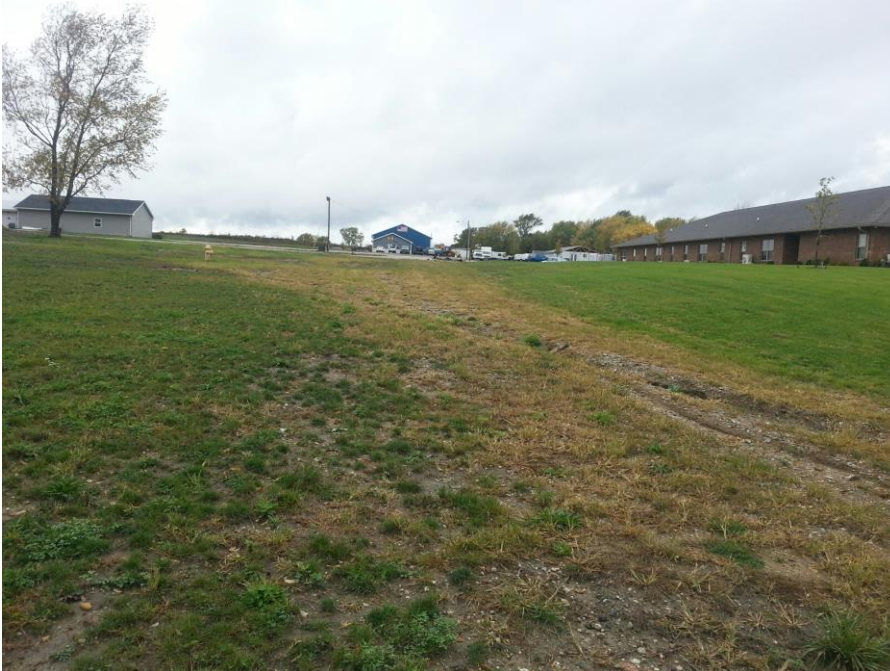
Look October 21st 2019 at erosion east of Herschel Lake Drive. Engineer plan, specification and cost estimate to force water into grated storm sewer manhole, repair ruts and establish turf. Delineate property line. Recommend grading be mow & pedestrian safe turf.

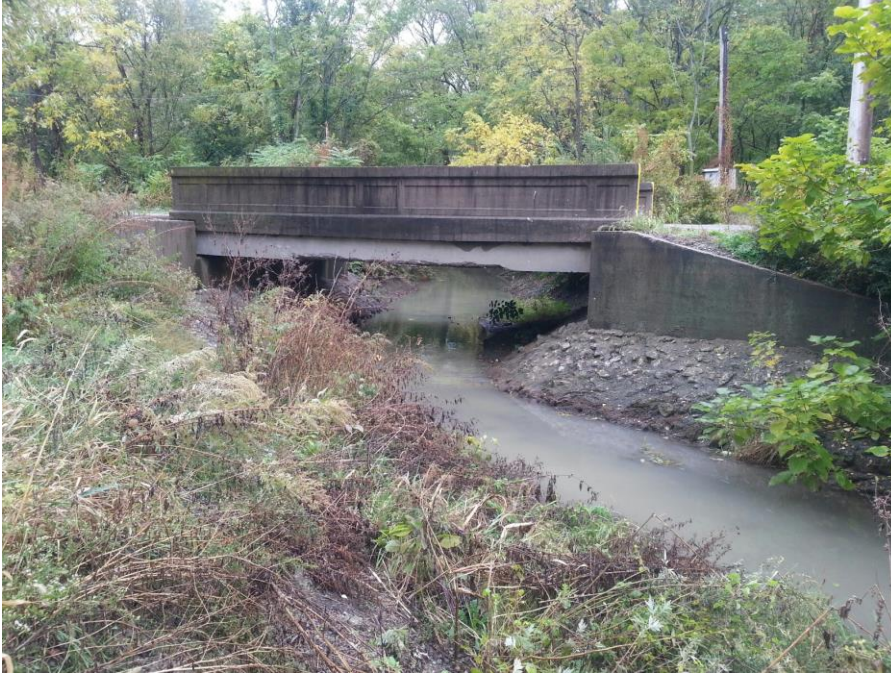
Storm Structure R8

Look from upstream towards downstream at Washington Avenue Bridge over Grape Creek October 21st 2019. Engineer plan and notice to remove sediment build-up; consider disposal in Votec deactivated sludge lagoon.

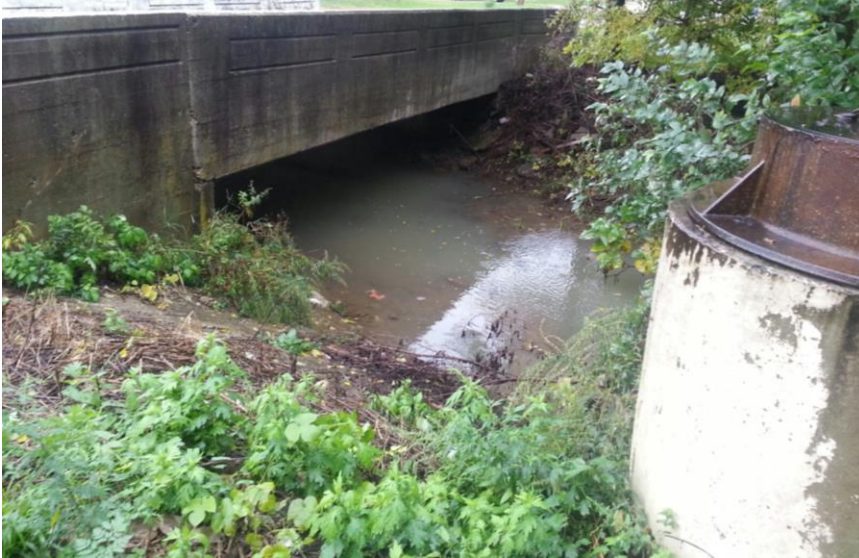
Storm Structure R10

Look southeast October 21st 2019 at upstream side of Keegan Street Bridge over Grape Creek. **Communicate with Engineer to schedule lifting lid to safely inspect inside of sanitary manhole.**

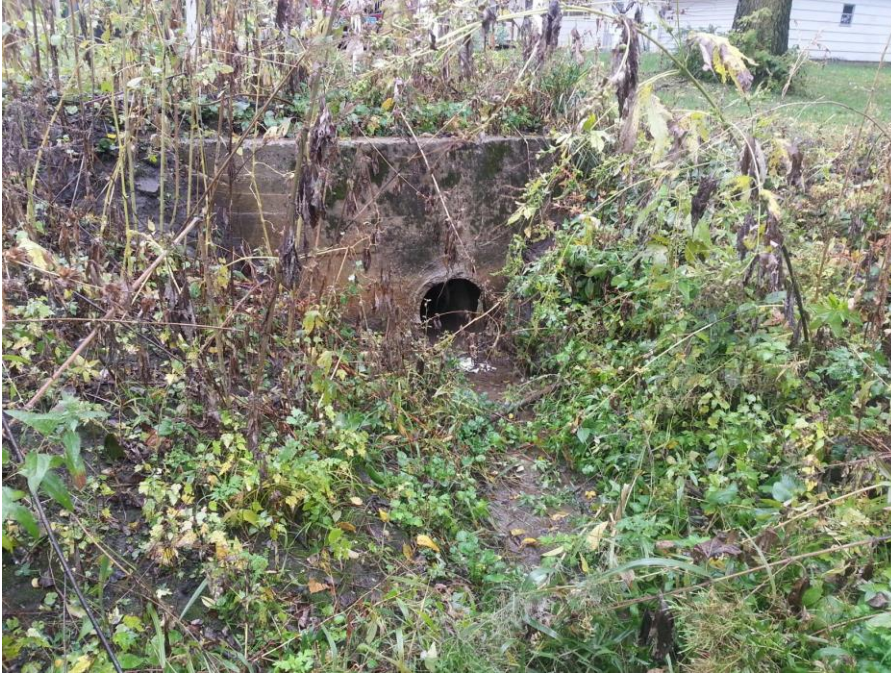
Storm Structure J1

Look south at storm sewer discharge on the North End of Adams Street October 21st 2019. Mow top of north end of Adams Street sufficient so delineators are visible.

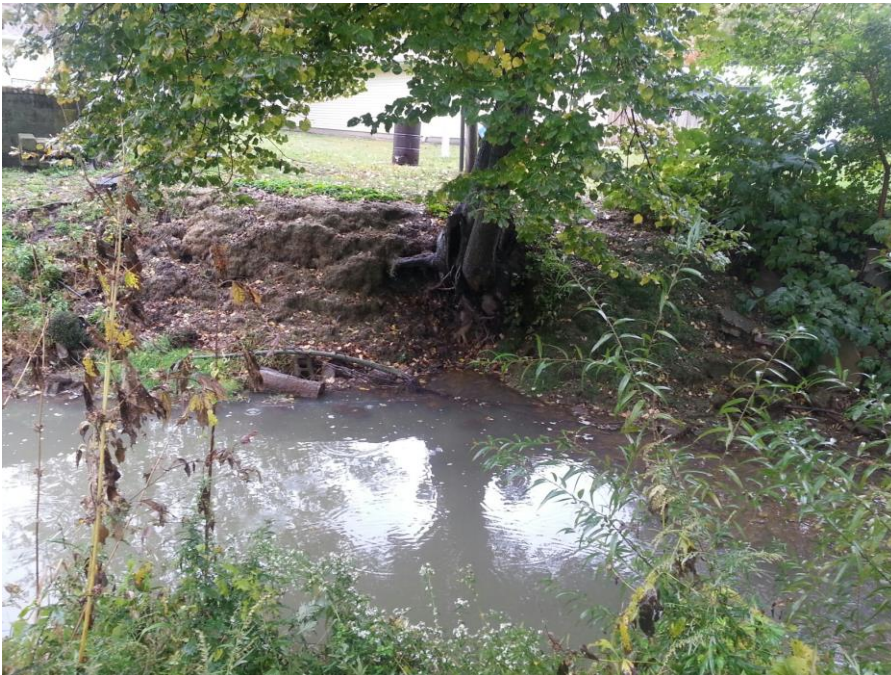
Look northwesterly October 21st 2019 at bend along Grape Creek located west of the North end of Adams Street approximately 350 feet. Appear grass clippings placed in erosion area at bend in creek.

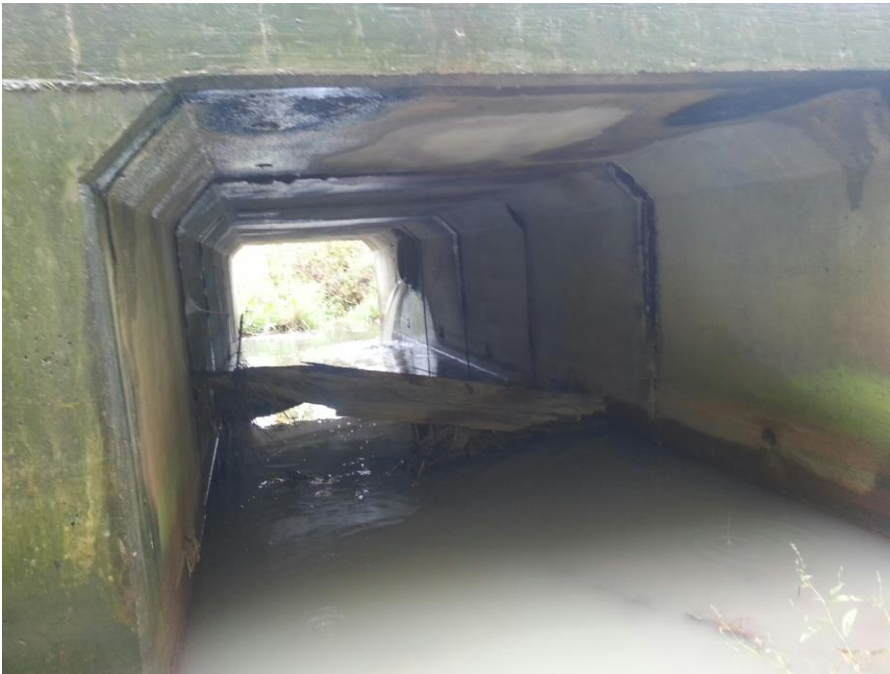
Storm Structure K1

Look toward upstream through West barrel of culvert under West Ross Lane over Grape Creek October 21st 2019. Appears water is cloudy discharging from storm sewer. Use mapping to inspect drainage from upstream of discharge. Test, communicate plan and eliminate condition.

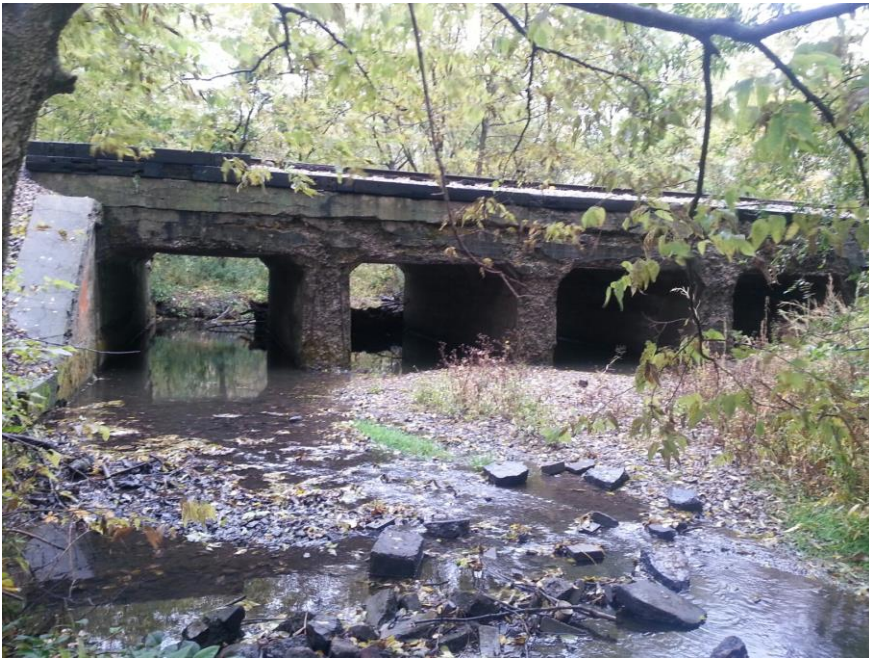
Storm Structure R11

Look West October 21st 2019 from downstream towards upstream at CSX railroad over Grape Creek

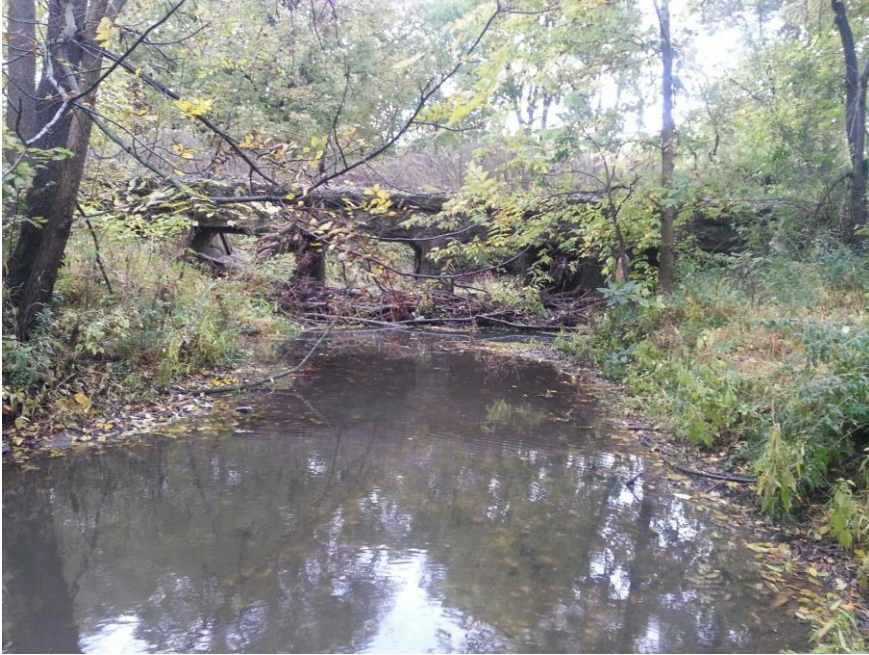
Storm Structure R12

Look from upstream towards downstream at CSX Railroad Bridge over Grape Creek October 21st 2019. Regularly police area and use telescoping pole with pool leaf rake to remove garbage and scum from stream and dispose of in legal manner.

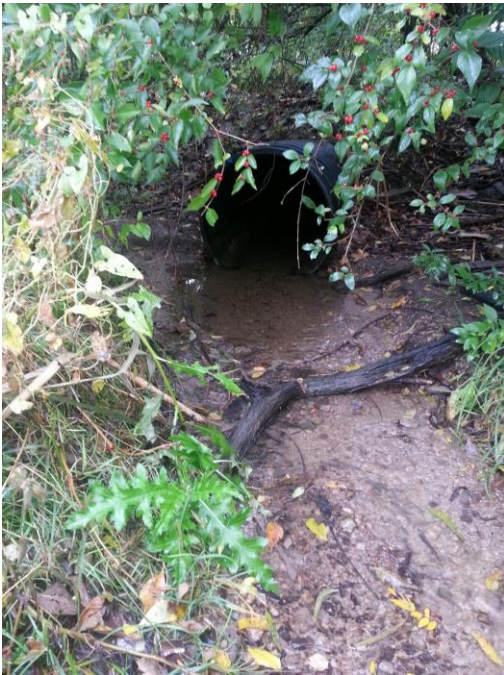
Storm Structure C1

Look October 21st 2019 at storm sewer discharging South of Coachlight Mobile Home Park. Engineer prepared plan to video inspect storm sewer upstream of discharge and smoke sanitary sewer along Morrison Street. Safely implement.

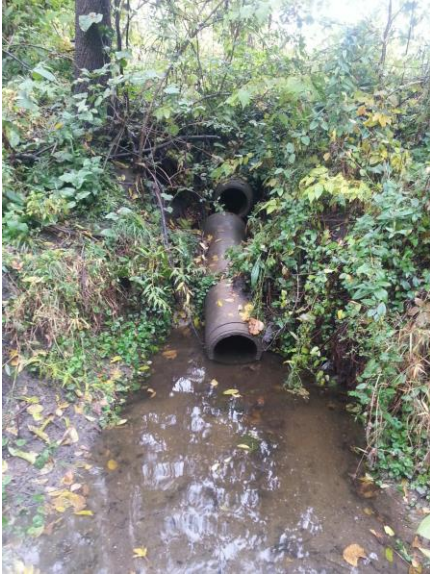
Storm Structure D1

Look North at storm sewer discharge October 21st 2019 from Coachlight Mobile Home Park into Grape Creek. Engineer plan, specification and estimate to reset pipe and stabilize erosion at the discharge. Consider obtaining permission from owner and Army Corp of Engineers to find and cut 6 foot wide path to outfall structure without cutting trees or limbs larger than 3" diameter. Reset pipe end, install flexible temporary bypass pipe & sand bag edge stream, configure erosion control material, cure then remove bypass and sand bags.

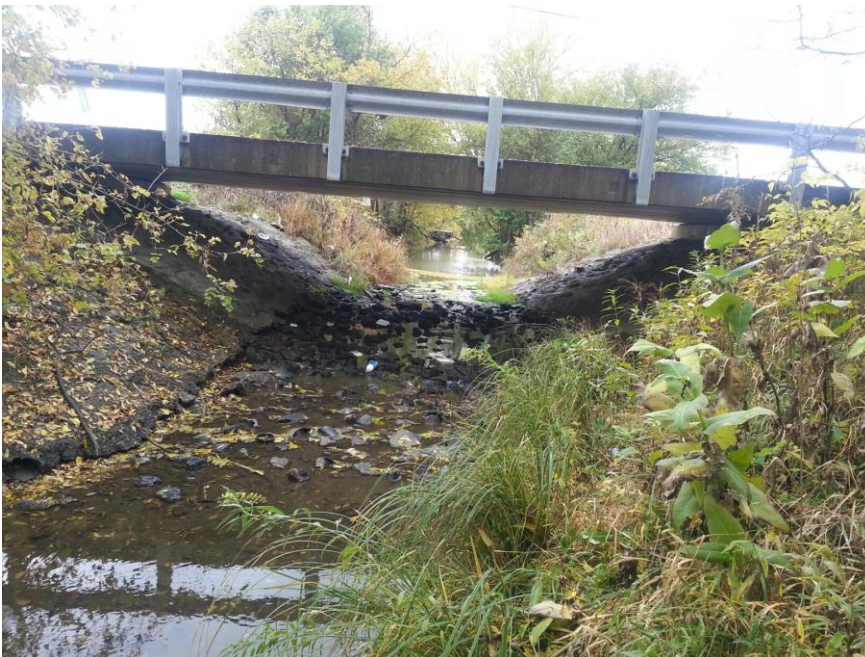
Storm Structure R13

Look October 21st 2019 from Downstream towards Upstream at Kingsdale Bridge over Grape Creek. Regularly police area and use telescoping poles with pool leaf rakes to remove trash from stream.

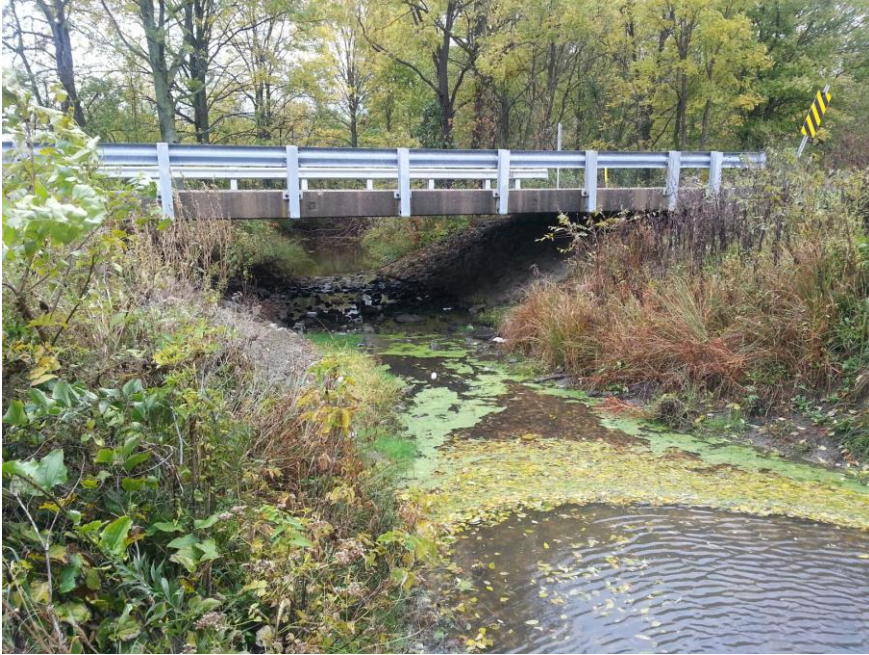
Storm Structure R14

Look from upstream towards downstream October 21st 2019 at Kingsdale Bridge over Grape Creek.

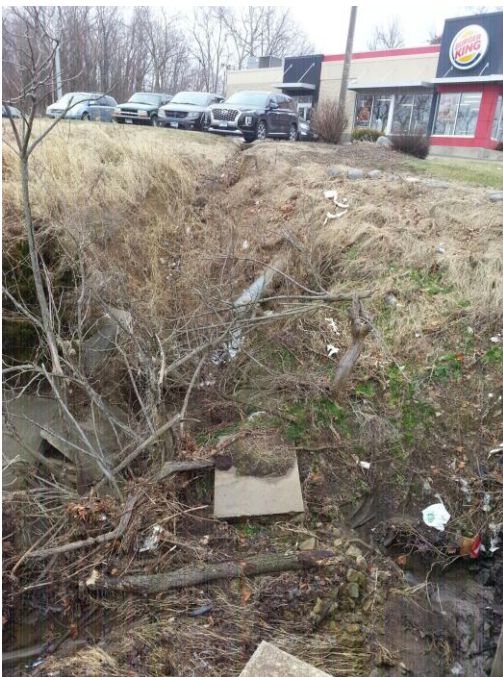
Look toward downstream January 23rd 2020 from Illinois Route 1 Bridge at washout in the bank at the southeast corner of Burger King parking lot. Significant erosion exists, communication required with restaurant property management to Engineer mitigation plan and obtain permits from Illinois Department of Transportation, Army Corps Engineers and Illinois Environmental Protection Agency. Regularly police area and use telescoping pole with pool leaf rake to safely remove garbage and scum from stream and dispose of in legal manner. Determine source of litter and eliminate.

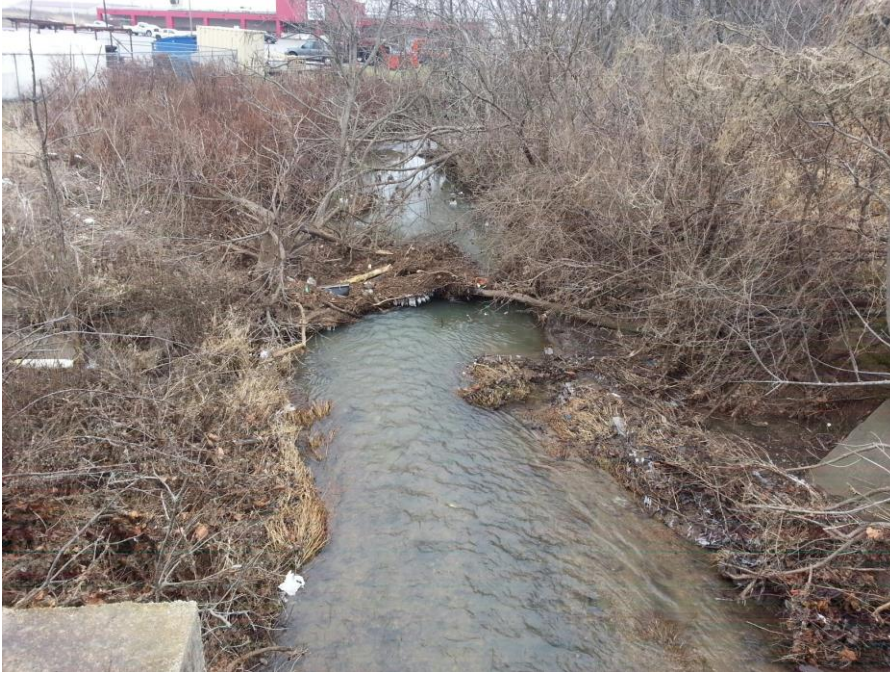
Look toward downstream from Illinois Route 1 at Grape Creek at logjam below January 23rd 2020. Regularly police area and use telescoping pole with pool leaf rake to safely remove garbage and scum from stream and dispose of in legal manner. Determine source of litter and eliminate.

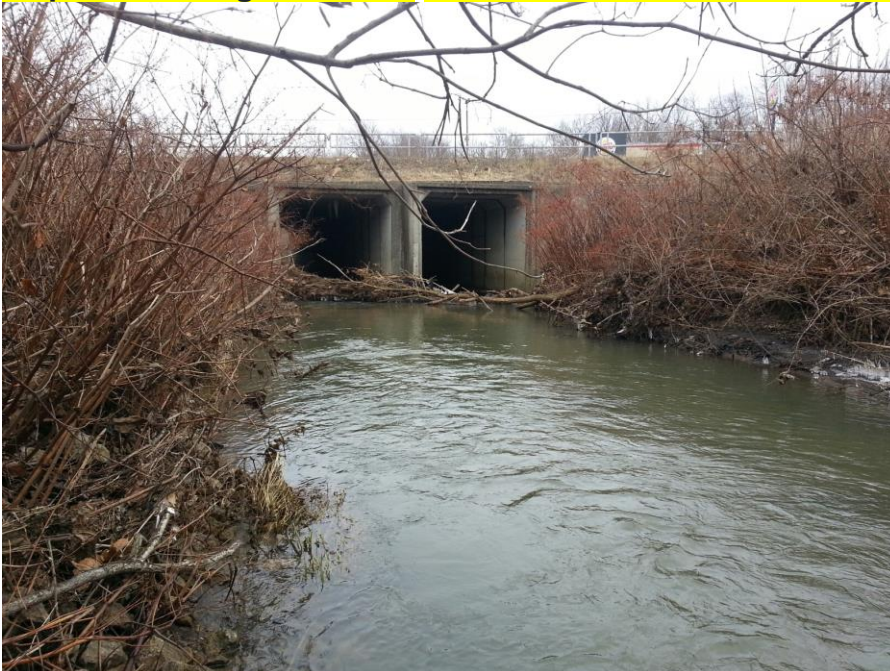
Look January 23rd 2020 toward downstream along Grape Creek at box culverts under Illinois Route 1. Communicate and coordinate with the Illinois Department of Transportation to keep culverts unobstructed. Regularly police area and use telescoping pole with pool leaf rake to safely remove garbage and scum from stream and dispose of in legal manner. Determine source of litter and eliminate.

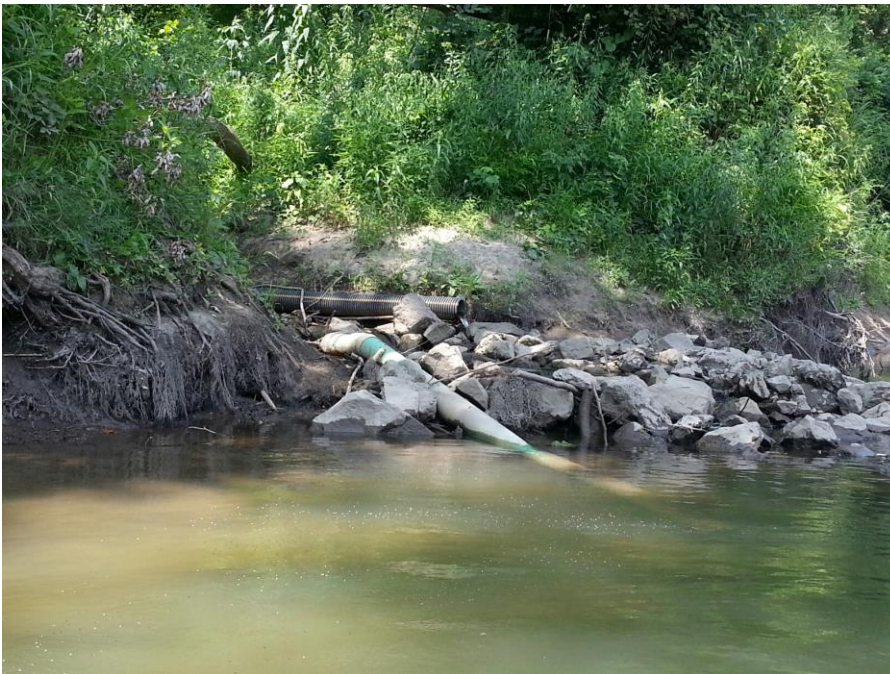
Look July 24th 2019 southerly at the south bank of Vermilion River near abandoned General Motors site upstream of CSX Railroad at black high density polyethylene pipe discharging liquid into stream and PVC attachment loose in river bank. Communicate with property owner regarding purpose of pipe.

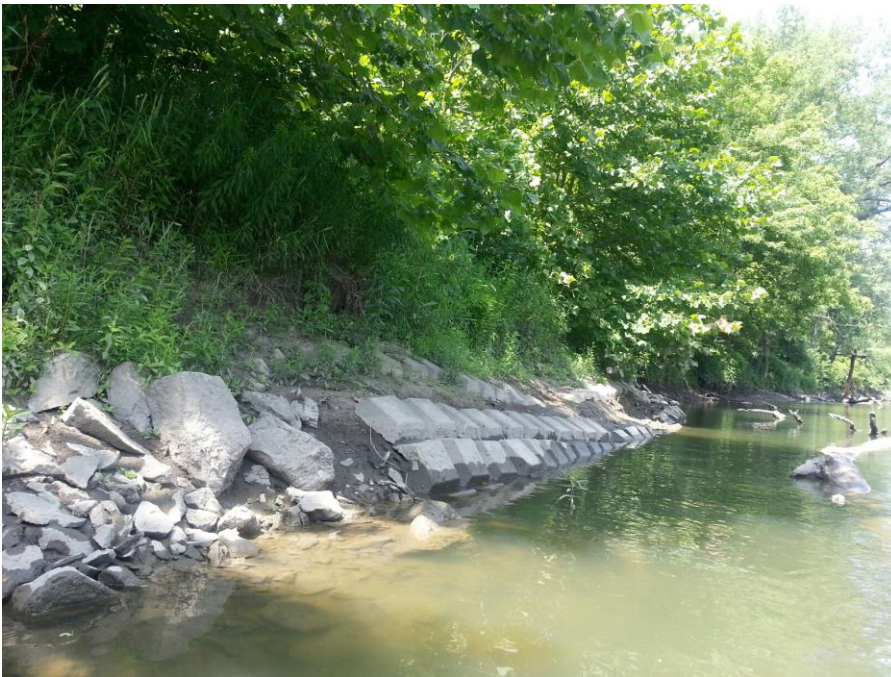
Look westerly July 24th 2019 at condition of concrete revetment mat along south bank of Vermilion River approximately 100 to 200 yards upstream of the Tilton Arch CSX Railroad Bridge near General Motors site

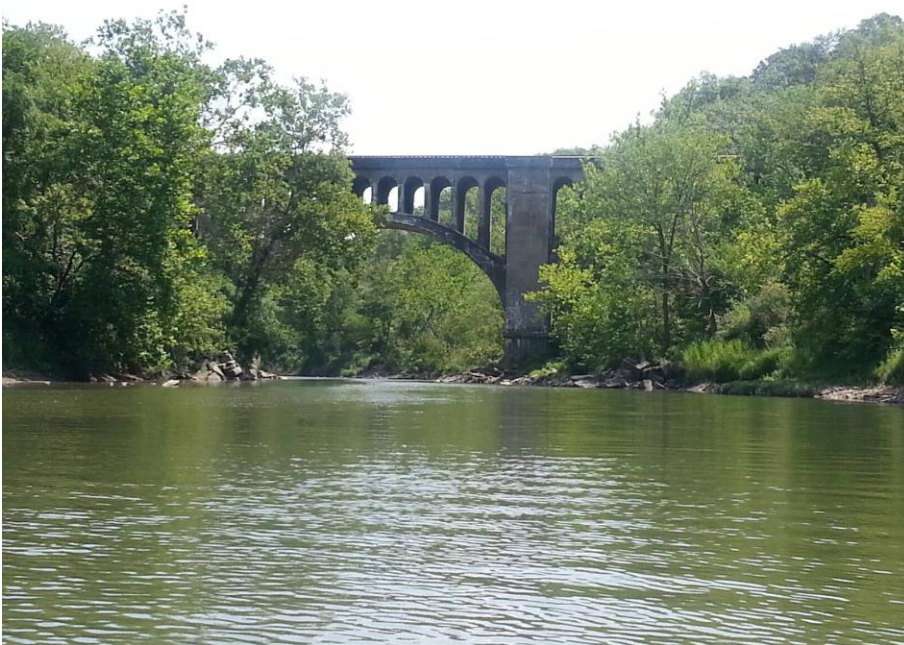
Look toward downstream July 24th 2019 at the upstream face of Tilton Arch CSX Railroad Bridge. Set elevation benchmarks & cross sectional survey of upstream & downstream face of bridge and river bottom sufficient to estimate bridge hydraulics.

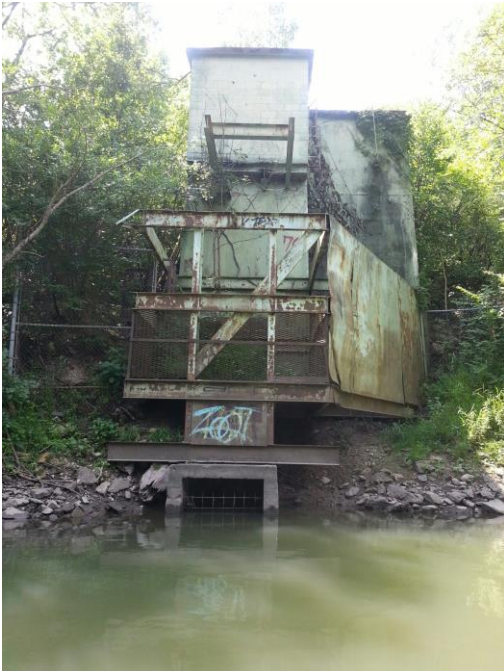
Look July 24th 2019 at green water structure, appears to be abandoned, on the south bank of Vermilion River upstream of Tilton Arch CSX Railroad Bridge. Communicate with property owner regarding purpose and details of structure

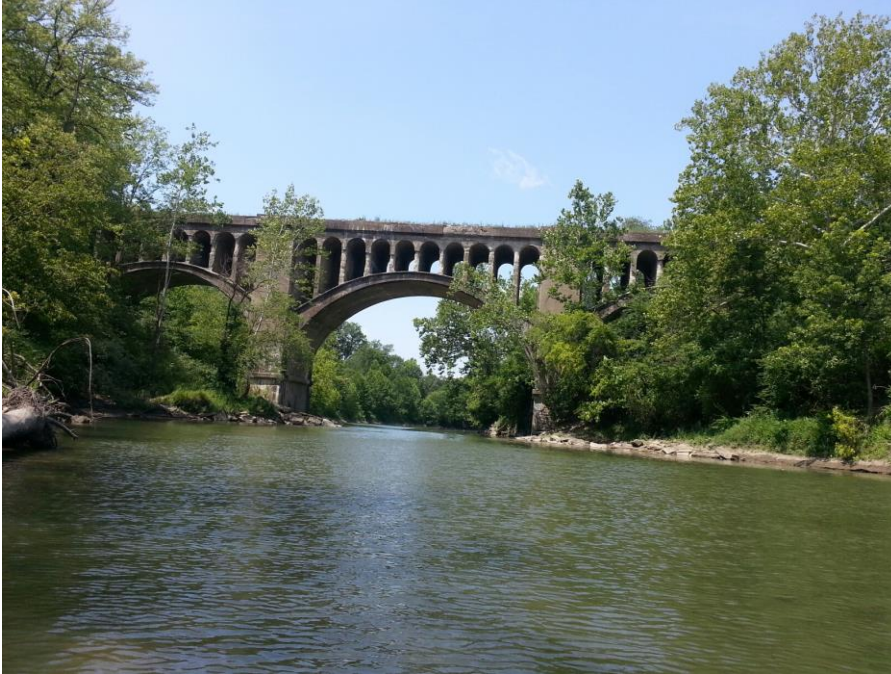
Look July 24th 2019 from downstream along the Vermilion River at the downstream face of Tilton Arch CSX Railroad Bridge
