Division of Water Pollution Control ANNUAL FACILITY INSPECTION REPORT

for NPDES Permit for Storm Water Discharges from Separate Storm Sewer Systems (MS4)

Report Period: From March, 2019 To March, 2020

Name: Village of Tilton Mailing Address 1: 1001 Tilton Road
Mailing Address 2: _____ County: Vermilion
City: Tilton State: IL Zip: 61833 Telephone: 217-477-0800
Contact Person: David Phillips, Mayor Email Address: dphillips@tilton.com
(Person responsible for Annual Report)

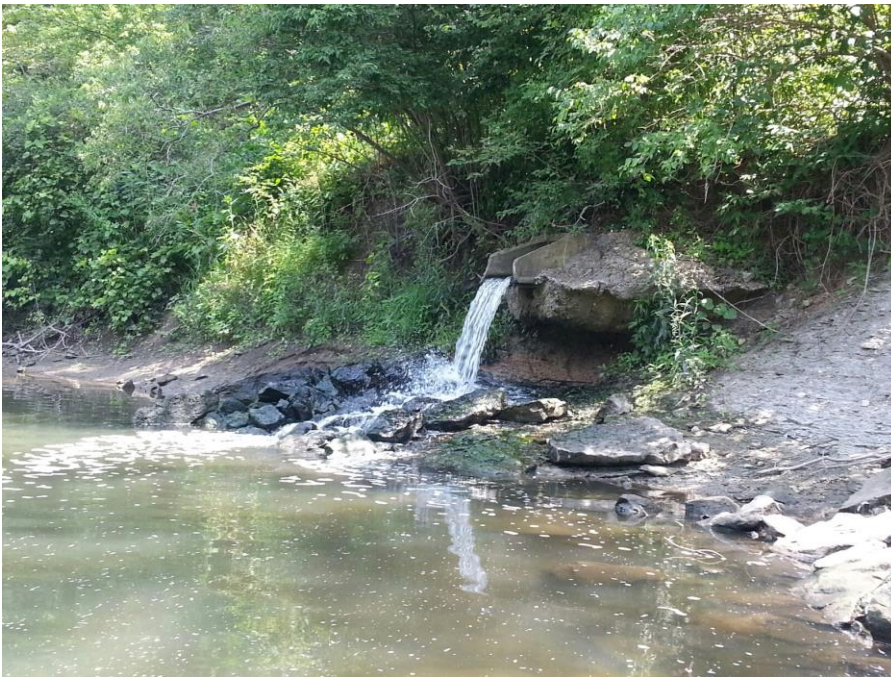
Look towards downstream July 24th 2019 at Tilton Sanitary Sewer Treatment Plant discharge into Vermilion River on the south bank. Village planning sewer treatment upgrades to eliminate discharge and/or improve the quality of discharge water.

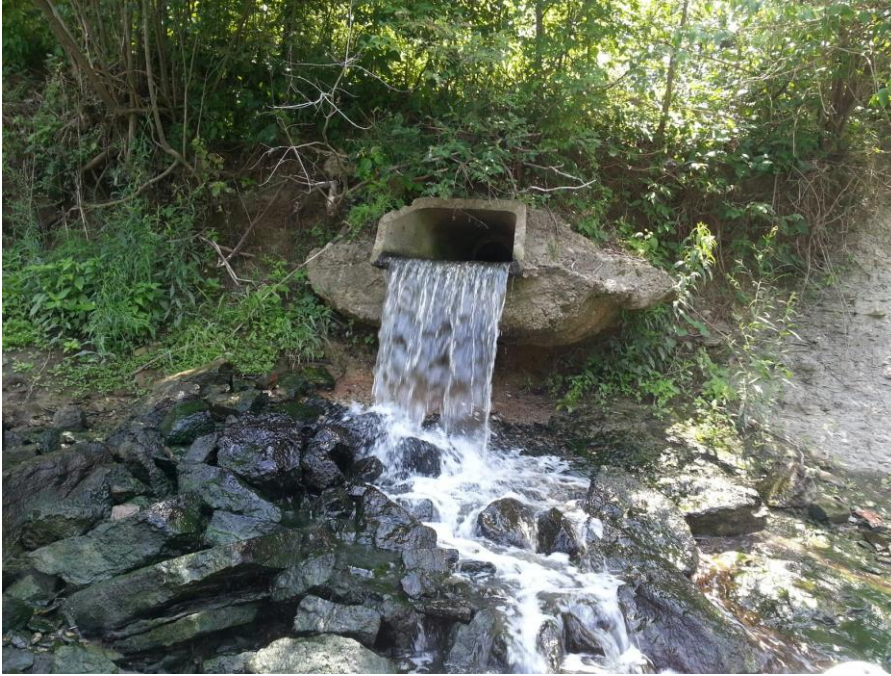
Look toward south July 24th 2019 at Tilton Sanitary Sewer Treatment Plant discharge at Vermilion River. Village planning sewer treatment upgrades to eliminate discharge and/or improve the quality of discharge water.

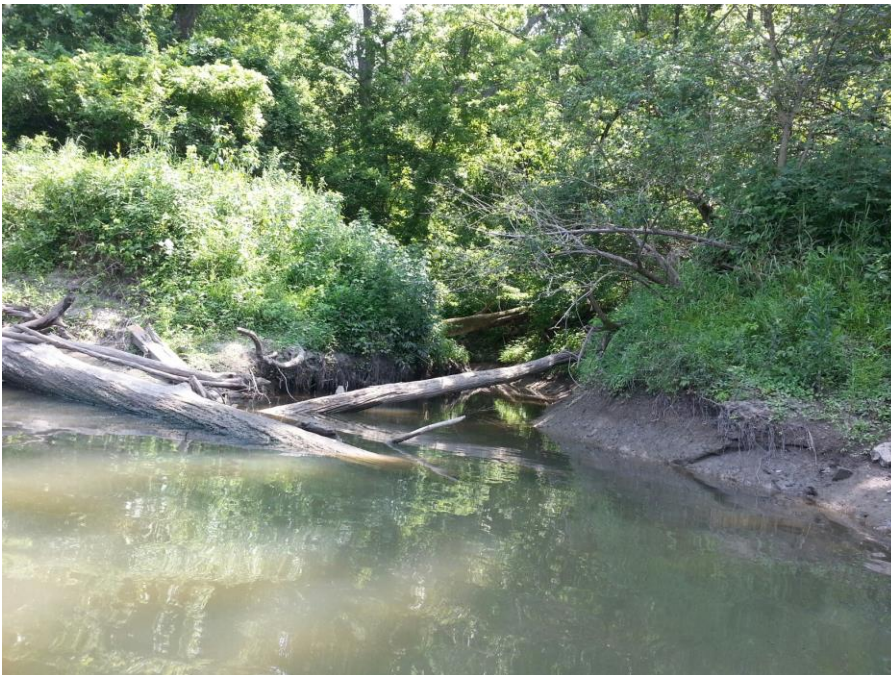
Look towards the south from Vermilion River July 24th 2019 at drainage swale immediately downstream of Tilton Sewer Treatment Plant Discharge.

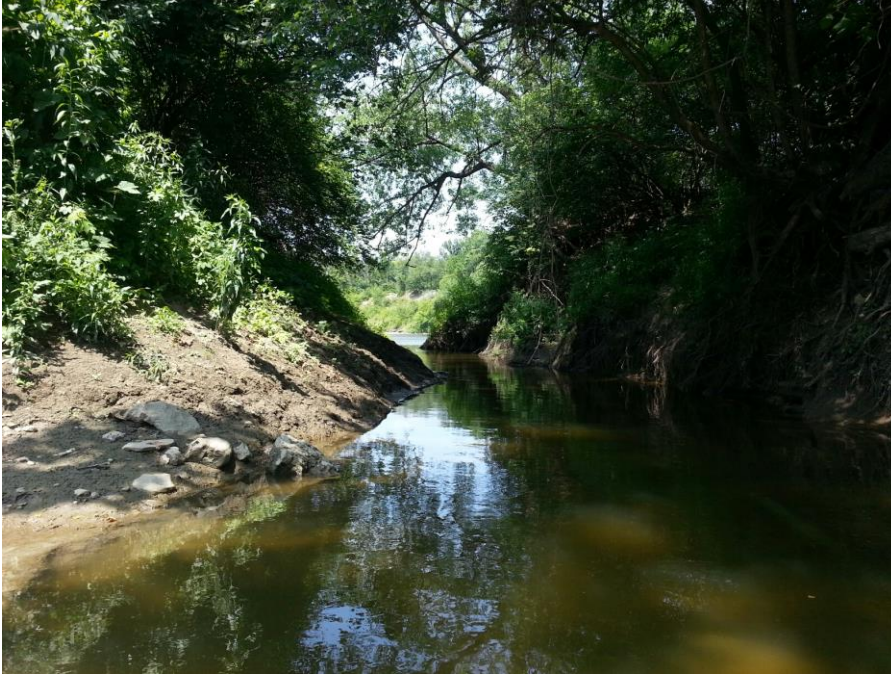
Look July 24th 2019 from Vermilion River toward the north at cut between river and pit. Flow is from pit towards river.

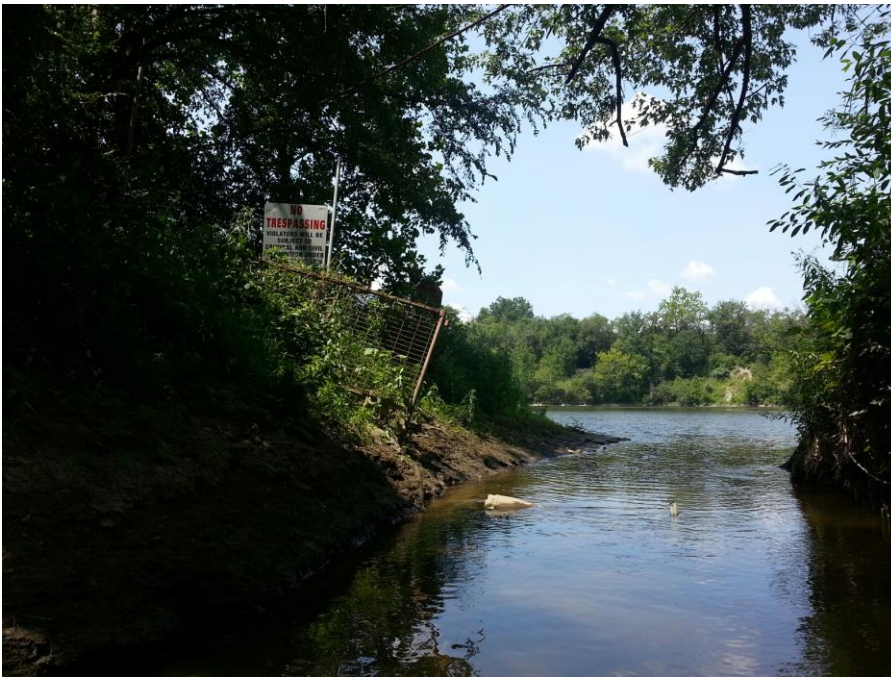
Look northerly at channel between Vermilion River and strip mine pit July 24th 2019. The flow is steady from the pit to the river also “no trespassing violators will be prosecuted” sign is posted at the entrance of the pit.

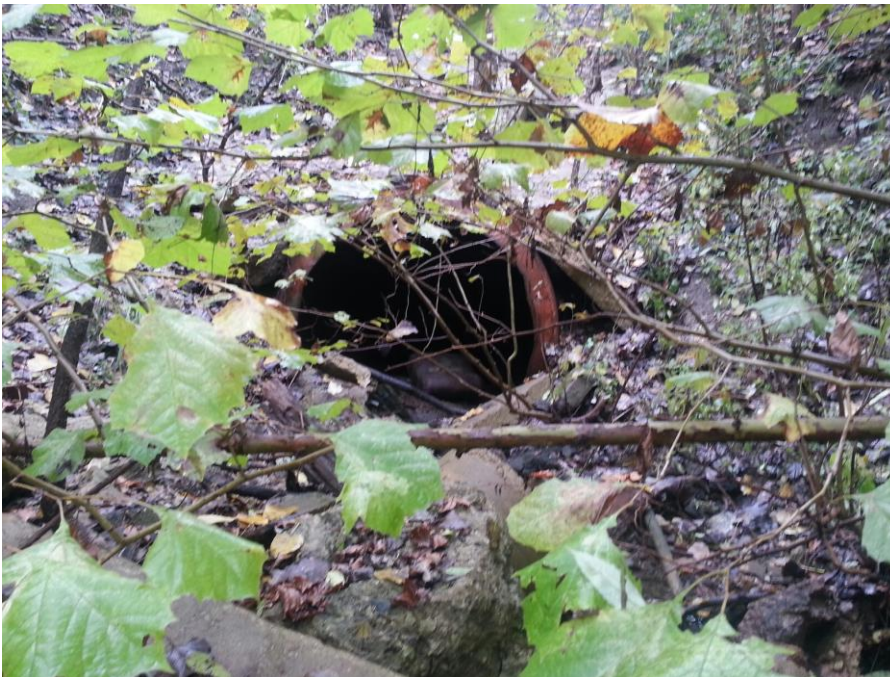
Storm Structure B1

Look South October 21st 2019 at downstream end of culvert under McVey Street. Village coordinate with engineer to safely perform and record video robotic inspection of pipe.

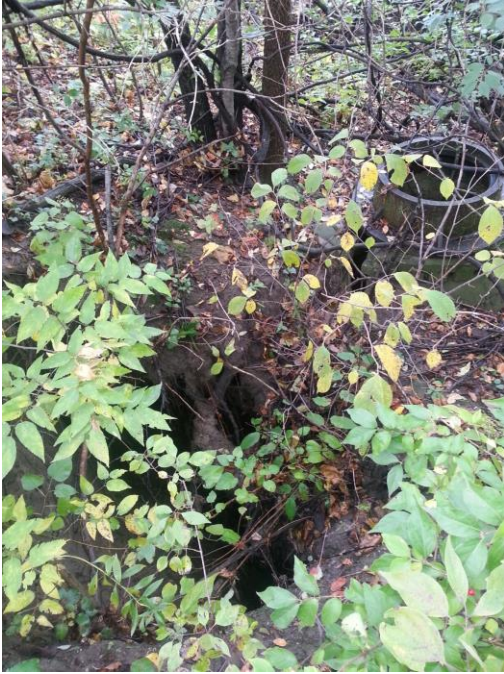
Storm Structure B3.1

Look at sinkhole near brick block manhole on IDOT Right-of-Way October 21st 2019 near Tilton ball fields. **Communicate and coordinate with the Illinois Department of Transportation to inspect and remediate conditions.**

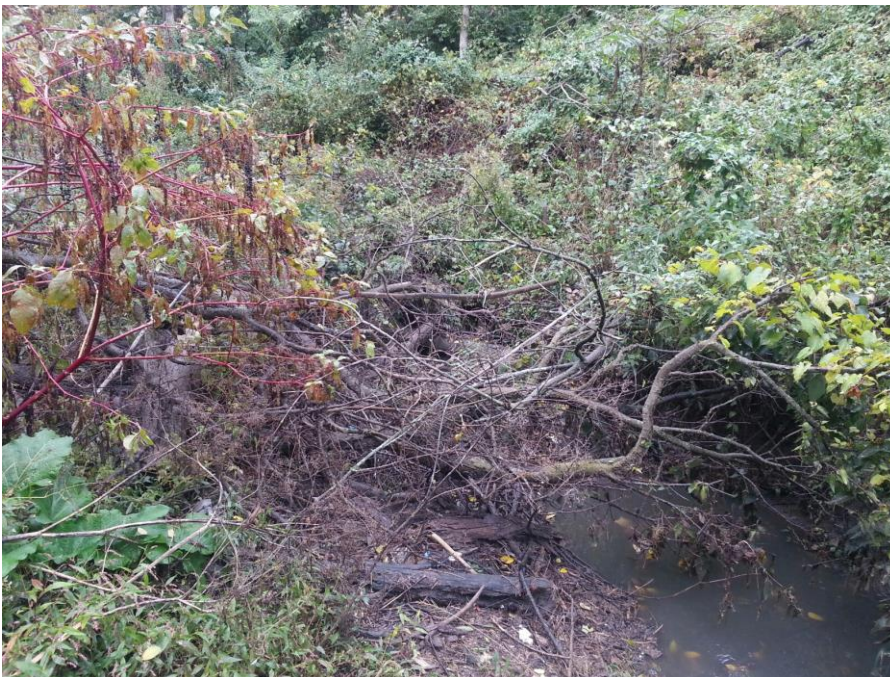
Storm Structure A3

Look at status of bar rack under abandon railroad spur north of East 1st Street October 21st 2019. Implement access improvement in accordance with Engineers plan, specifications & estimate also regularly inspect and clear debris.

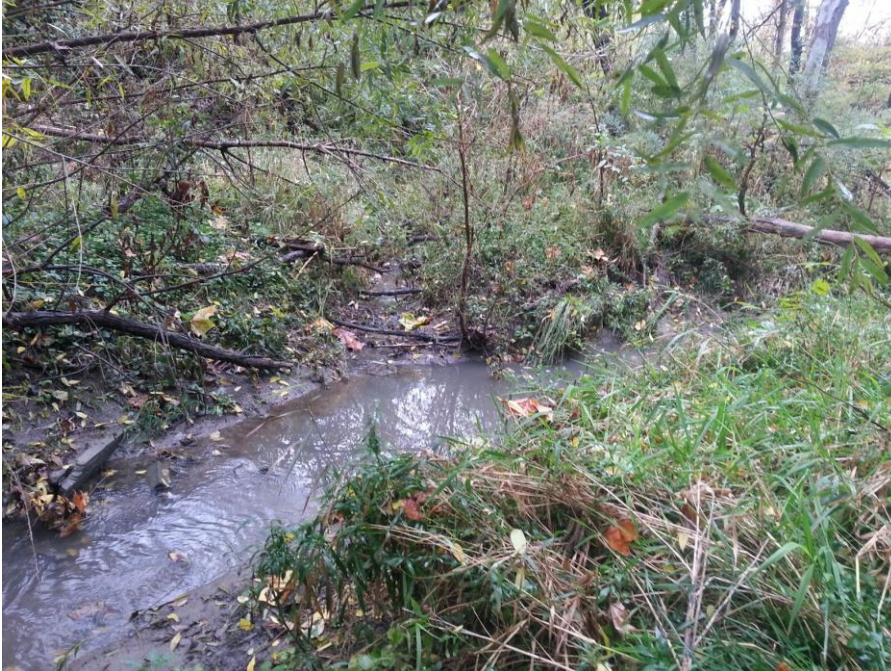
Look October 21st 2019 at merging storm water from CSX railroad and north East 1st Street

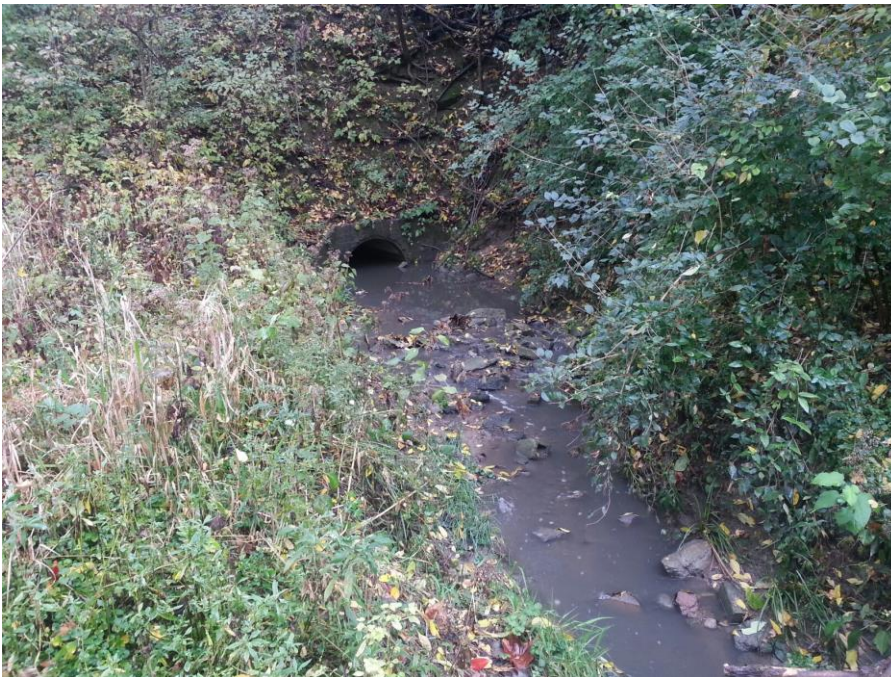
Storm Structure A4

Look storm sewer discharging north of East 1st Street October 21st 2019

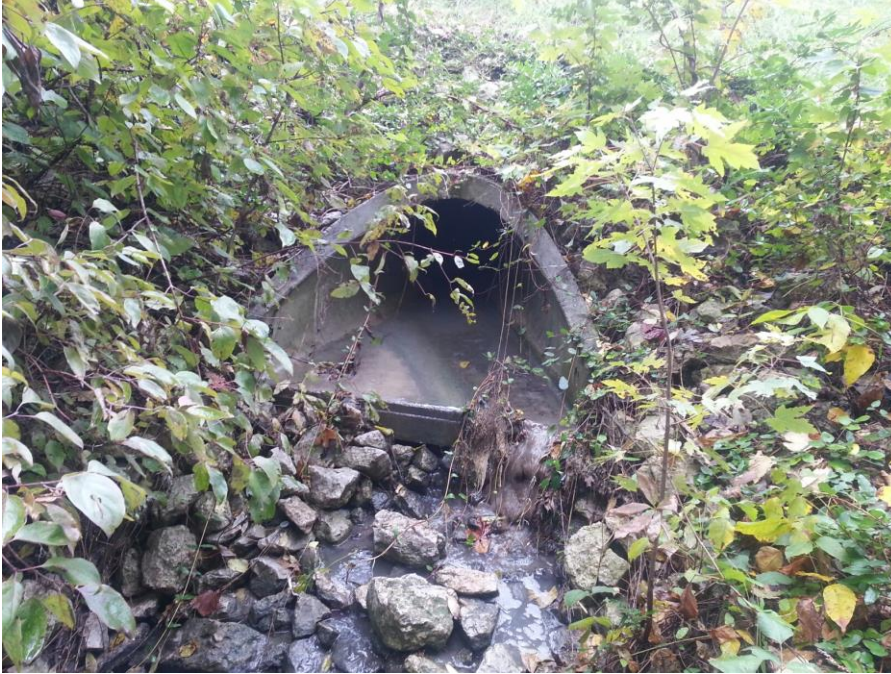
Storm Structure U1

Look October 21st 2019 at stormwater discharging from flared end section along north side 14th Street

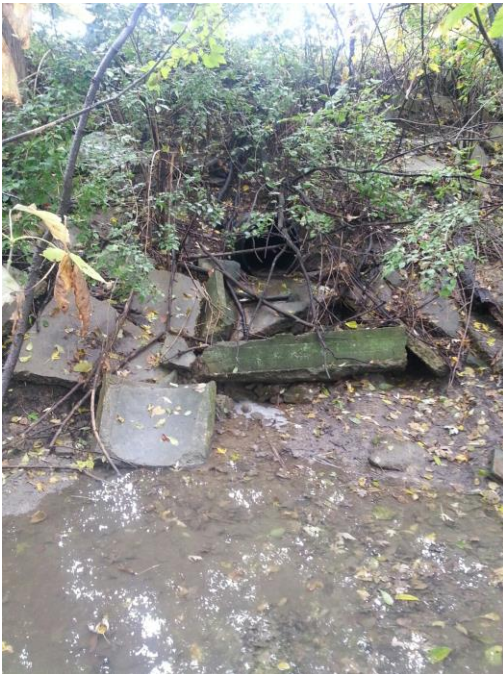
Storm Structure A60

Look October 21st 2019 at storm sewer discharging into open ditch east of North F Street and near East 3rd Street Right-of-Way

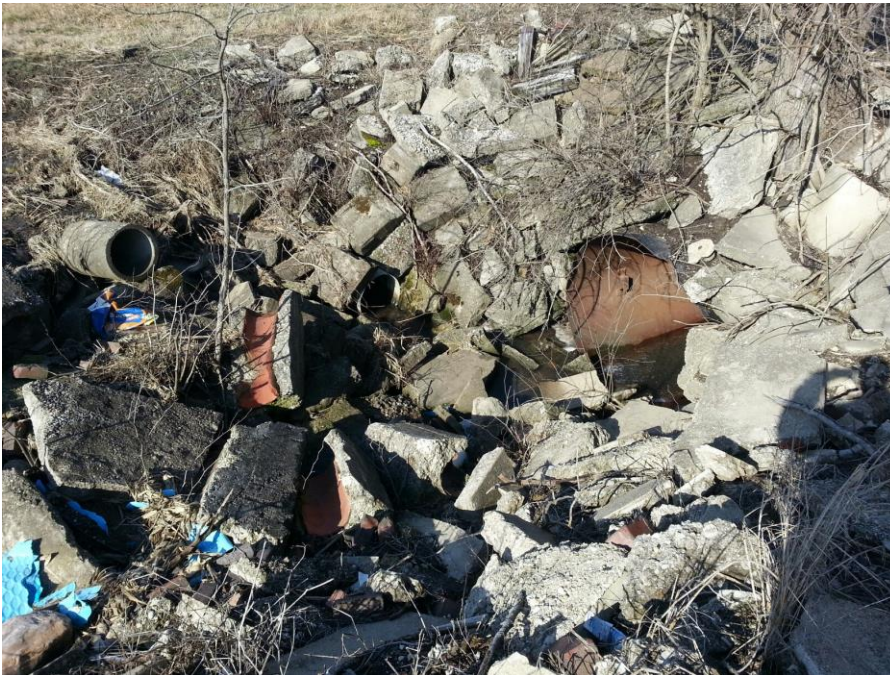
Look at tile from west near farm crossing west of Vermilion County Animal Shelter February 19th 2020. Consider video inspection of pipes & communication with County, IDOT, Village and owner. Engineer a plan, specifications and estimate to improve conditions.

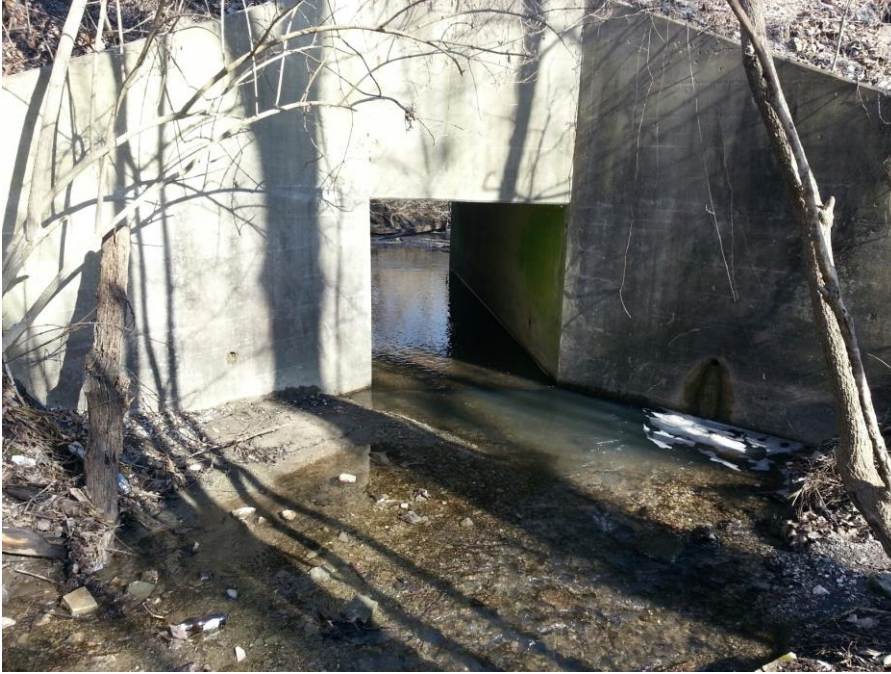
Look February 19th 2020 at upstream side of box culvert under Songer Cemetery Road

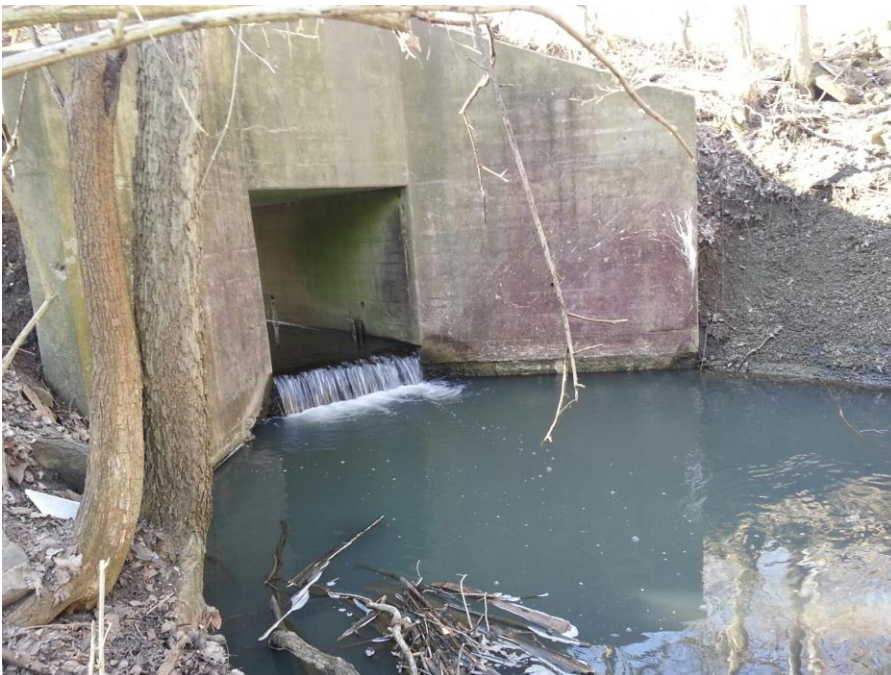
Look February 19th 2020 at downstream side of box culvert under Songer Cemetery Road

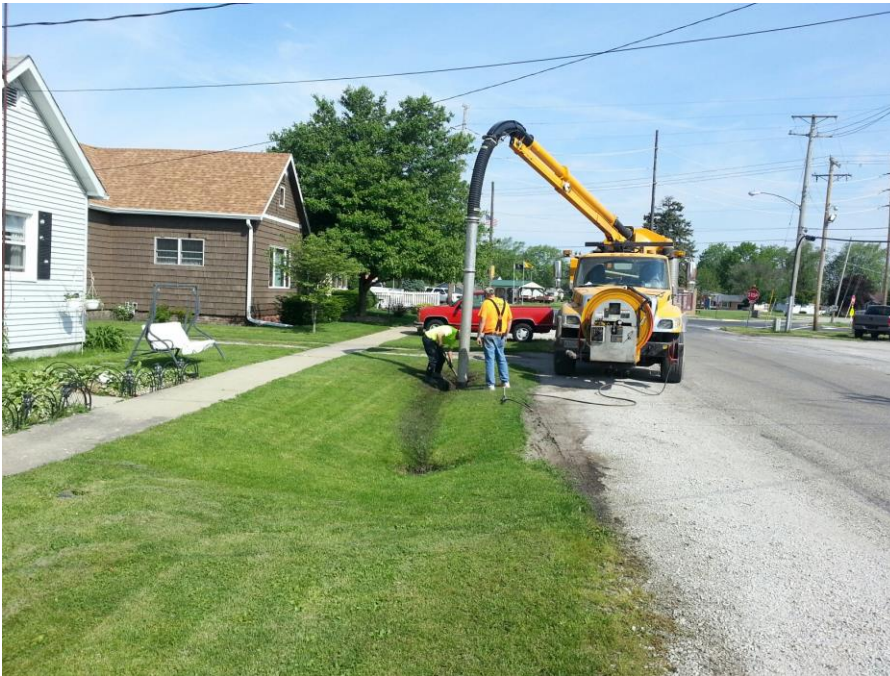
Look North at Village two-man crew using Vactor truck to clean storm sewer drainage system along the western side of H Street south of West 5th Street. Village staff concentrated storm sewer cleaning program efforts generally north of Norfolk Southern Railroad and east of CSX Railroad. Using mapping, Engineer measures 130 storm structures and 19,870 feet of pipe in this area. Use Sewer Log Sheet included in Attachment G to comply with measurable reporting requirements of IEPA.

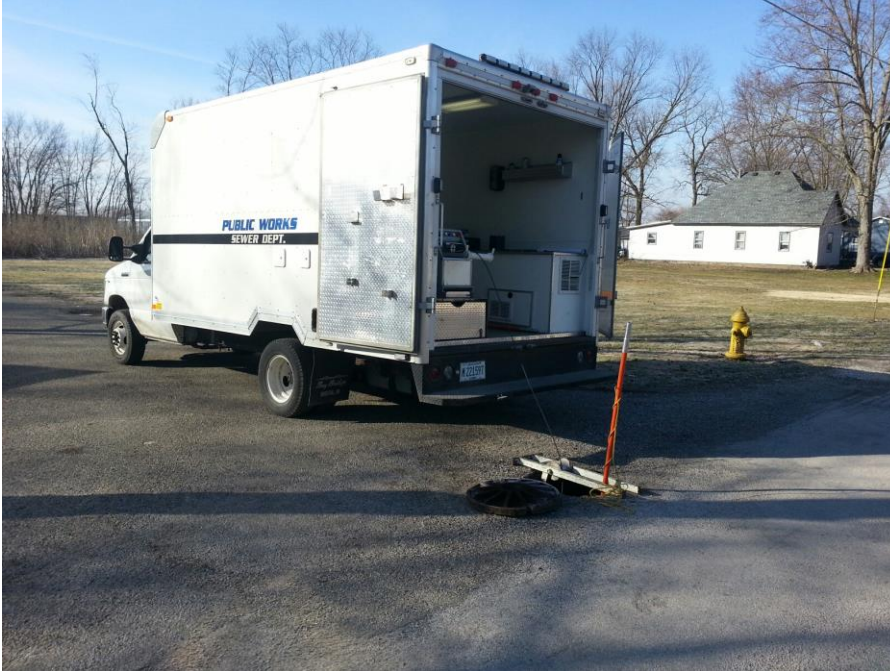
Sanitary Structure 69.2

Look westerly February 19th 2020 at Village sewer video inspection vehicle looks into sewer pipe. Excessive flow appears to exist in sanitary.

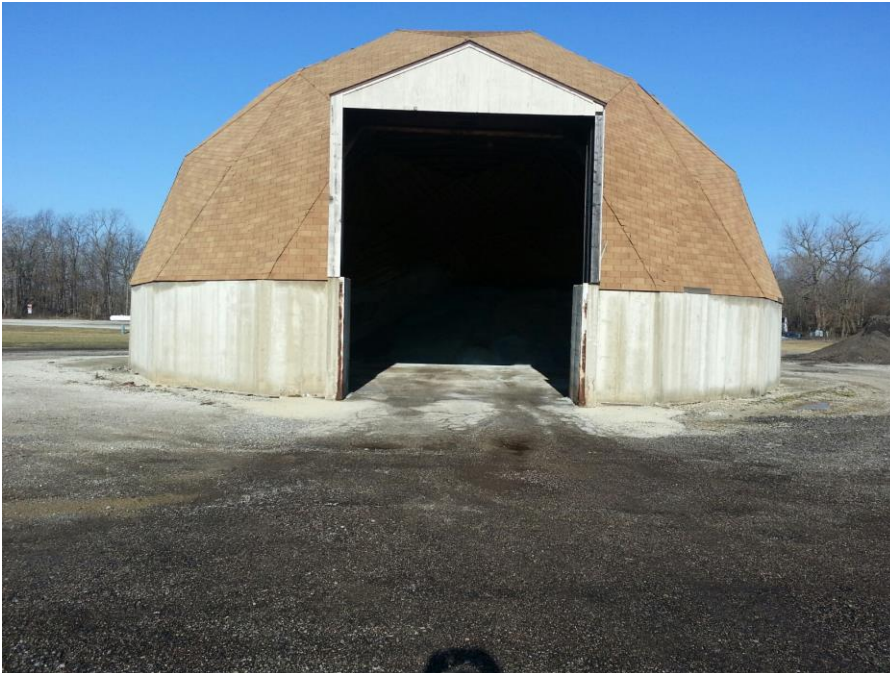
Look westerly at Village salt shed February 19th 2020. Provide Engineer with Village Salt Purchase Quantities since 2017 for reporting.

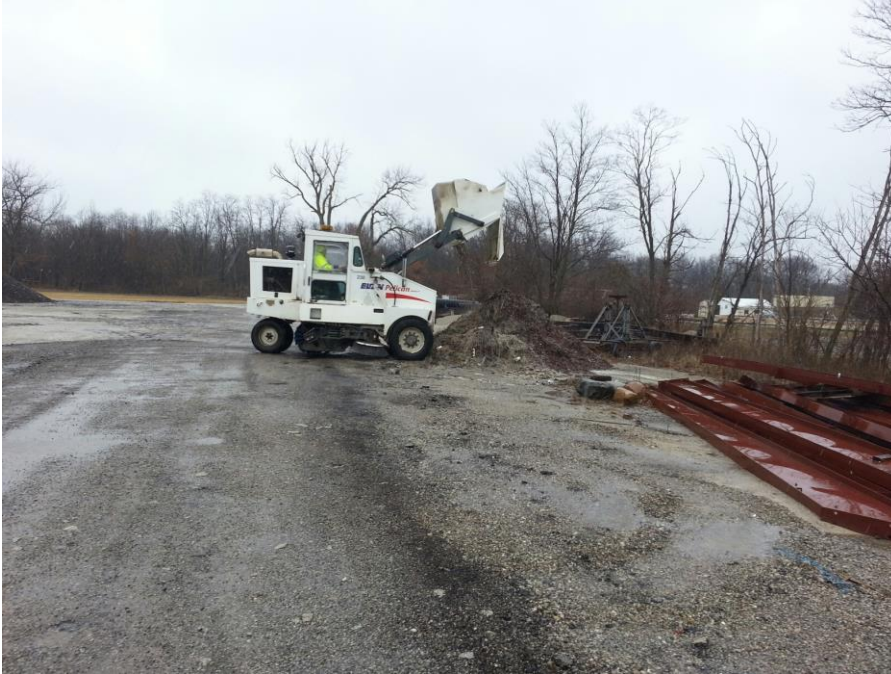
Look northerly February 25th 2020 at Village street sweeper stockpiling sweepings on pile near Public Works facility. Appears to be approximately 5.5 cubic yards on stockpile; 9 days of sweeping streets logged by Village Staff: **Use Sweeper Log Sheet included in Attachment G to comply with measureable reporting requirements by IEPA. Provide Engineer with ultimate location of material disposal.**

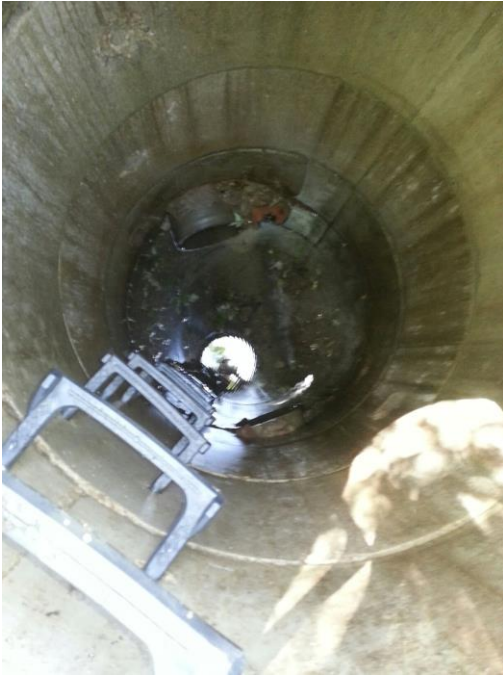
Look into Storm Sewer Manhole C3 draining slowly & surcharged with water at the southeast corner of the intersection of Henson and Glendale. Clean & video inspect storm sewer line downstream and upstream manhole while Engineer observes. Prevent storm sewer and surface drainage of this area from mixing with the sanitary sewer system.

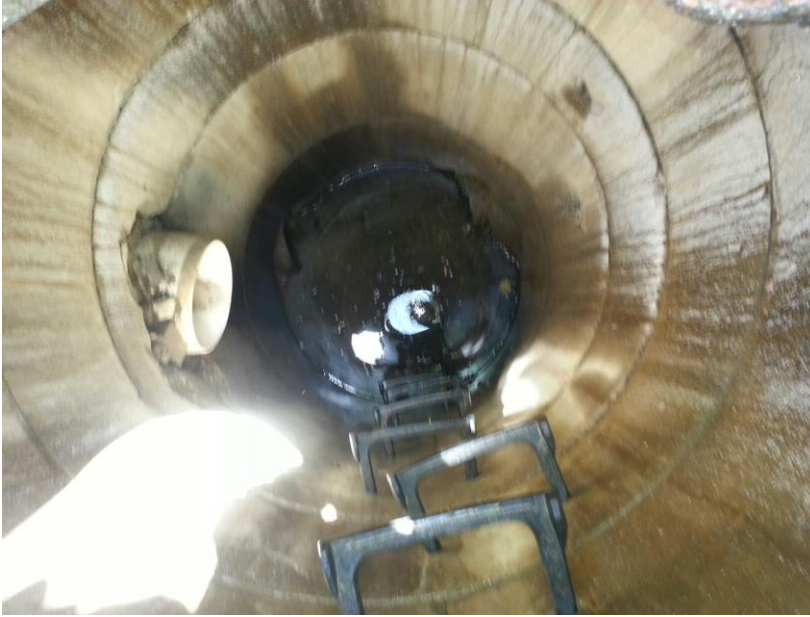
Look into Storm Manhole C4 draining slow and surcharged at the southeast corner of the intersection of Glendale and Emerson May 22nd 2019. Clean and video inspect pipe line downstream and up stream of manhole during observation by engineer. Ensure storm & sanitary sewer are separated.

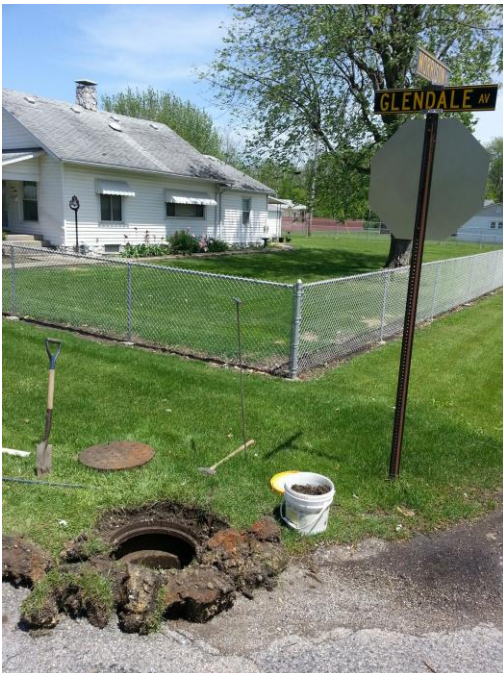
Look northeasterly May 22nd 2019 at Storm Sewer Manhole C8 6in below grade with a 22 and 3/4 inch cover ring diameter at the northeast corner of the intersection of Morrison and Glendale. Use vactor truck to clean storm sewer downstream & upstream towards all the way to Grape Creek and video inspect line. Prevent storm sewer and surface drainage of this area from mixing with the sanitary sewer system.

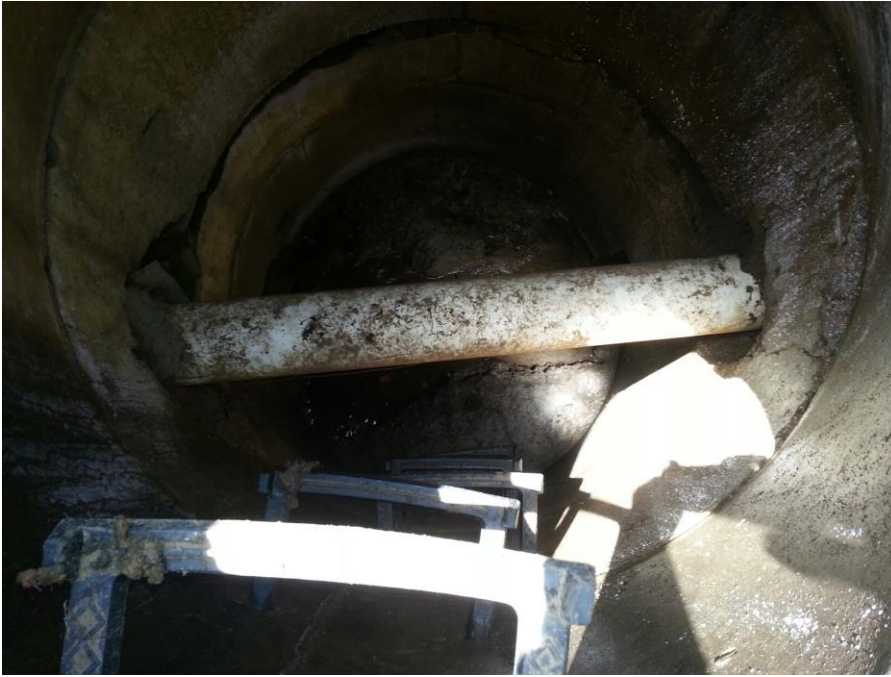
Look May 22nd 2019 in Storm Sewer Manhole C8 at possible conflict sanitary line in storm sewer manhole

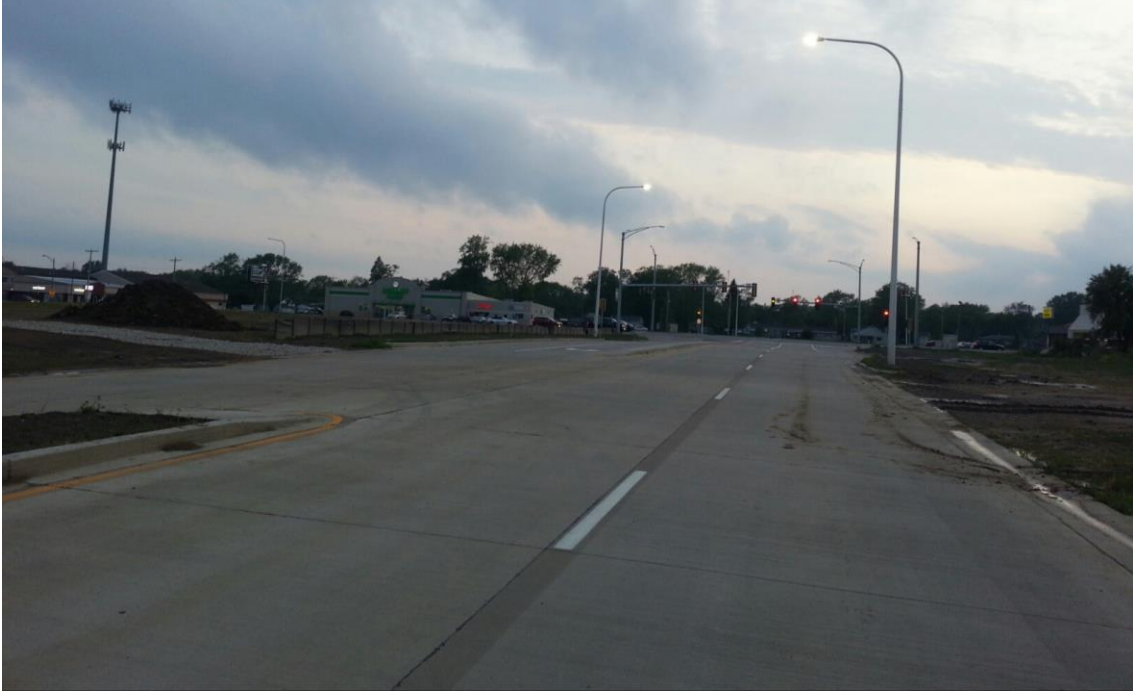
Look west July 15th 2019 at pavement along Ramp Road where soil appears to have been swept from the pavement after previous workday.

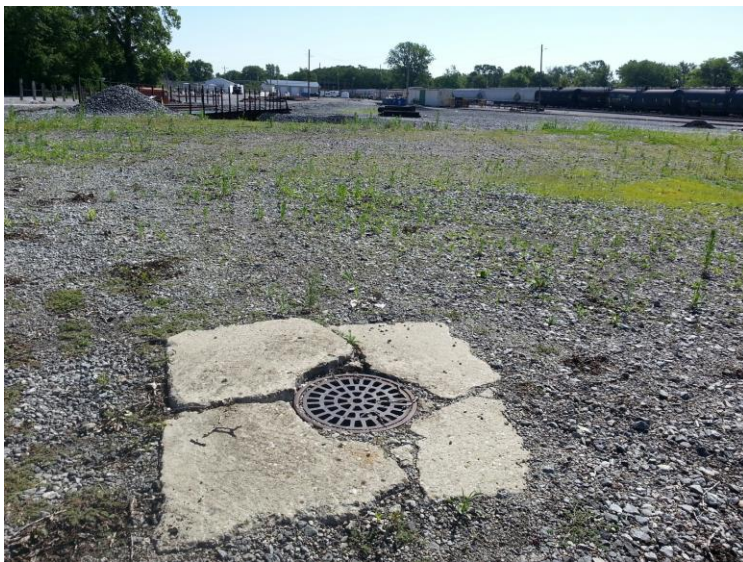
Photo A

Look southeasterly June 25th, 2019 at existing drainage structure in Norfolk Southern Railroad Right-of-Way

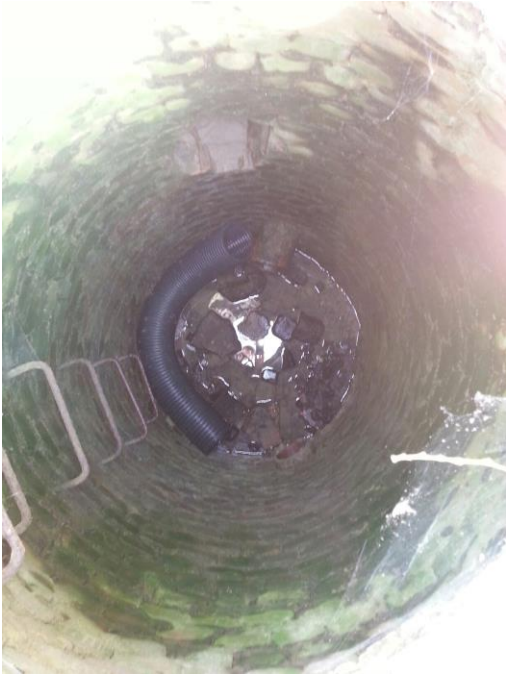
PHOTO B

Look June 27th 2019 into storm manhole on Norfolk Southern Railroad Right-of-Way near yard in Tilton. Near north is up on image. Appears to be clay tiles extending northeasterly and southeasterly; also possible drain port north where brick appear missing.

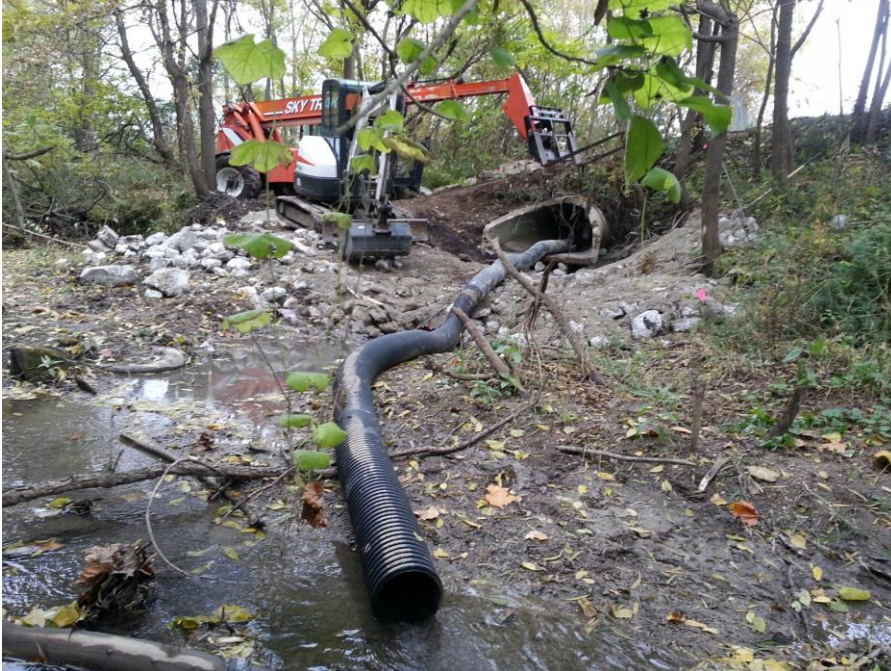
Look October 24th 2019 at mastic placed at joint prior to flared end section being installed on 36 inch diameter storm sewer discharge

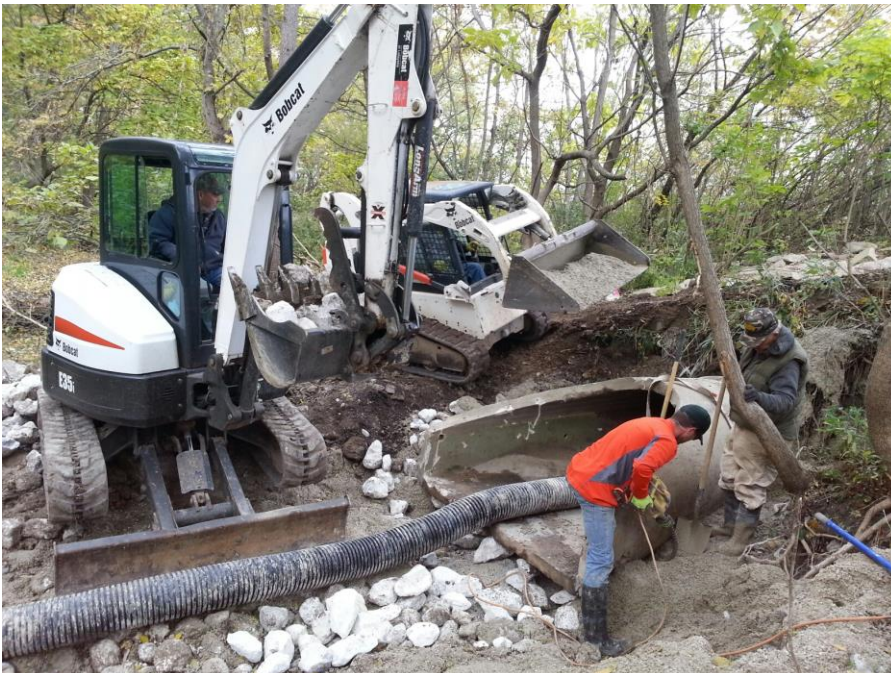
Look northerly October 24, 2019 at 36 inch diameter concrete flared end section, temporary bypass pipe and equipment while in propped and leveled into position on riprap prior to grouting operation

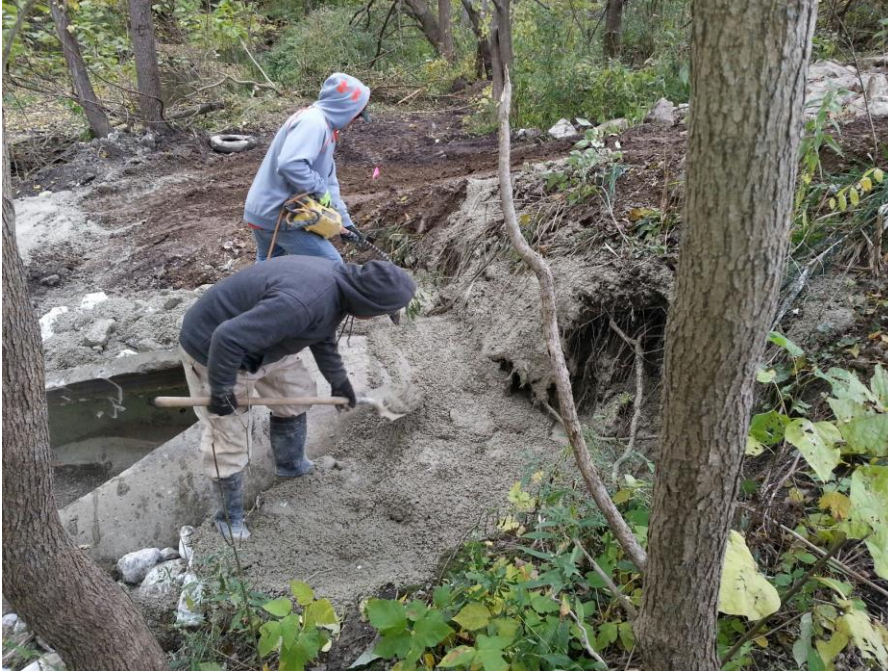
Look October 24th 2019 northwest at concrete and riprap mixing with vibrator, manual shoveling, mini excavator placing rip rap and skid steer delivering cement aggregate mix around flared end section to stabilize and anchor

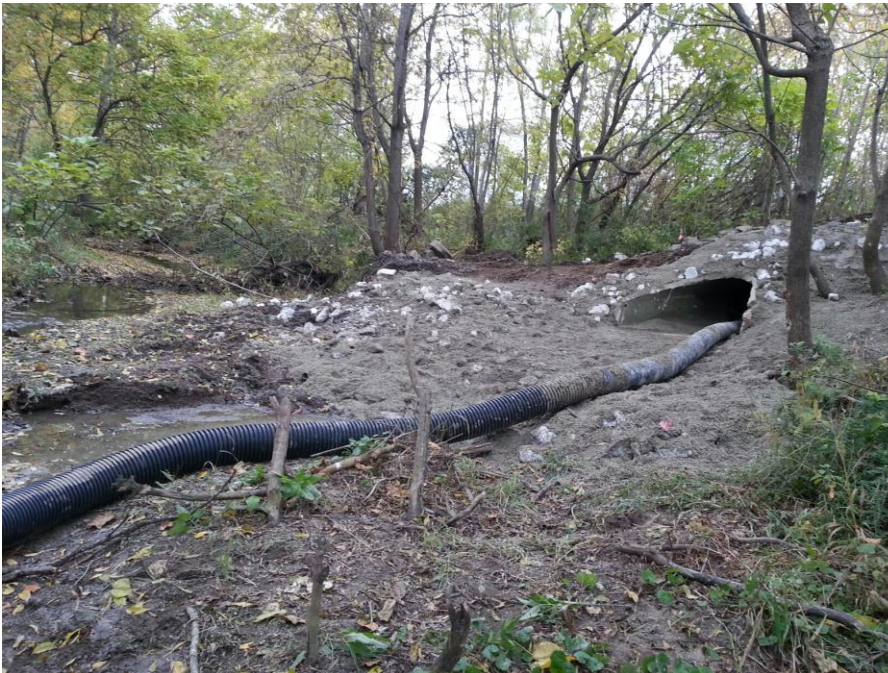
Look October 24th 2019 at concrete collar being placed on the exterior joint of flared end section and storm sewer pipe

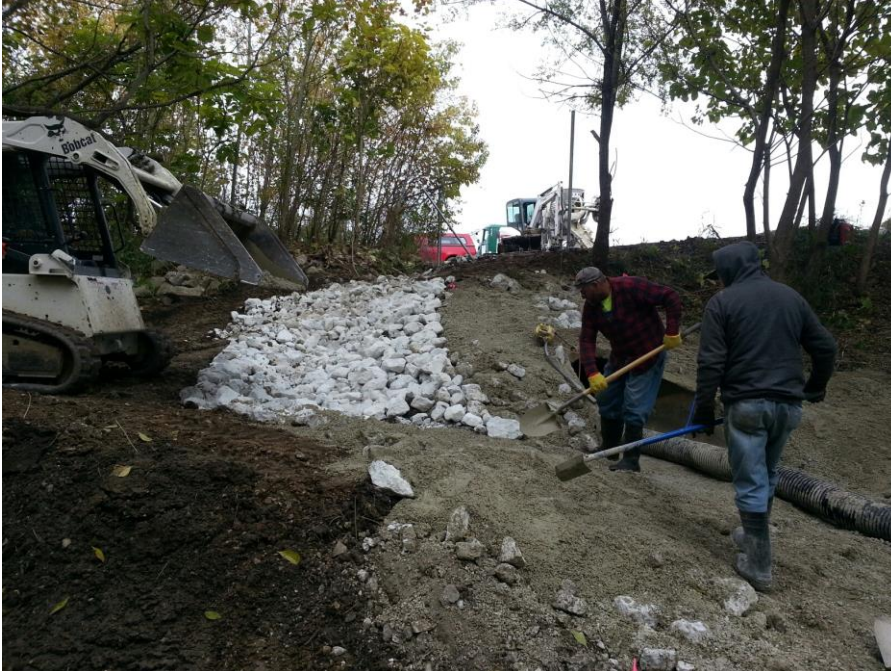
Look October 24th 2019 towards the northwest at status of end section repair and dissipation riprap grouting at end of work day

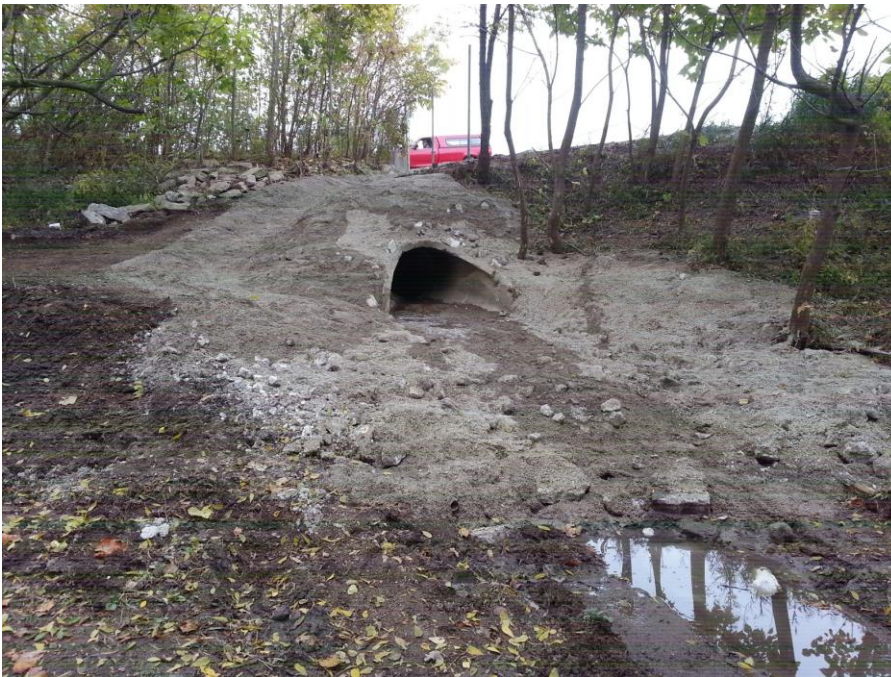
Look northeast October 25th 2019 at crew mixing grout into graded riprap drainage swale voids

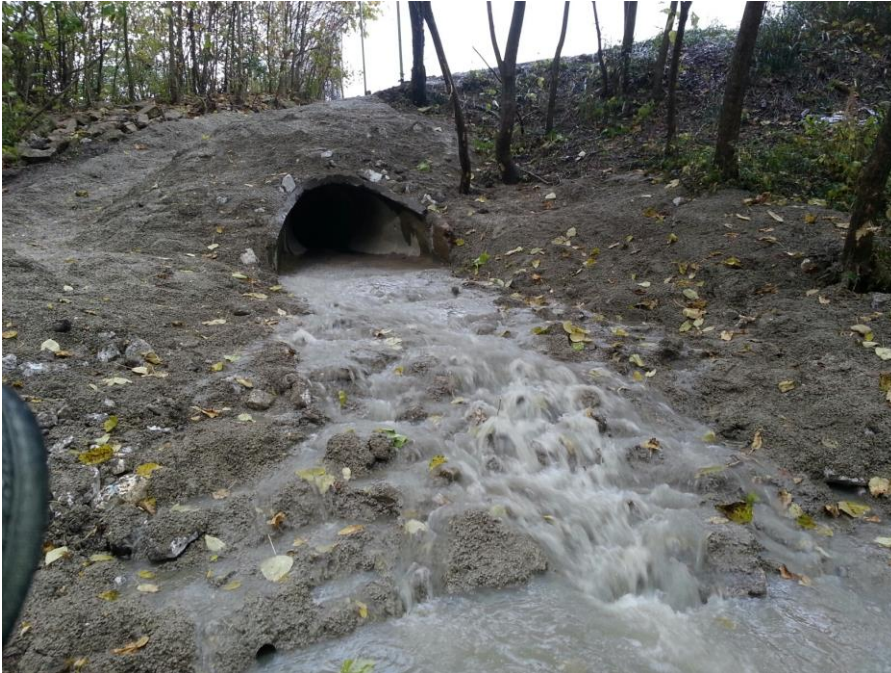
Look October 25th 2019 toward the northeast at the status of discharge and drainage swale riprap and concrete shape status at end of work day after temporary by-pass piping removed in anticipation of precipitation

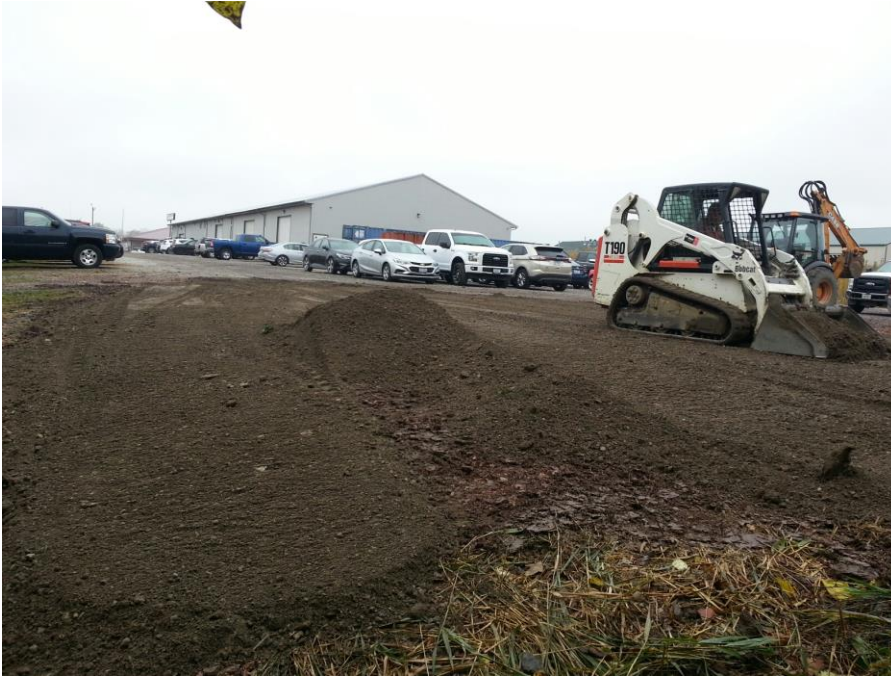
Look northeasterly October 28th 2019 at wheel loader backhoe, tandem dump truck and rubber track skid steer being utilized to during site restoration effort

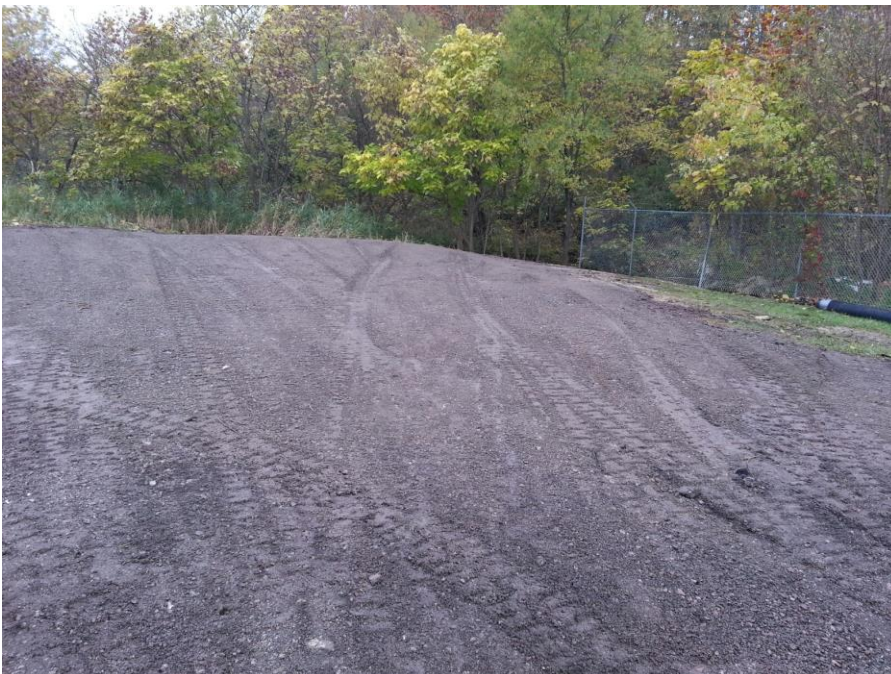
Look northeast October 28th 2019 at rubber tracks skid steer grading a load of crushed recycled concrete on disturbed auto body repair facility parking area

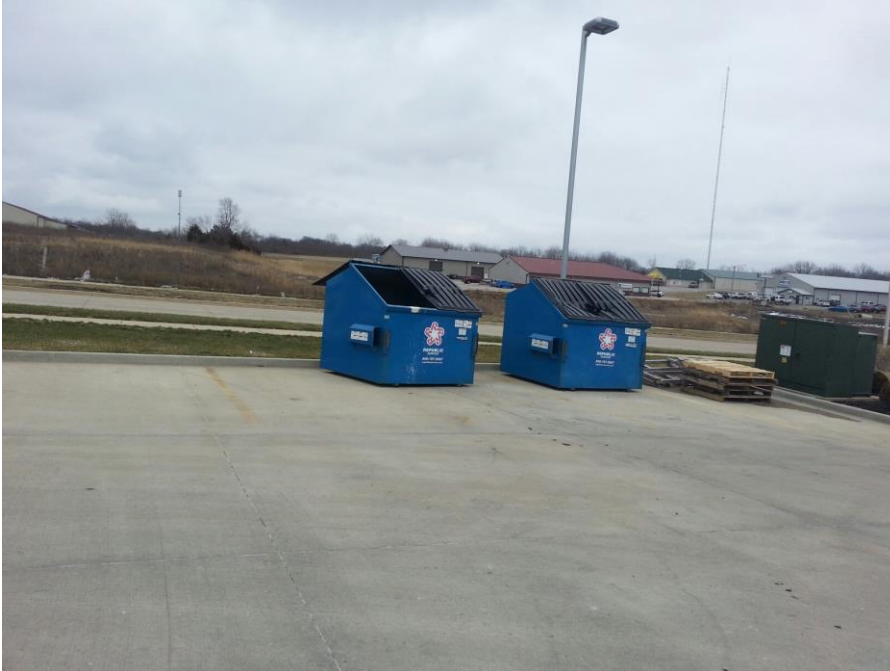
Look southeast January 28th 2020 at solid waste containers on the east side of Vermilion Chevy Buick GMC auto dealer. Ensure lids are closed on dumpsters and solid waste is contained in accordance with Village ordinances.

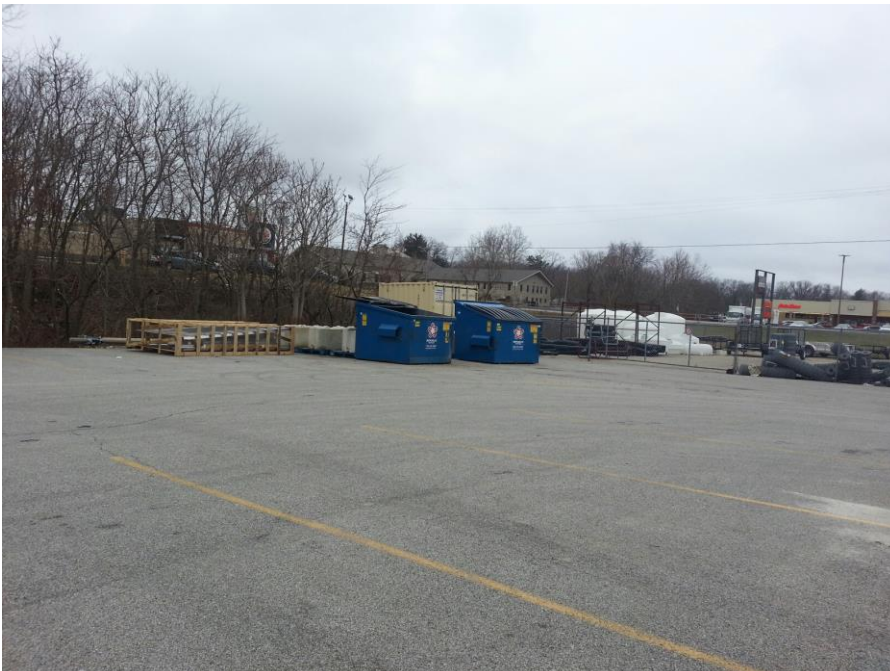
Look Southwest early at solid Waste containers on the west side of Stock + Field January 28th 2020. Ensure lids are closed on dumpsters and solid waste is contained in accordance with Village ordinances.
