Division of Water Pollution Control ANNUAL FACILITY INSPECTION REPORT

for NPDES Permit for Storm Water Discharges from Separate Storm Sewer Systems (MS4)

Report Period: From March, 2019 To March, 2020

Name: Village of Tilton Mailing Address 1: 1001 Tilton Road
Mailing Address 2: _____ County: Vermilion
City: Tilton State: IL Zip: 61833 Telephone: 217-477-0800
Contact Person: David Phillips, Mayor Email Address: dphillips@tilton.com
(Person responsible for Annual Report)

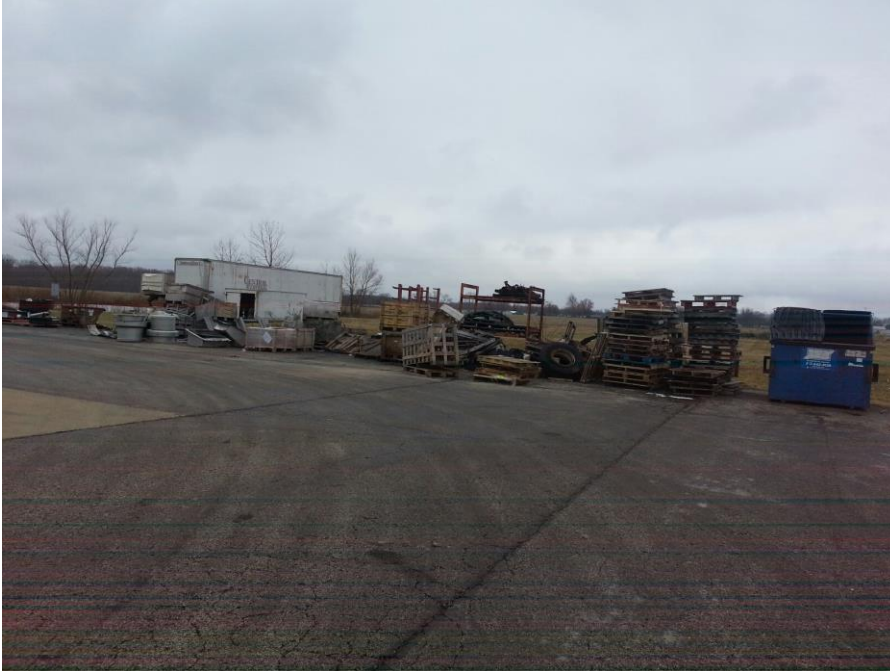
Look south at solid waste containment area on the south side of Burke Spring & Alignment January 28th 2020. Ensure lids are closed on dumpsters and solid waste is contained in accordance with Village ordinances.

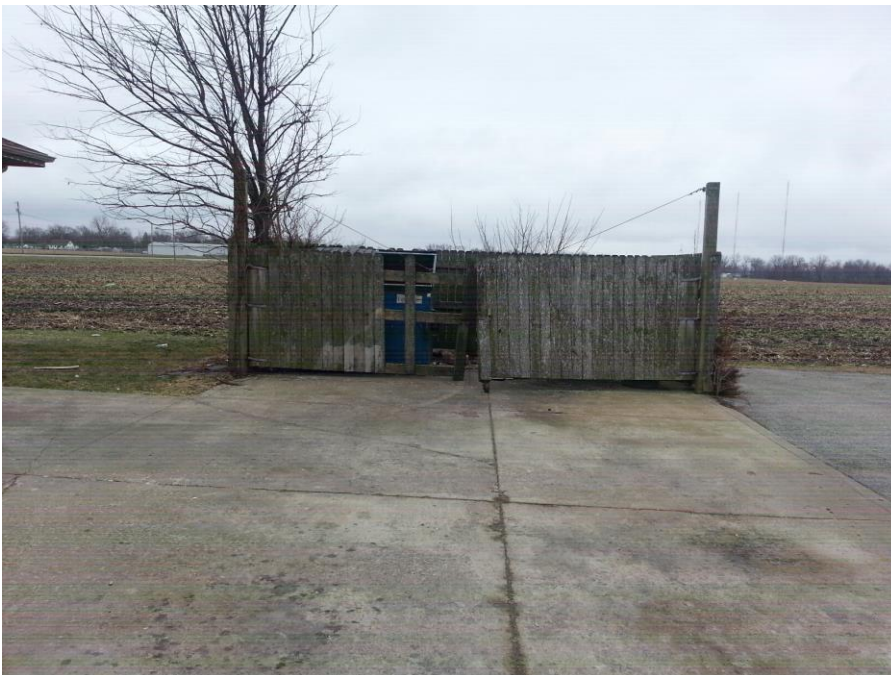
Look south at solid waste containment area January 28th 2020 on the west side of Riches Restaurant. Ensure lids are closed on dumpsters and solid waste is contained in accordance with Village ordinances.

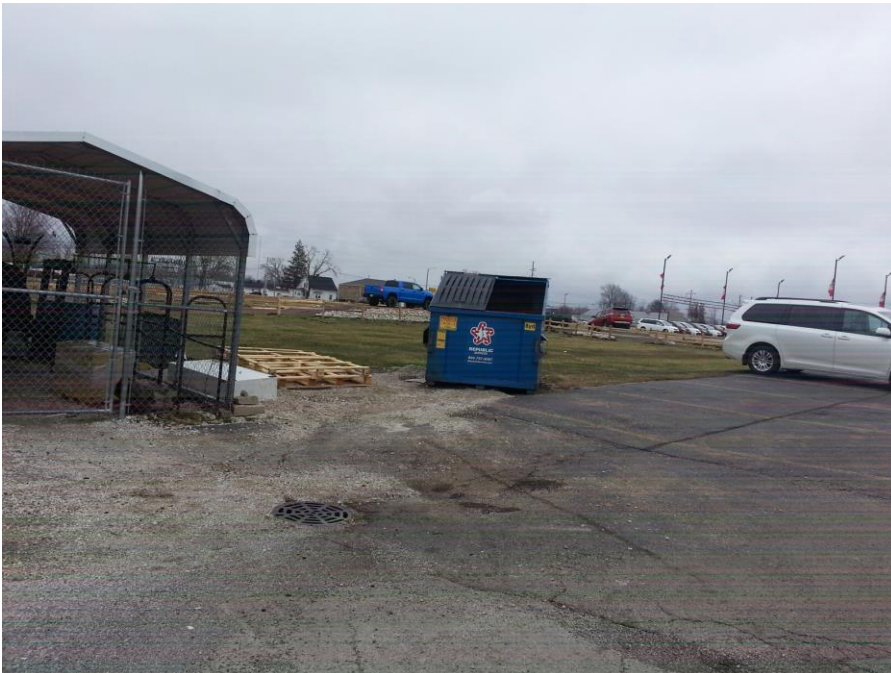
Look northeasterly at solid waste container at Toyota dealer. Ensure lids are closed on dumpsters and solid waste is contained in accordance with Village ordinances.

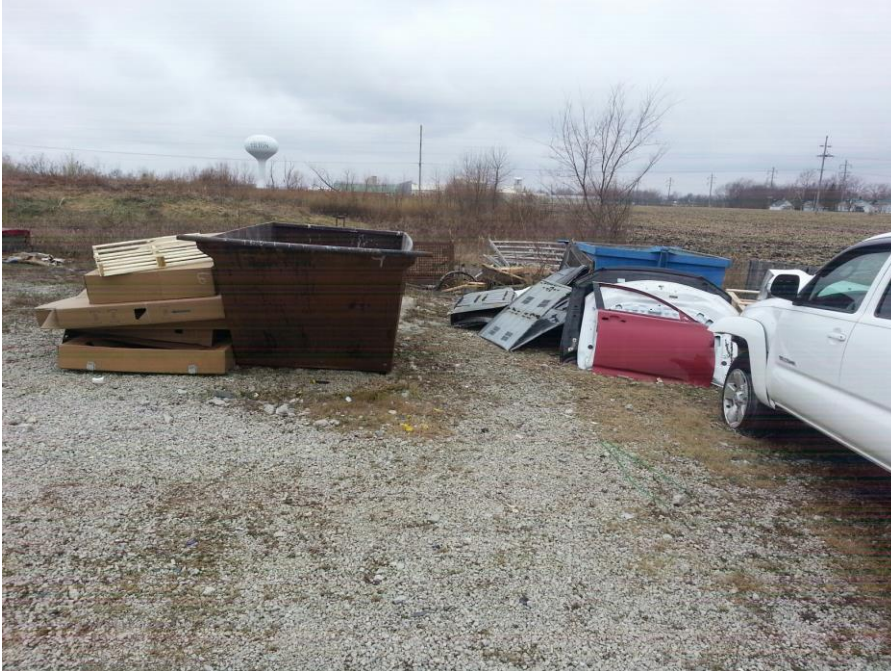
Look west January 28, 2020 at solid waste containers on the northwest side of Truscelli Collision Repair. Ensure lids are closed on dumpsters and solid waste is contained in accordance with Village ordinances.

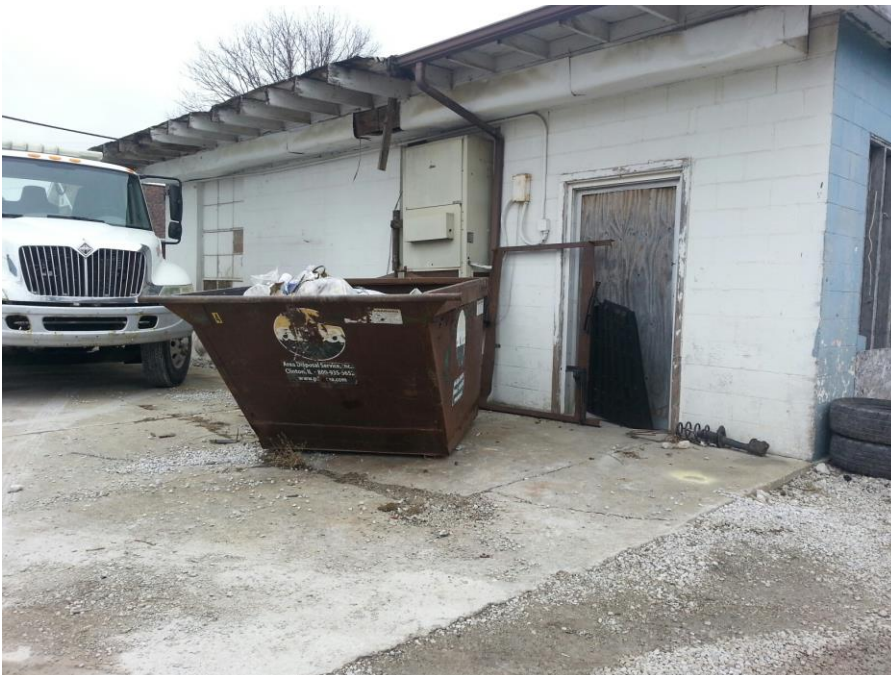
Look easterly January 28th 2020 at dumpster on the west side of Carnegie. Ensure lids are closed on dumpsters and solid waste is contained in accordance with Village ordinances.

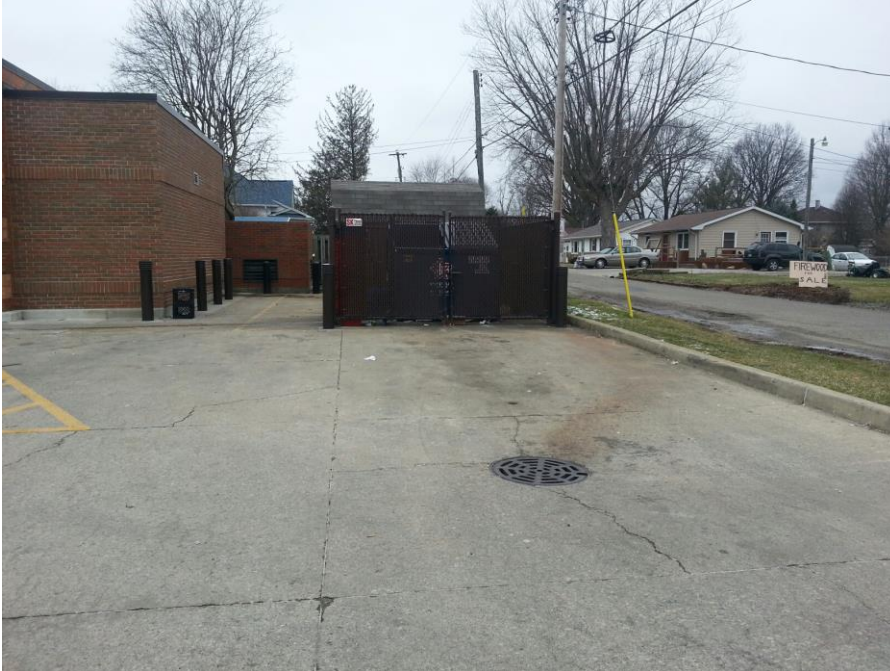
Look west January 28th 2019 at solid waste containment area on the north side of Casey's General Store. There appears to be stain on pavement from container area. **Ensure dumpster is leak proof, lids are closed and solid waste is contained in accordance with Village ordinances.**

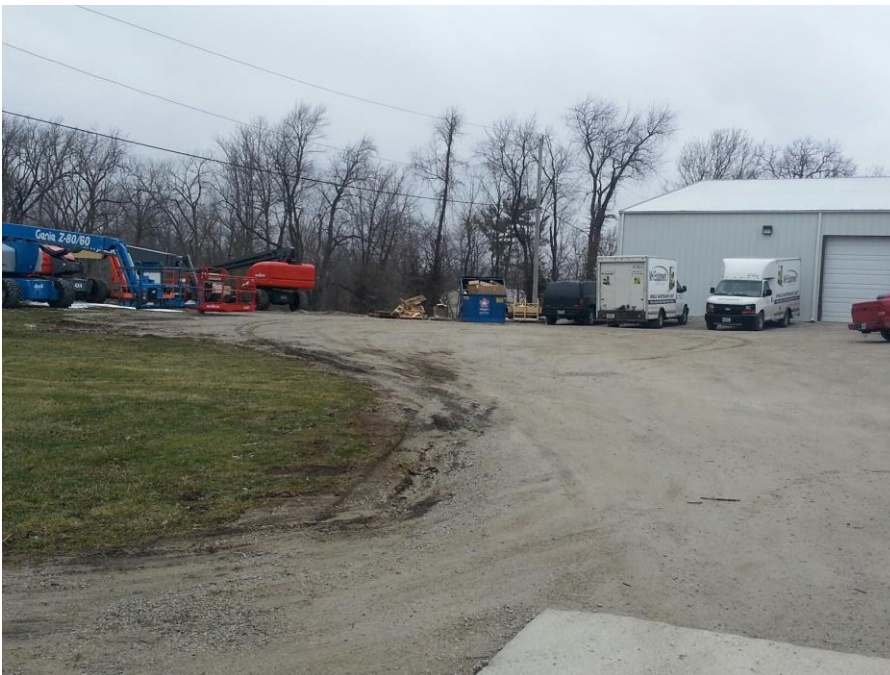
Look northeasterly January 28th 2019 at solid waste dumpster on the west side of MH equipment. Ensure lids are closed on dumpsters and solid waste is contained in accordance with Village ordinances.

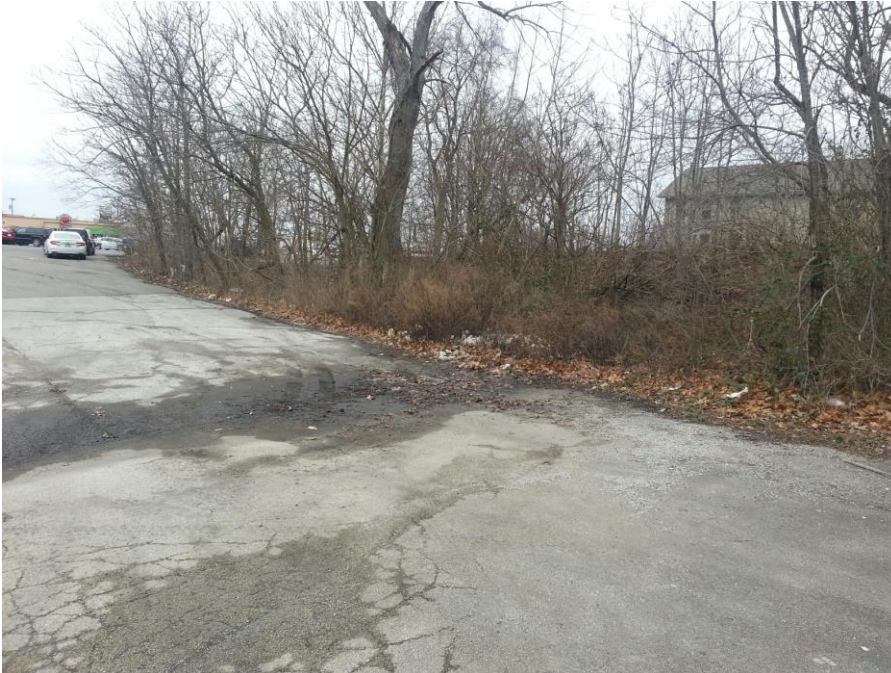
Safely police area along Grape Creek banks near County Market Grocery Store pick-up and properly dispose of litter and contain litter

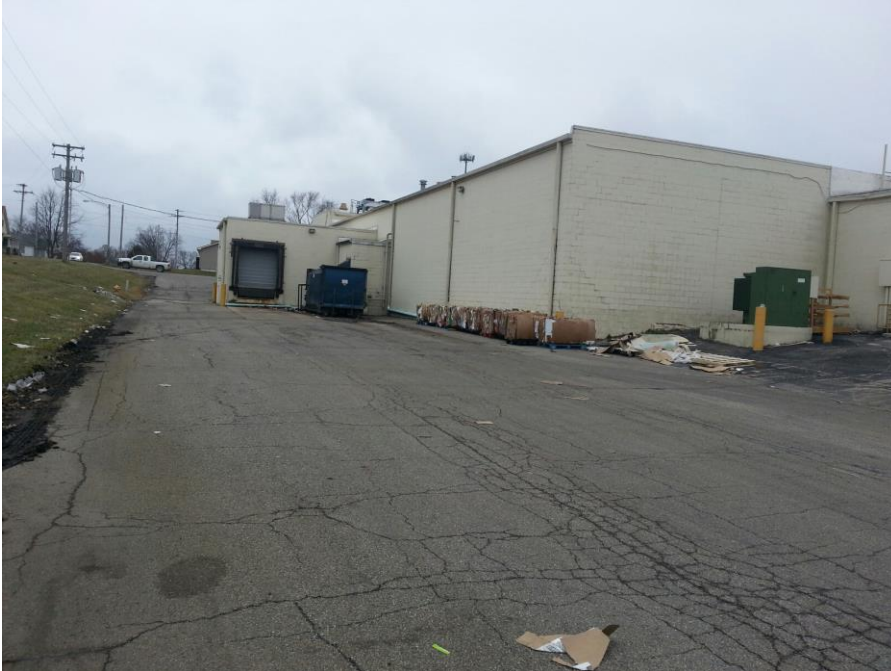
Look northeasterly at solid waste container on the west side of County Market Tilton January 28th 2020. Ensure solid waste is contained in accordance with Village ordinance.

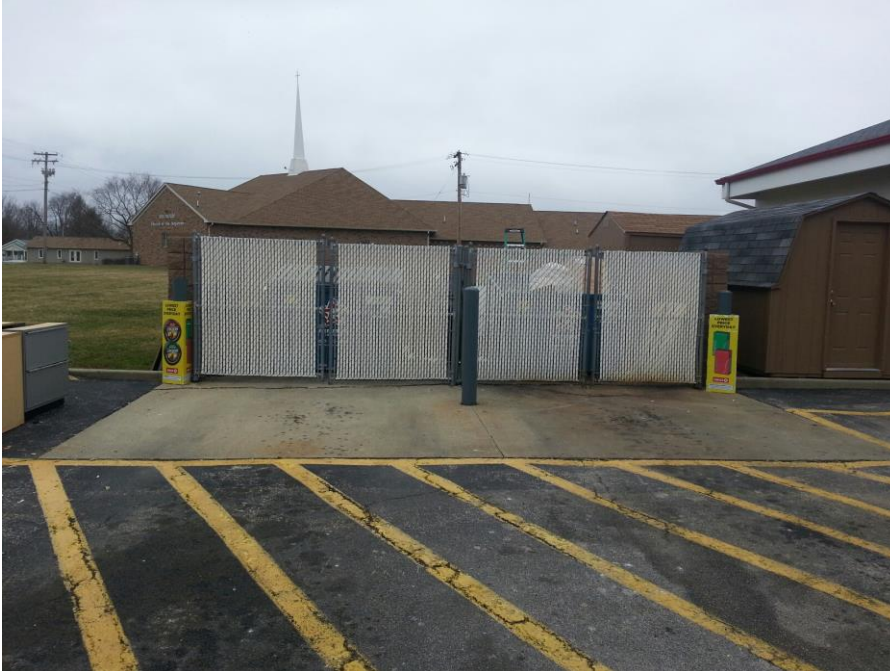
Look westerly January 28th 2020 at solid waste dumpster containment area at Circle K. Ensure lids are closed on dumpsters and solid waste is contained in accordance with Village ordinances.

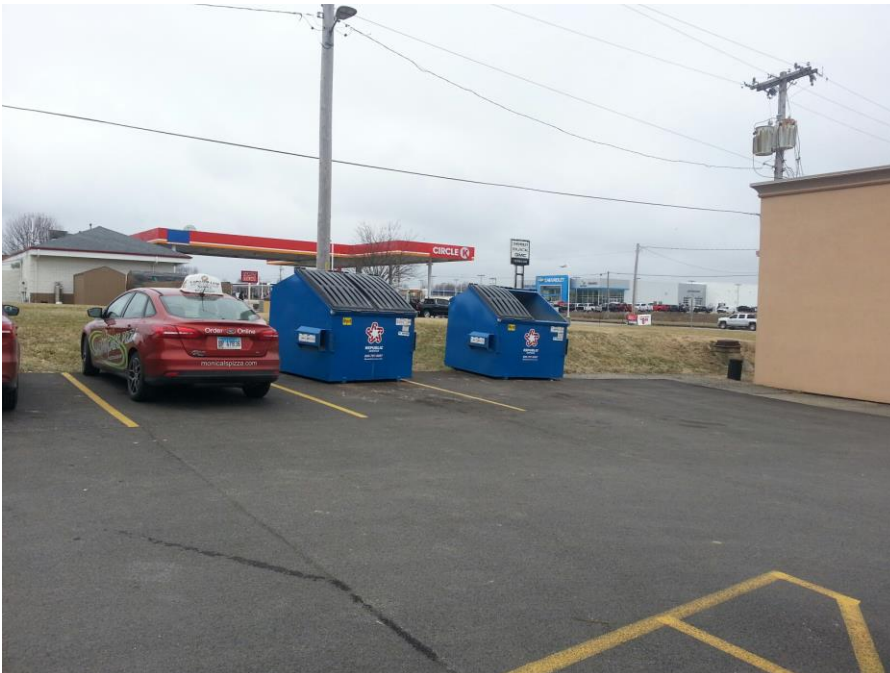
Look northeasterly January 28th 2020 at dumpsters on the west side of Monical's Pizza. Ensure lids are closed on dumpsters and solid waste is contained in accordance with Village ordinances.

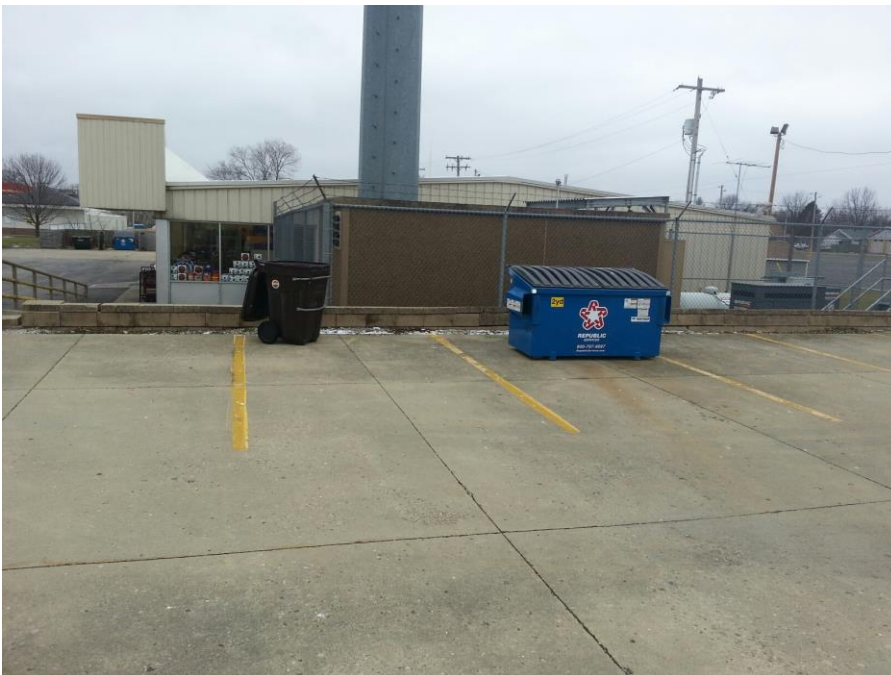
Look southerly January 28th 2020 at dumpster and toter on the southwest side of Verizon. Ensure lids are closed on dumpsters and solid waste is contained in accordance with Village ordinances.

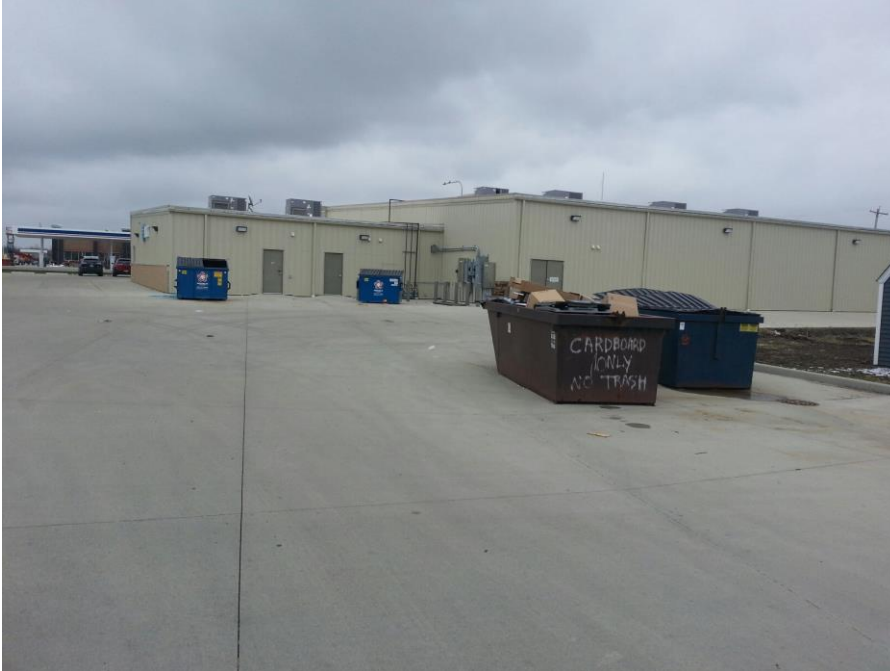
Look easterly January 28, 2020 at dumpsters located on the west side of Dollar Tree, AT&T and Dotty's Gaming. Ensure lids are closed on dumpsters and solid waste is contained in accordance with Village ordinances.

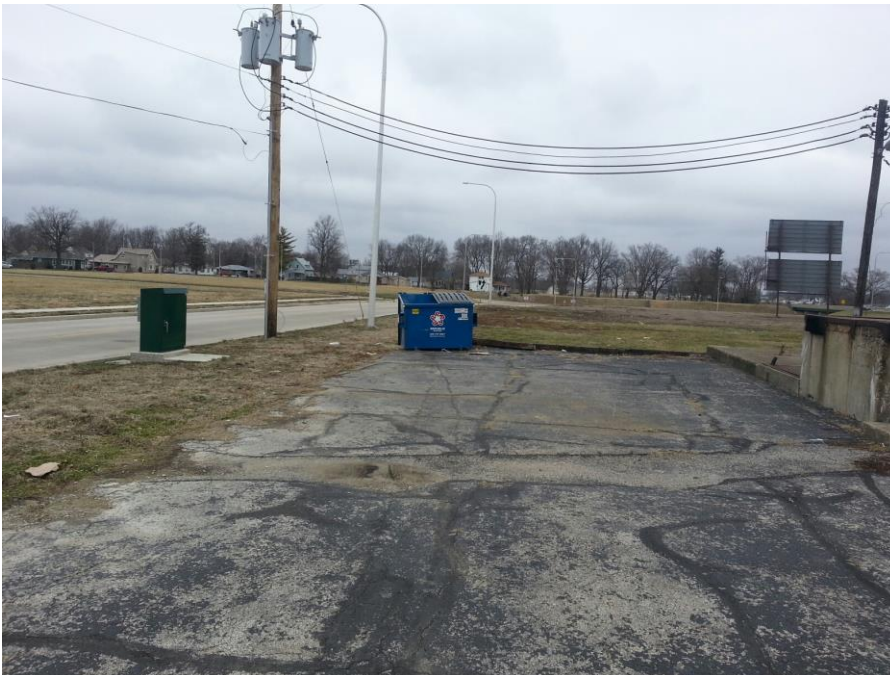
Look northerly January 28th 2020 at dumpster on the west side of Dollar General. Ensure lids are closed on dumpsters and solid waste is contained in accordance with Village ordinances.

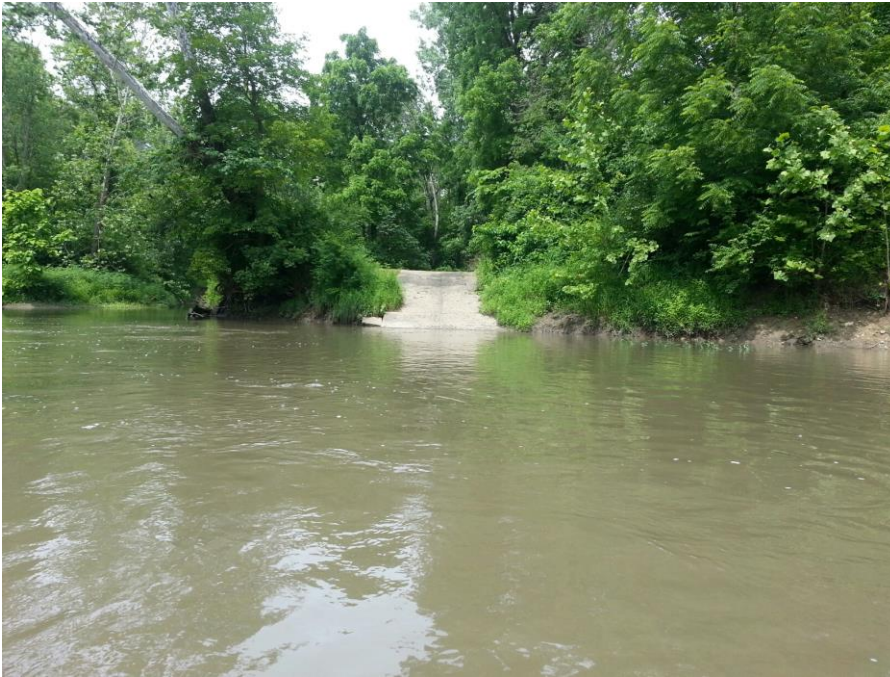
**Look at concrete boat ramp into Middle Fork River in Kennekuk County
Park June 22nd 2019**

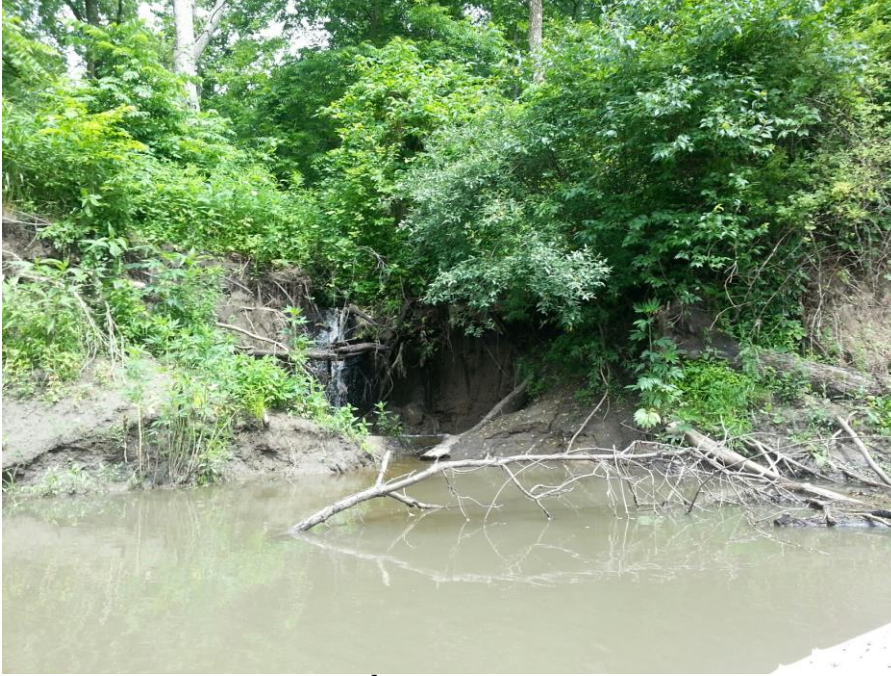
Look easterly June 22nd at water discharging into Middle Fork River downstream of Kennekuk Park boat ramp

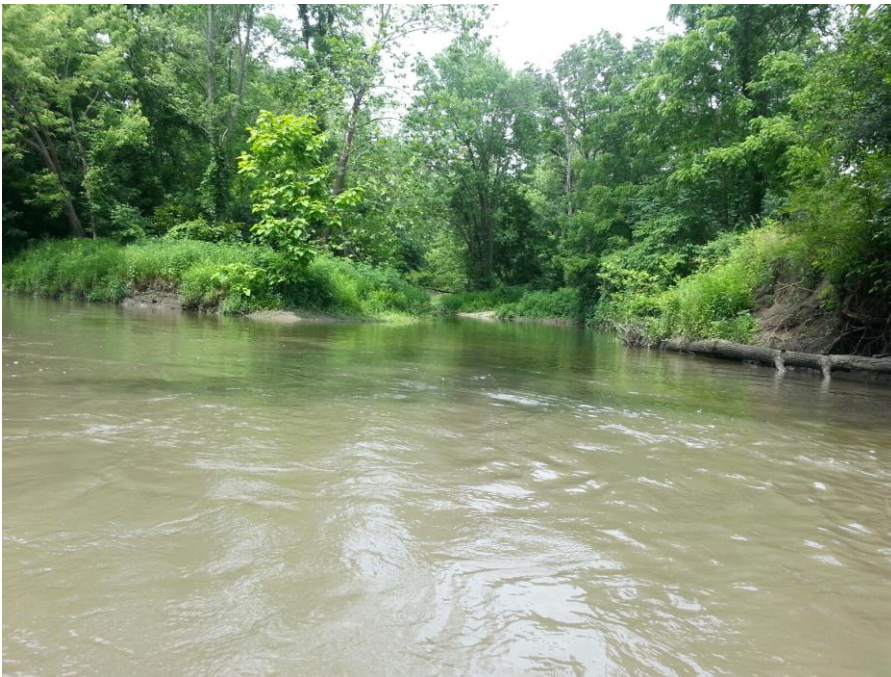
Look June 22nd 2019 from downstream towards upstream at Windfall Creek downstream of Lake Mingo Dam in Kennekuk discharging into the Middle Fork River. Windfall Creek water clarity quality visible at mouth of Middle Fork River.

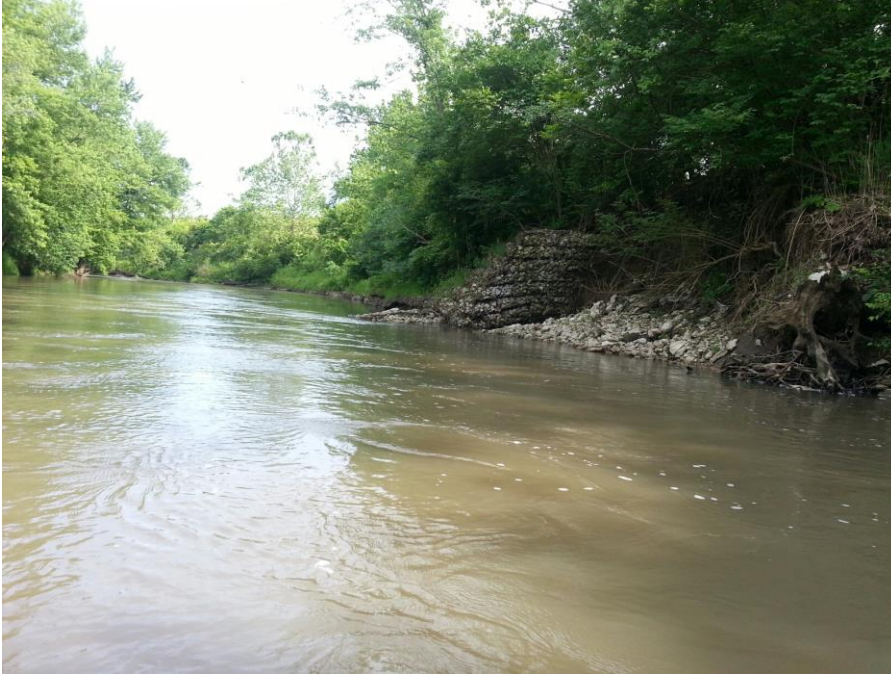
Look June 22nd 2019 towards downstream along Middle Fork River at stone gabion baskets on west bank near deactivated power plant coal ash ponds. **Communicate with site authorities to determine status of permits for proposed erosion control.**

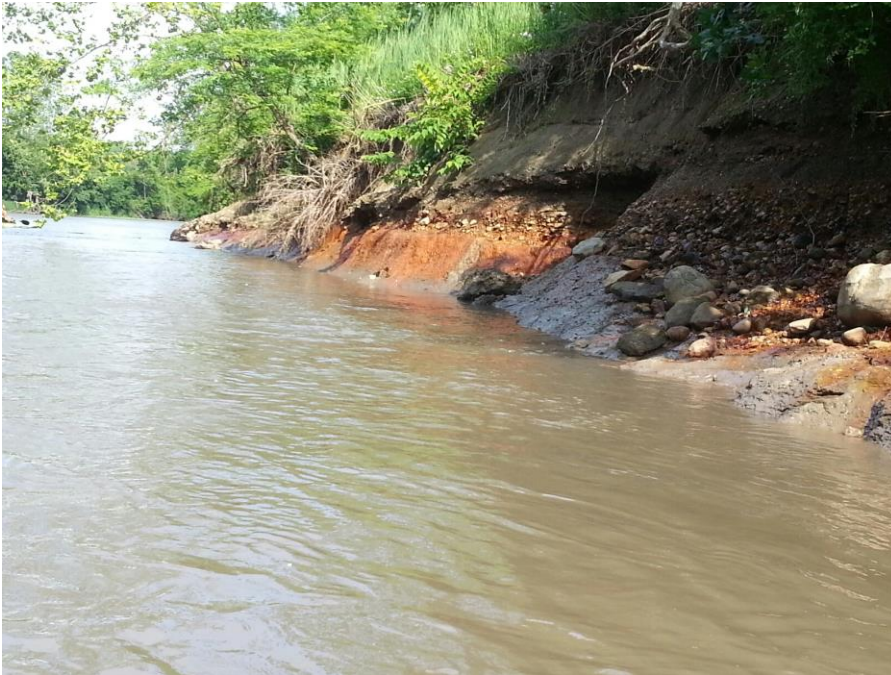
Look towards the western bank of Middle Fork River near deactivated power plant coal ash ponds at bank erosion and orange substance

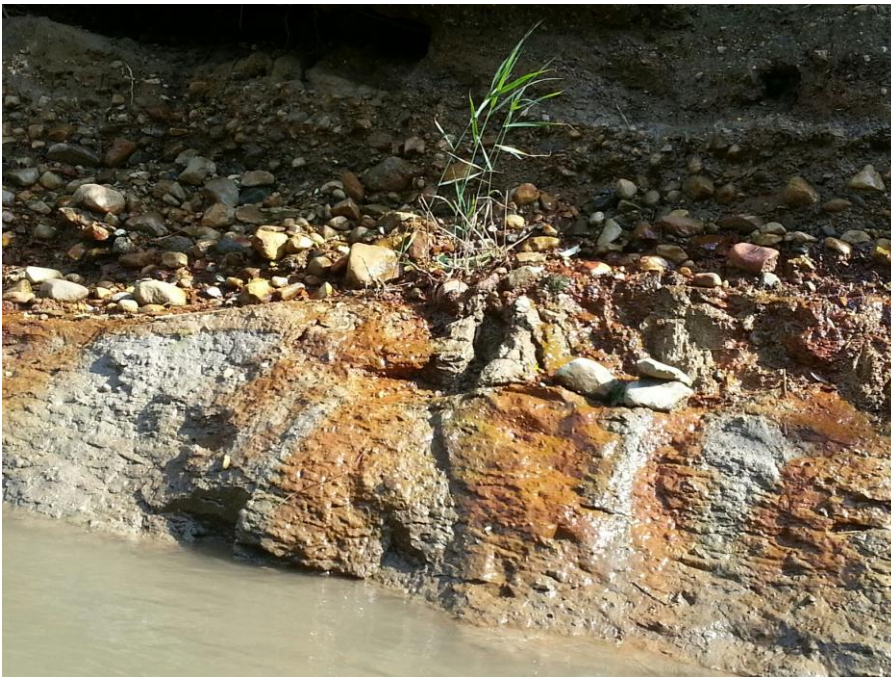
Look close June 22nd 2019 at orange substance along eroded bank near deactivated power plants along Middle Fork River

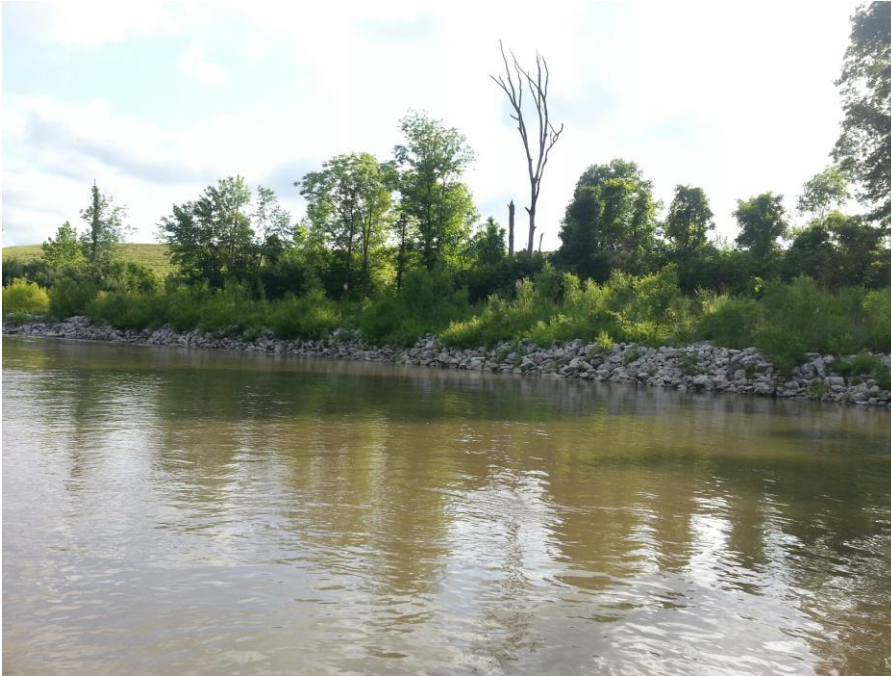
Look at rip-rap along the bank of Middle Fork River near deactivated power plant June 22nd 2019

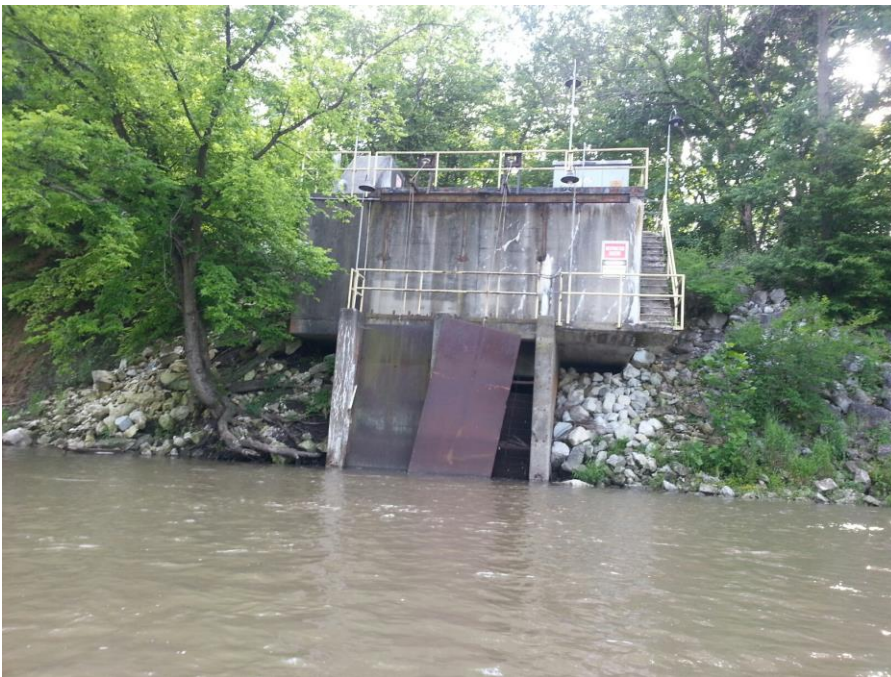
Look at structure June 22nd 2019 along the western bank of Middle Fork River near deactivated power plant. **Communicate with site authorities to determine the purpose of structure.**

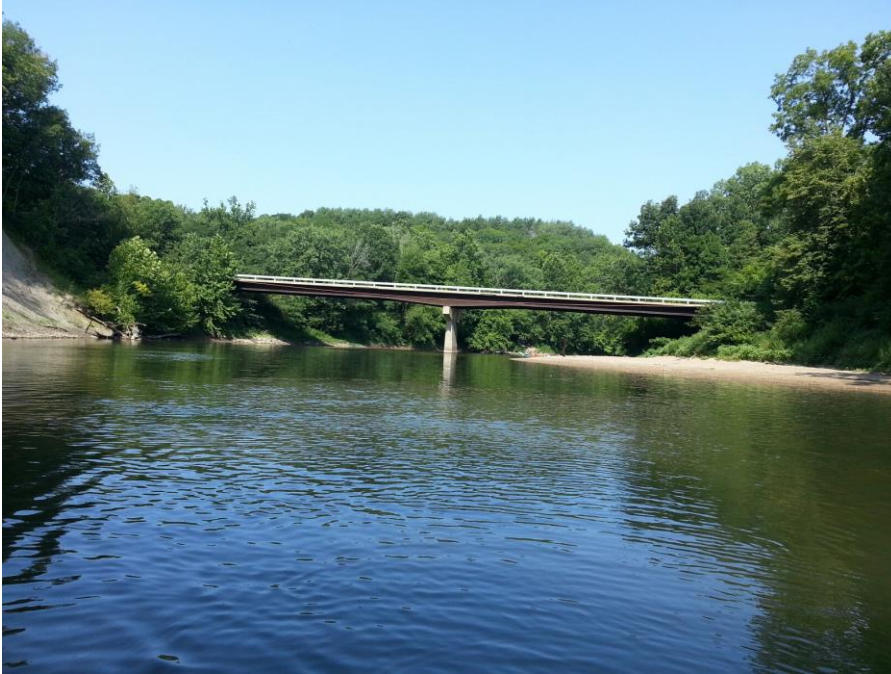
Look towards upstream July 24th 2019 at downstream face of Shangri La Road Bridge over Vermilion River

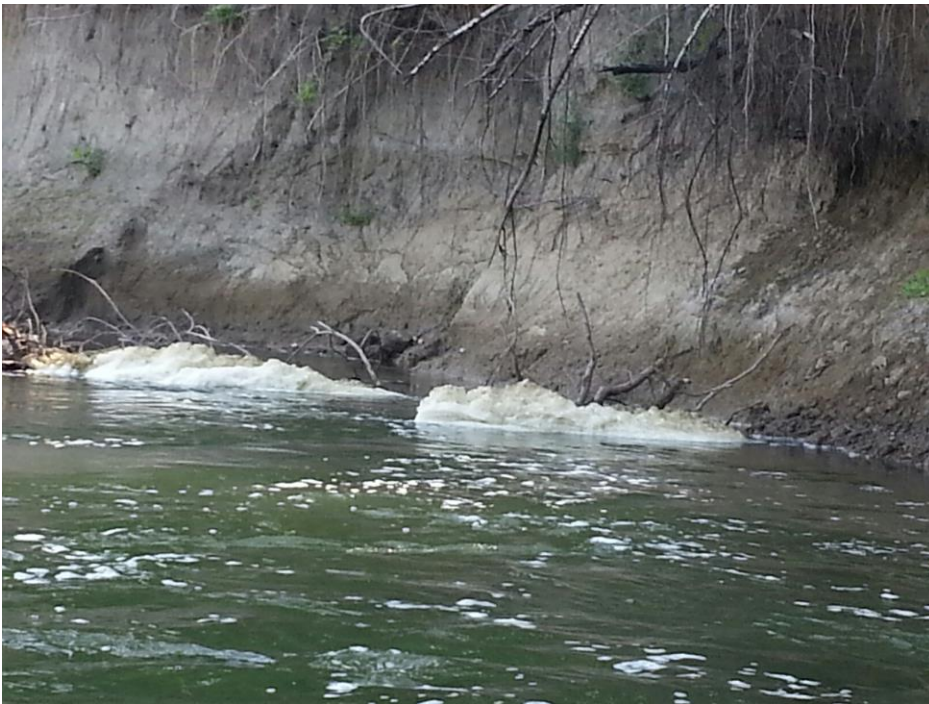
Look July 24th 2019 at foam along Vermilion River

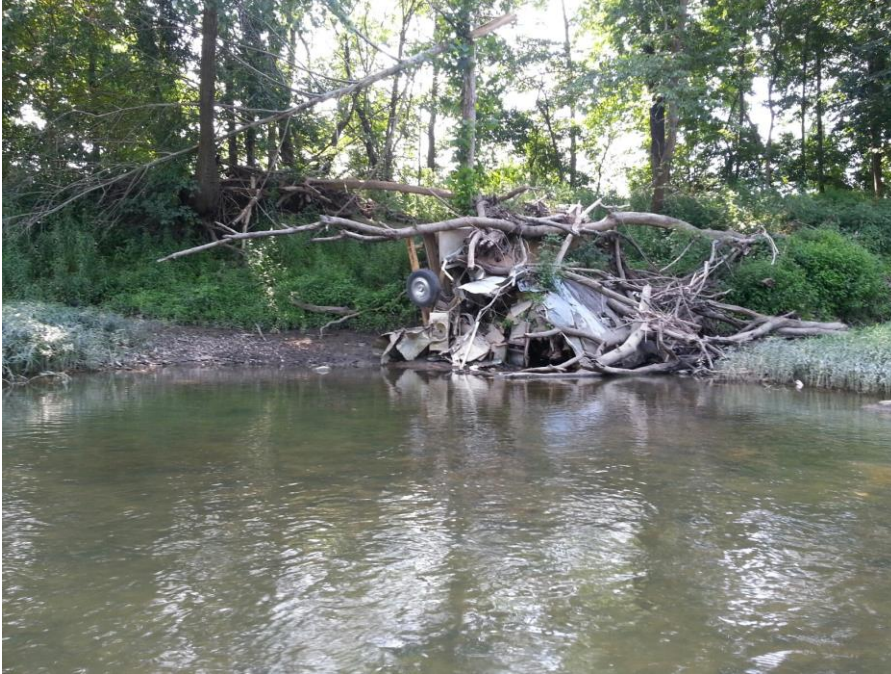
Look southerly at camper wedged into the south bank of Vermilion River near Farmland Reserve Inc. property July 24th 2019. This camper & license plate were included in previous annual reporting.

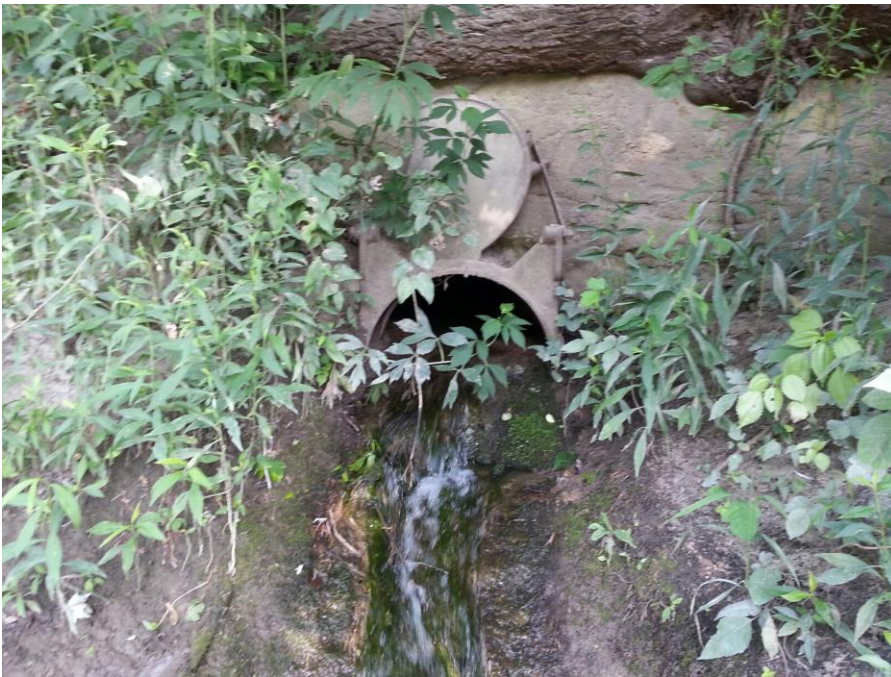
Look Northerly July 24th 2019 along north bank of Vermilion River at open baffle drainage pipe discharging into the river from Mike MC Cormick property

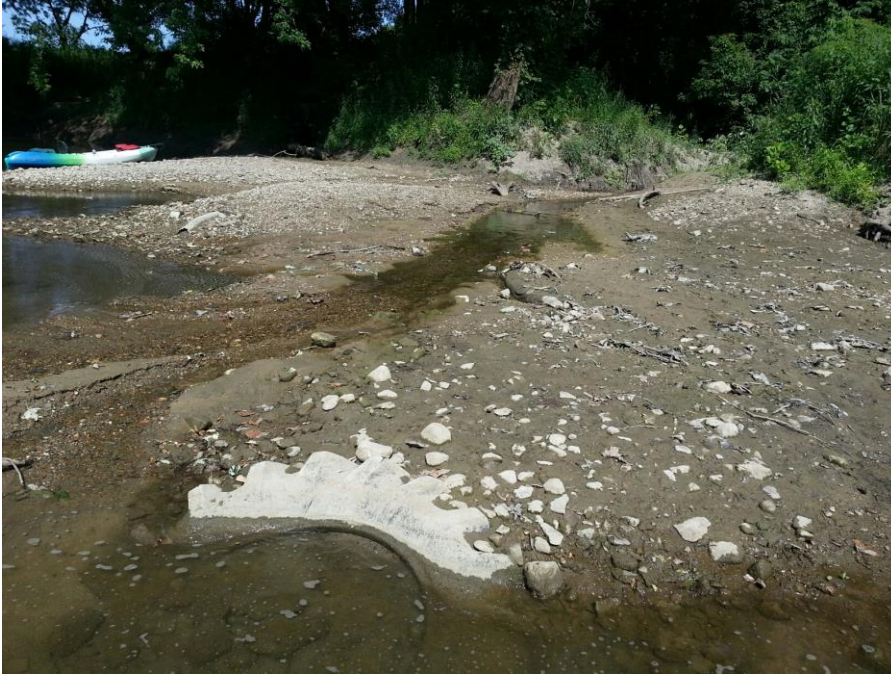
Look July 24th 2019 at tire in sediment of Vermilion River northern bank where tributary meets the river near Mike MC Cormick TRTE property

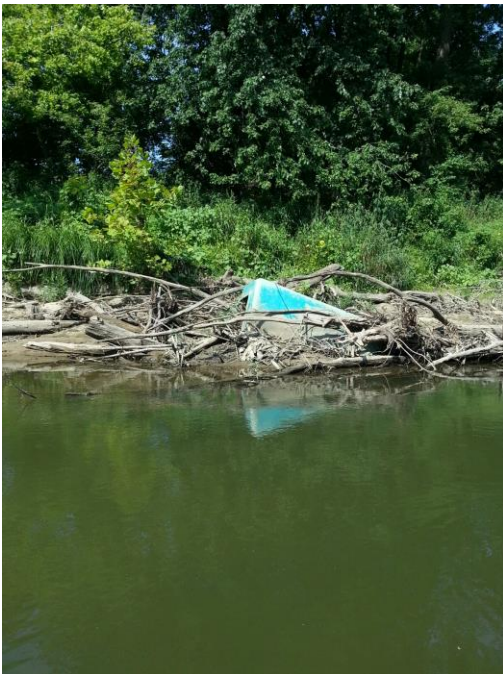
Look July 24th 2019 at plastic debris along Vermilion River upstream of Interstate 74

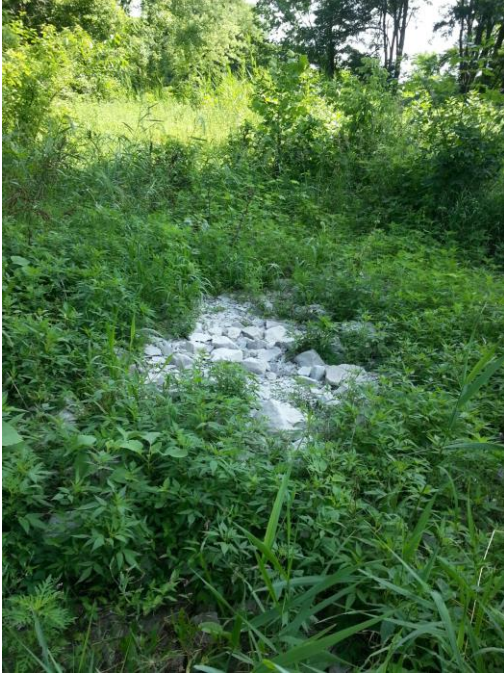
Look at condition of riprap under Interstate 74 Bridge where soffit discharges water from fall on to bank of Vermilion River

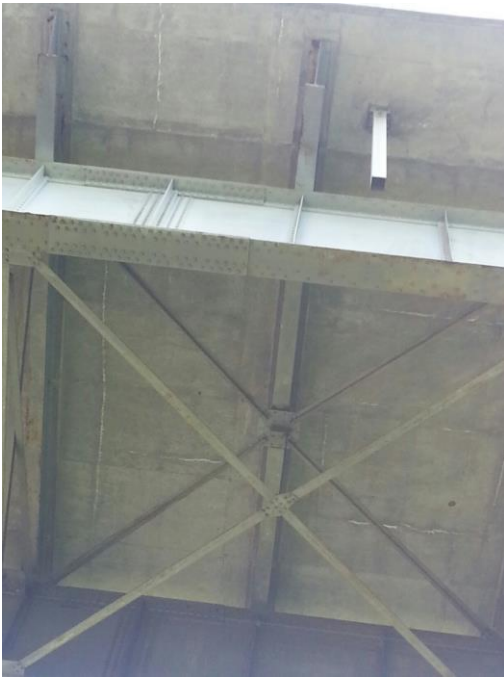
Look July 24th 2019 at soffit under Interstate 74 Bridge near Vermilion River

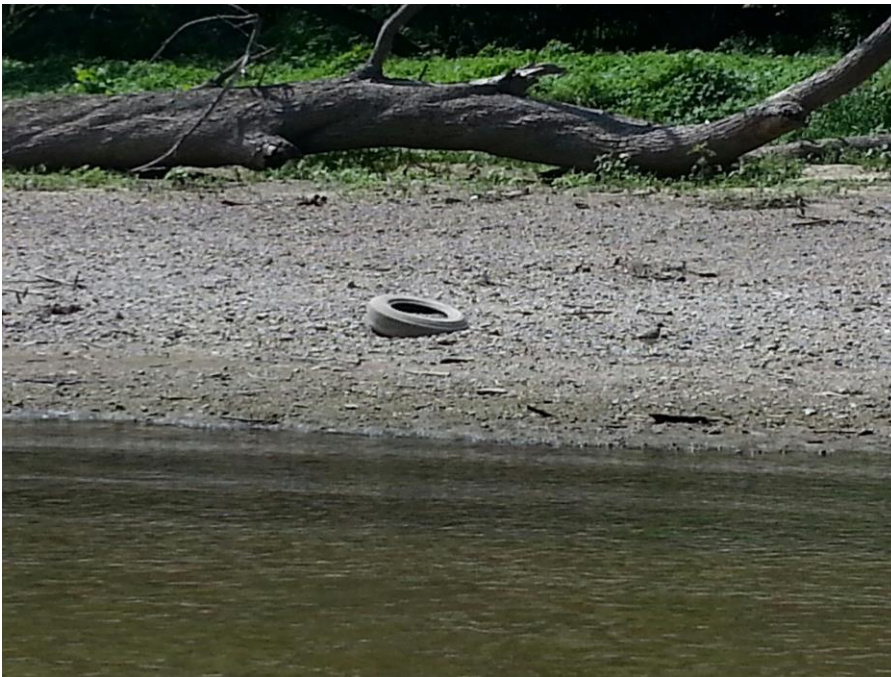
Look July 24th 2019 at rubber tire in bank of river. Many tires are now apparent during low-flow season due to dam removals downstream in Danville. Considered organizing crews with canoes and buoyancy hoisting devices to lift rubber tires, load on canoes and removed from river and properly recycle

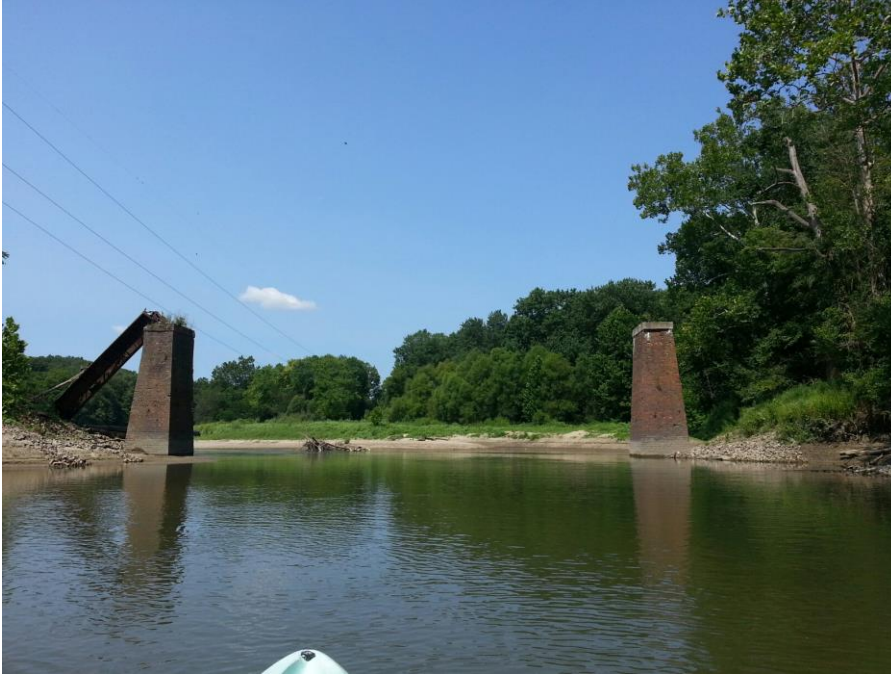
Look towards upstream along Vermilion River at brick piers and steel structure collapse July 24th 2019. **Determine owner of structure.**

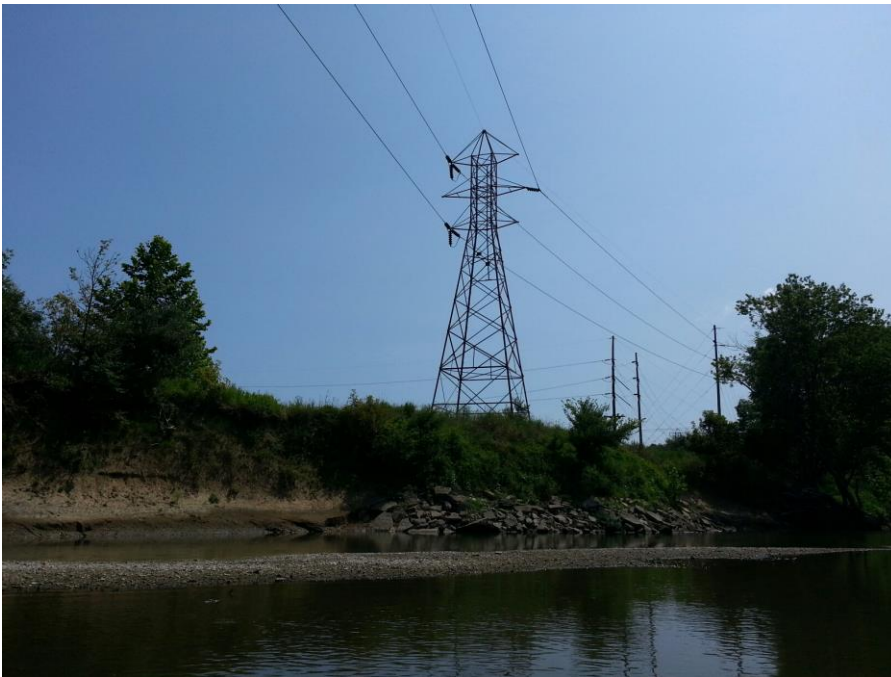
Look toward downstream on Vermilion River July 24th 2019 at overhead utility structures. **Communicate with utility company to inspect condition of bank near structures to ensure structural stability. Give notice to Army Corps of Engineers to obtain permission prior to discharge of erosion stabilization material onto bank**

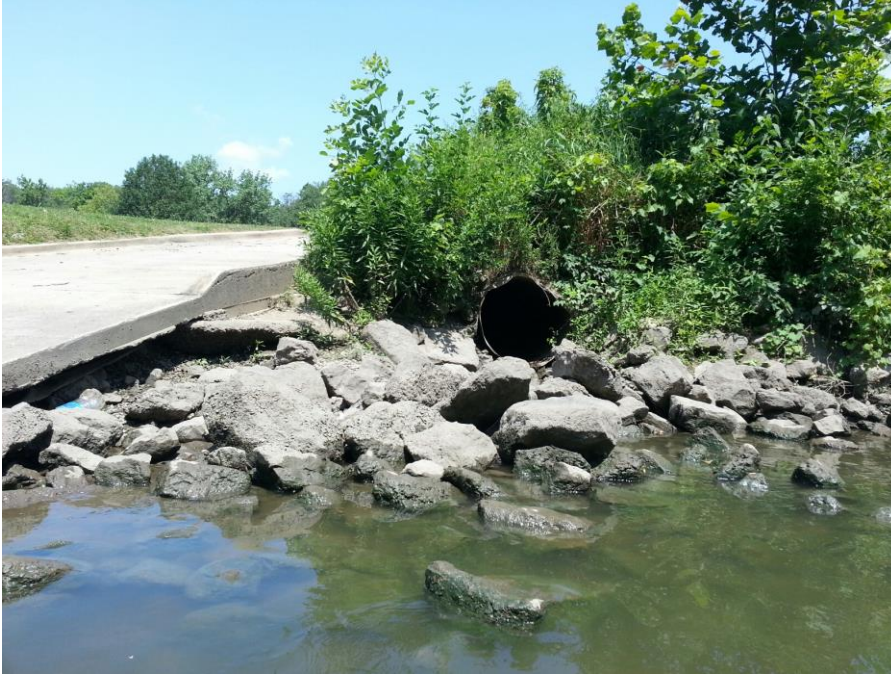
Look July 24th 2019 at void under concrete boat ramp in Ellsworth Park in to North Fork River; also Danville jurisdiction storm sewer discharge. Communicate with Danville to inspect and communicate with Army Corp of Engineers for permits to repair void under boat ramp. Consider pressure grouting mixture into void during low river flow.

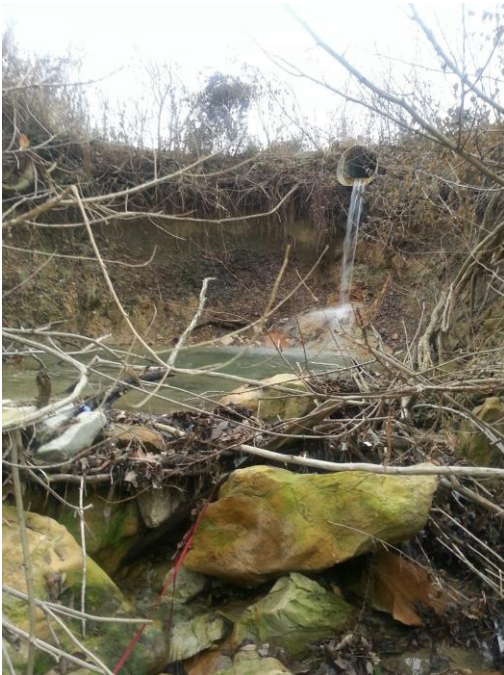
Look southerly November 26th 2019 at storm sewer discharging near the southeast corner of Illinois Route 1 Bridge over Vermilion River

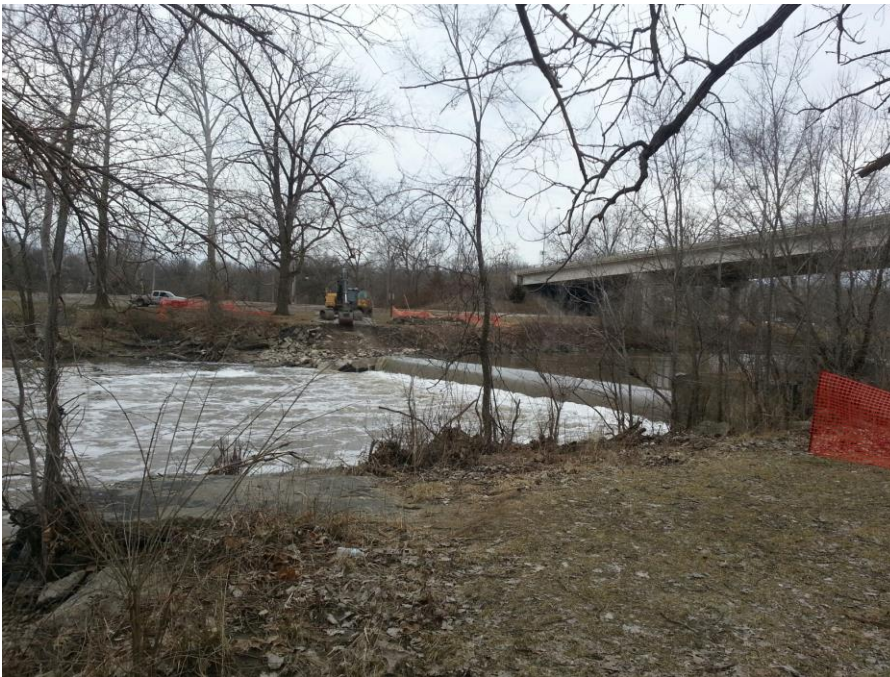
**Look at the status of the Ellsworth Park Dam removal from the North Fork
River March 12th 2019**

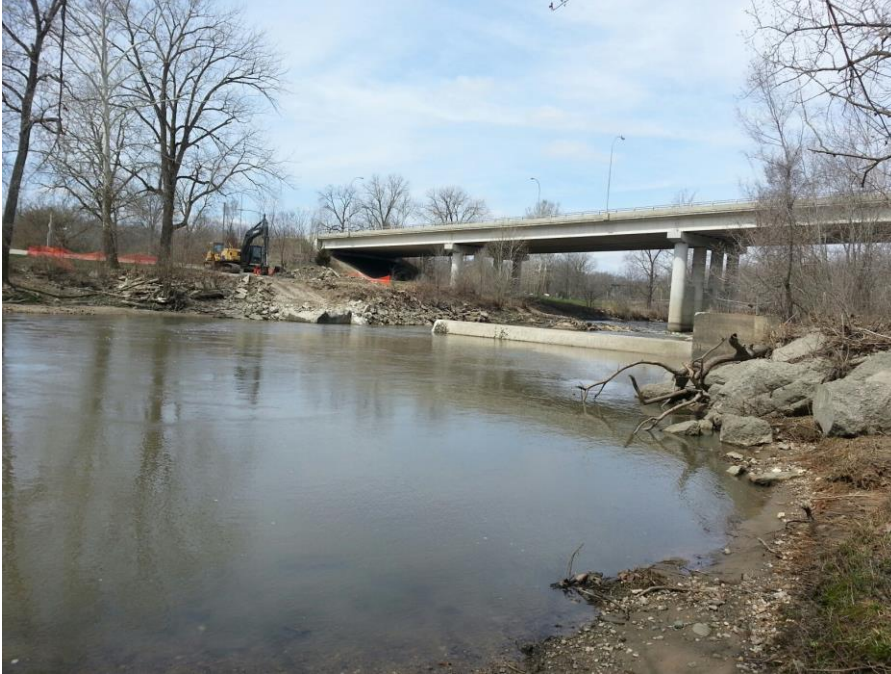
Look northwesterly April 6th 2019 at status of the Ellsworth Park Dam removal from the east bank of North Fork River
