Division of Water Pollution Control ANNUAL FACILITY INSPECTION REPORT

for NPDES Permit for Storm Water Discharges from Separate Storm Sewer Systems (MS4)

Report Period: From March, 2019 To March, 2020

Name: Village of Tilton Mailing Address 1: 1001 Tilton Road
Mailing Address 2: _____ County: Vermilion
City: Tilton State: IL Zip: 61833 Telephone: 217-477-0800
Contact Person: David Phillips, Mayor Email Address: dphillips@tilton.com
(Person responsible for Annual Report)

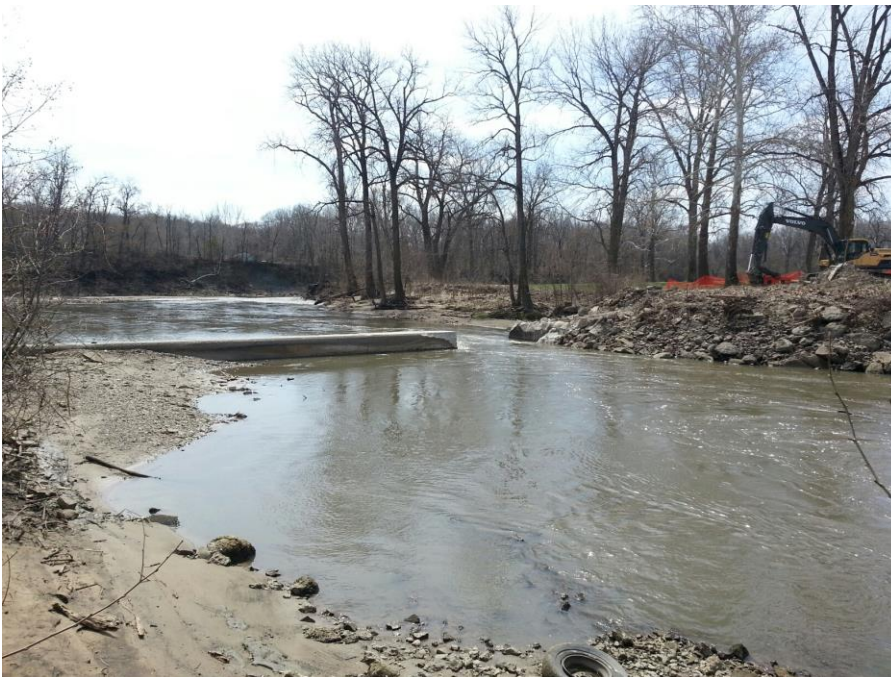
Look southeasterly from east bank of North Fork River at Ellsworth Park Dam removal status April 6th 2019. Safely remove tire and rebar immediately from drainage way and legally dispose of.

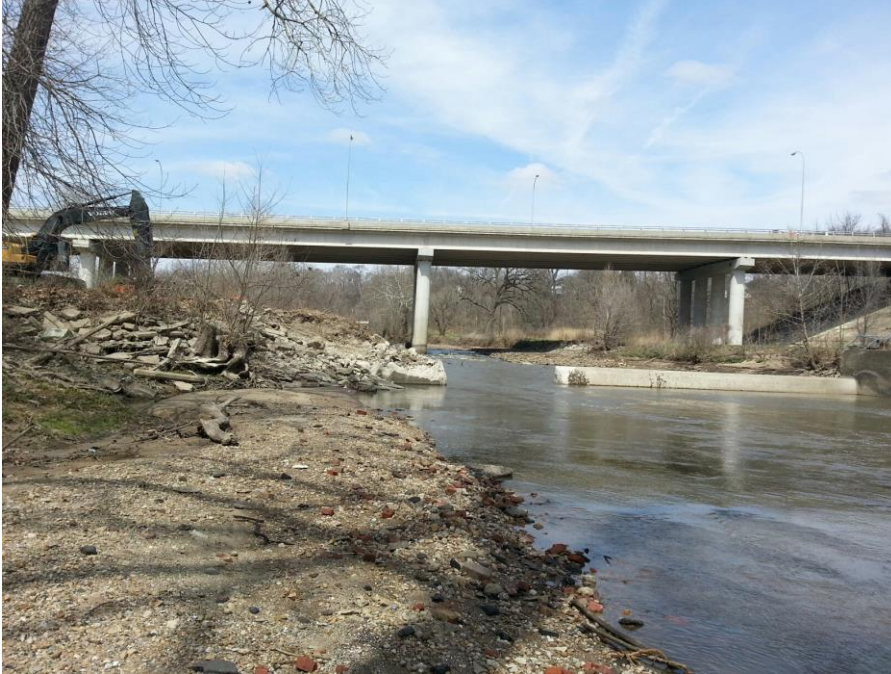
Look from the west bank of the North Fork River towards upstream at status of the Ellsworth Park Dam removal April 6th 2019

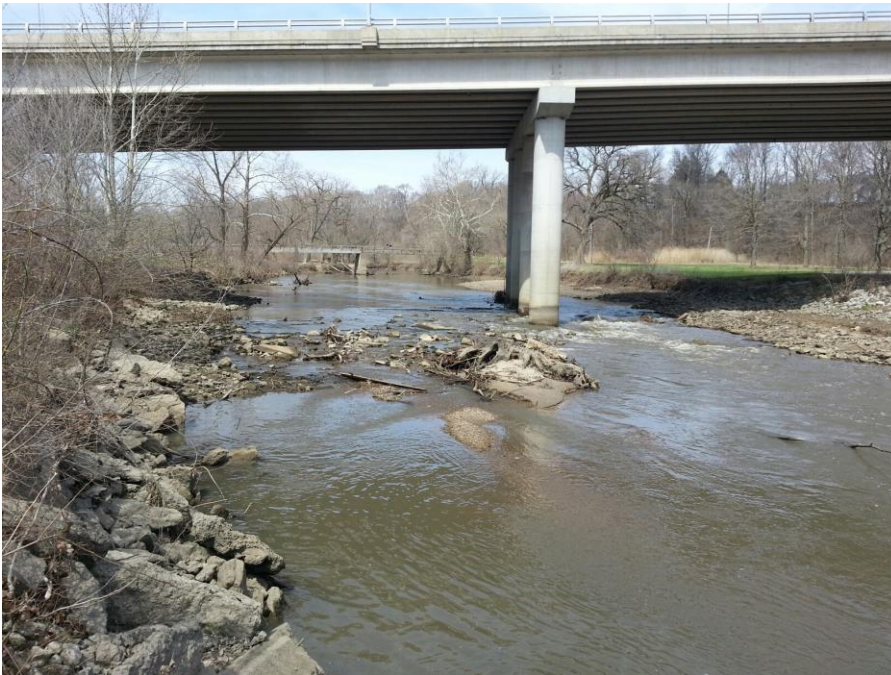
Look April 6th 2019 from the west bank of the North Fork River upstream of dam removal project in Ellsworth Park at the U.S. 150 Bridge over the North Fork River. Water flowing towards and under center pier also demolition debris exposed due to lower water elevation. **Remedy conditions.**

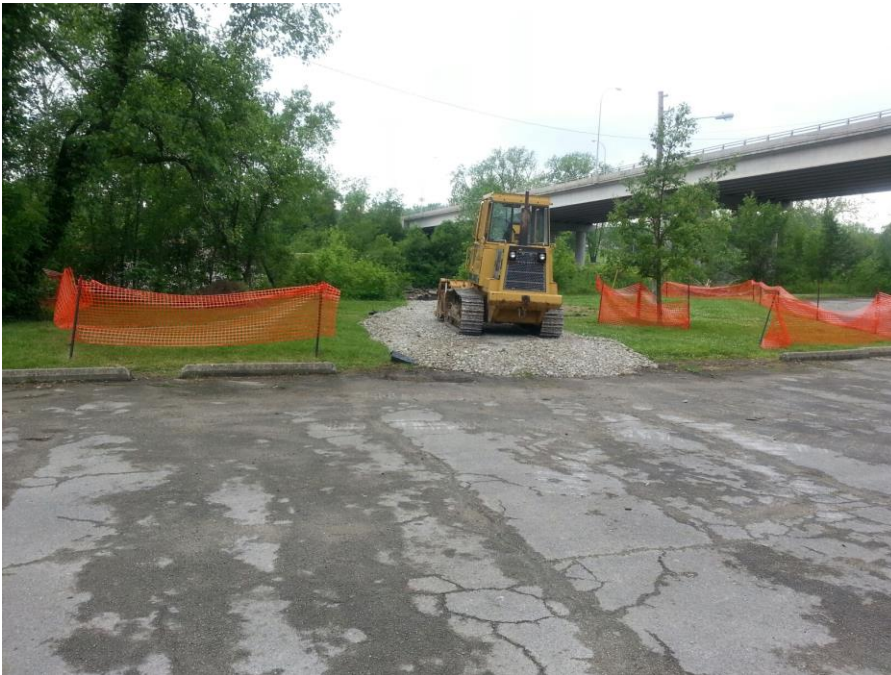
Look westerly June 9th 2019 from parking lot east of Ellsworth Park Dam at equipment & access stone placed

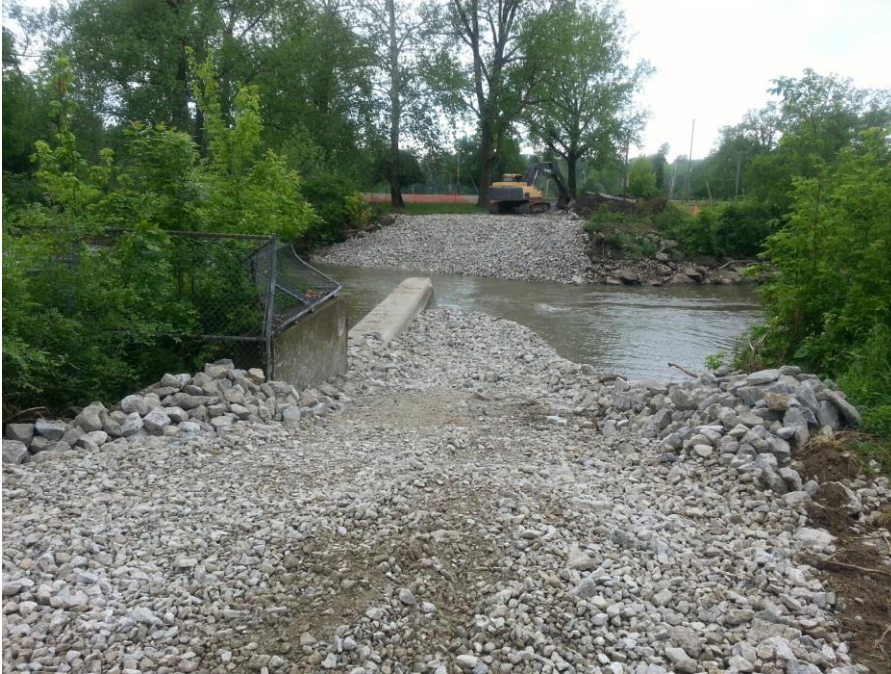
Look westerly June 9th 2019 from the east side of Ellsworth Park Dam at status of dam removal from North Fork River

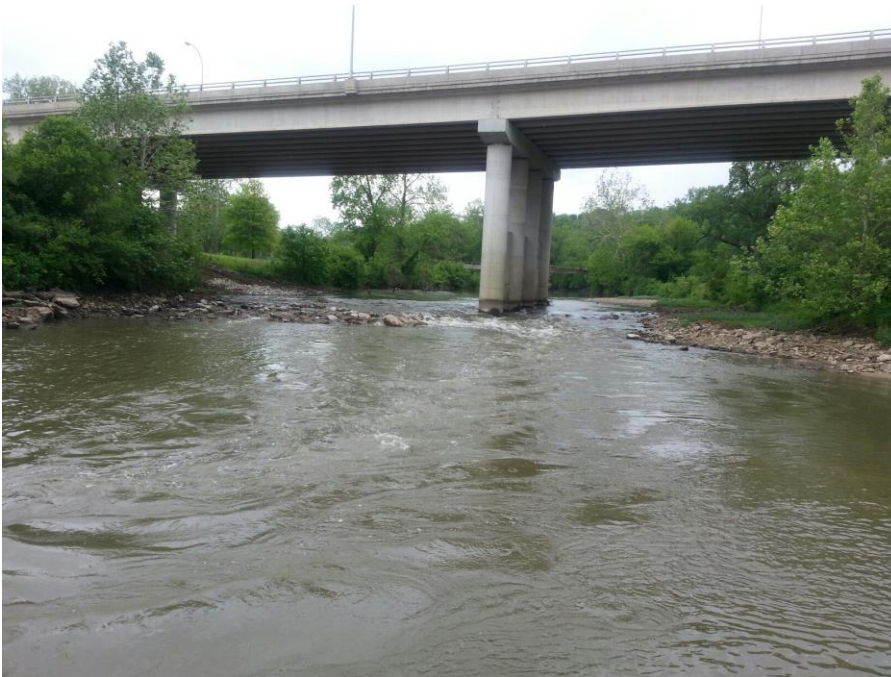
Look June 9, 2019 from Ellsworth Park Dam towards upstream at North Fork River flowing under Martin Luther King US 150 Bridge

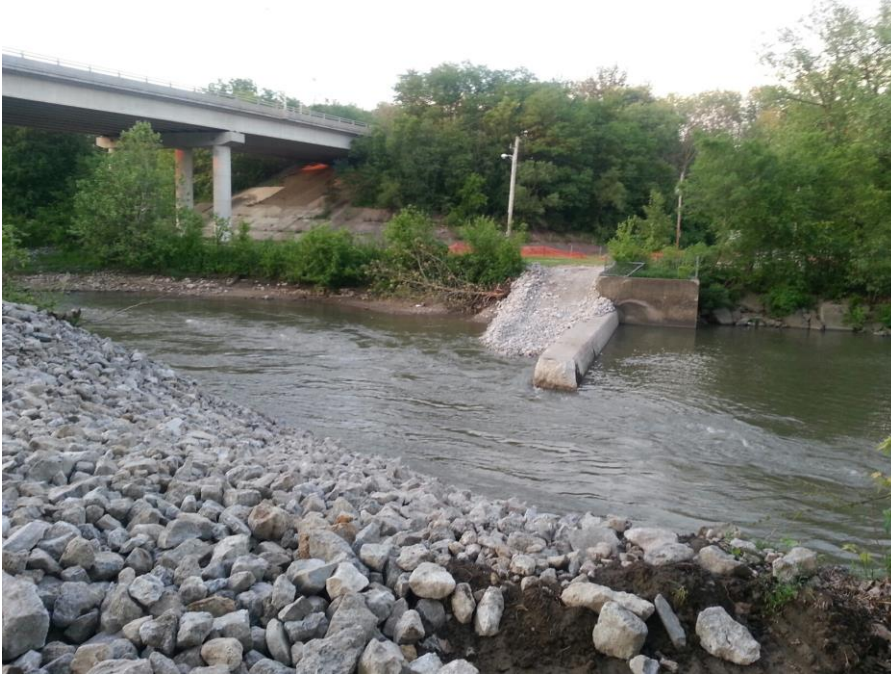
Look east June 9th 2019 from the west bank of North Fork River at status of the Ellsworth Park Dam removal

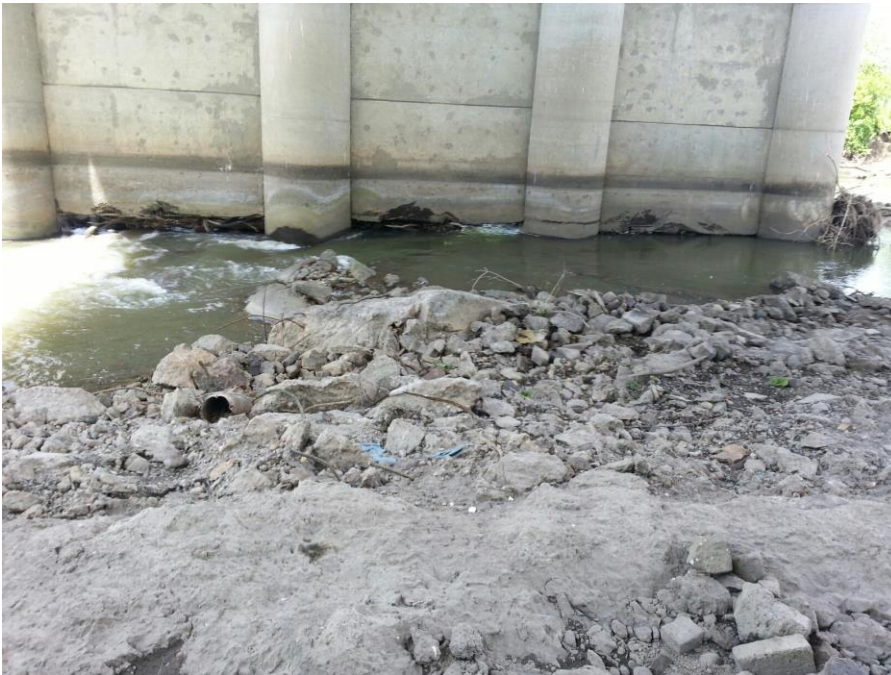
**Look June 14th 2019 at stream flow diverted underneath center pier concrete wall of Martin Luther King (US150) bridge over North Fork River).
Communicate and remedy condition.**

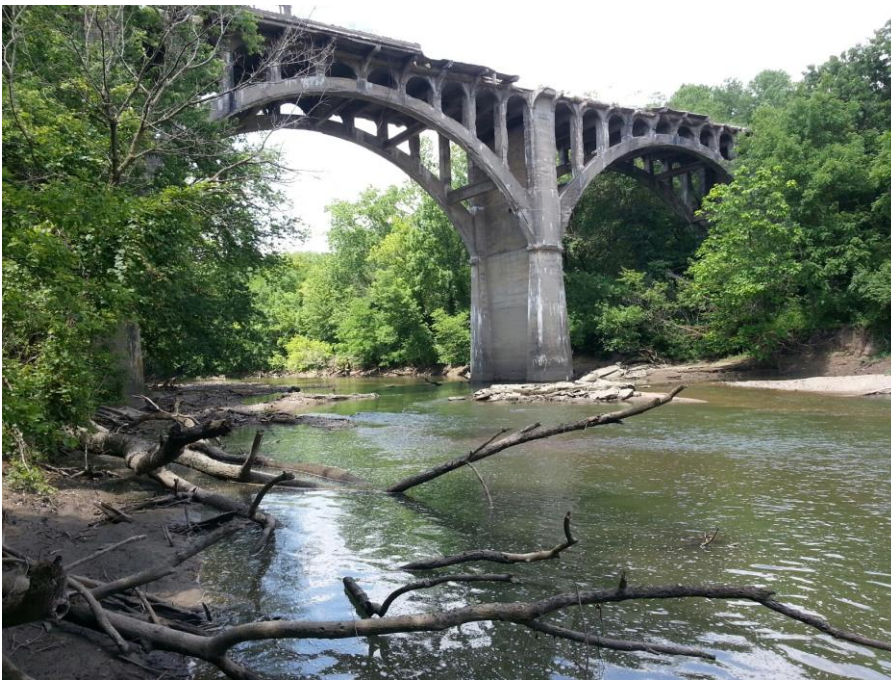
Look from downstream towards upstream June 29th 2019 at status of Danville jurisdiction abandoned Mill Street Bridge over the North Fork River. Communicate to determine if hazards exist to river users & eliminate.

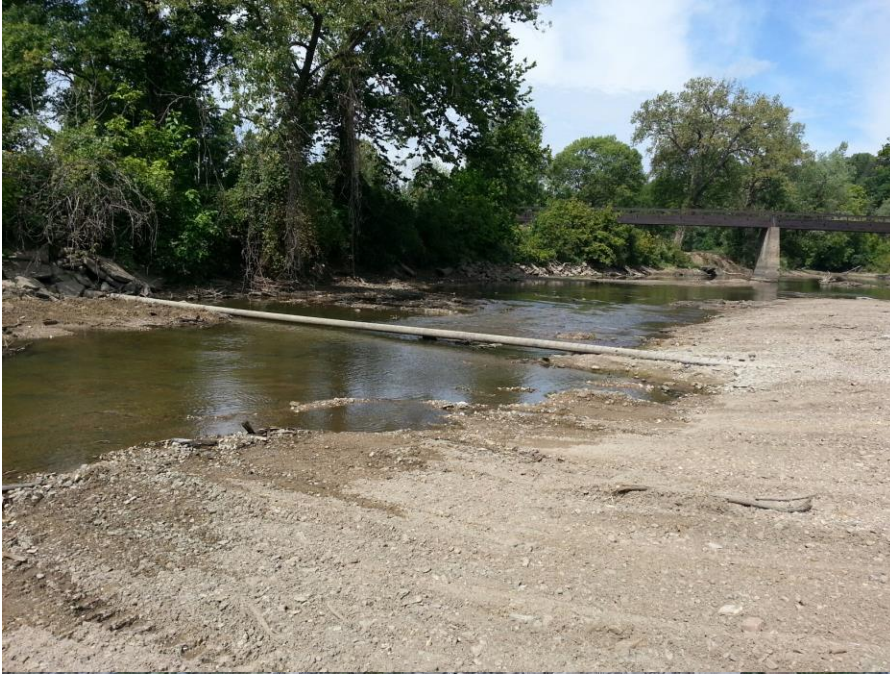
Look northerly September 13th 2019 from east bank of North Fork River at pipe exposed across North Fork River. **Determine purpose of pipe and eliminate hazard.**

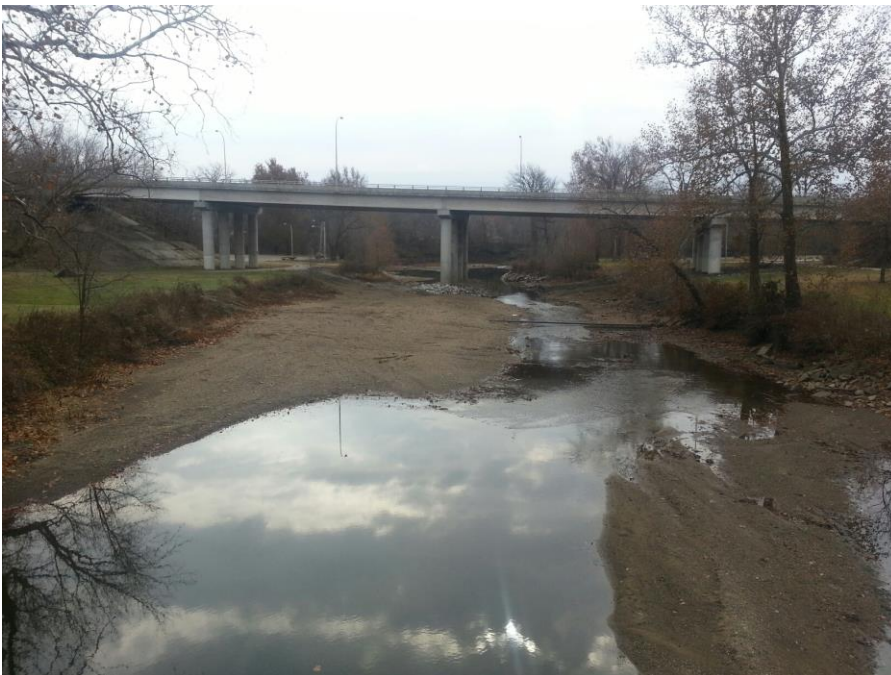
Look toward downstream from pedestrian bridge in Ellsworth Park at status of dam removal from North Fork River November 26th 2019

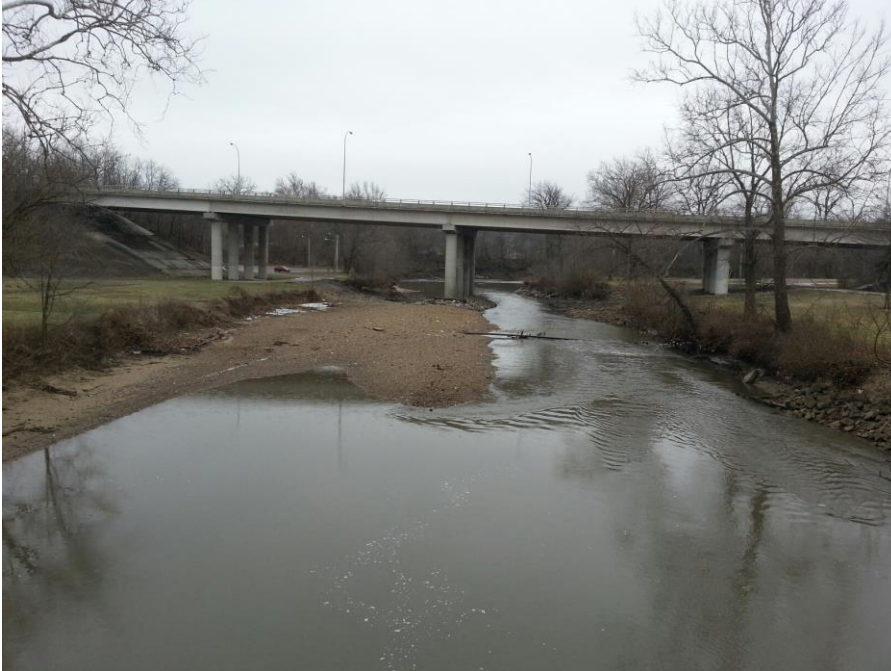
Look toward downstream January 23rd 2020 from pedestrian bridge in Ellsworth Park at status of North Fork River Dam removal

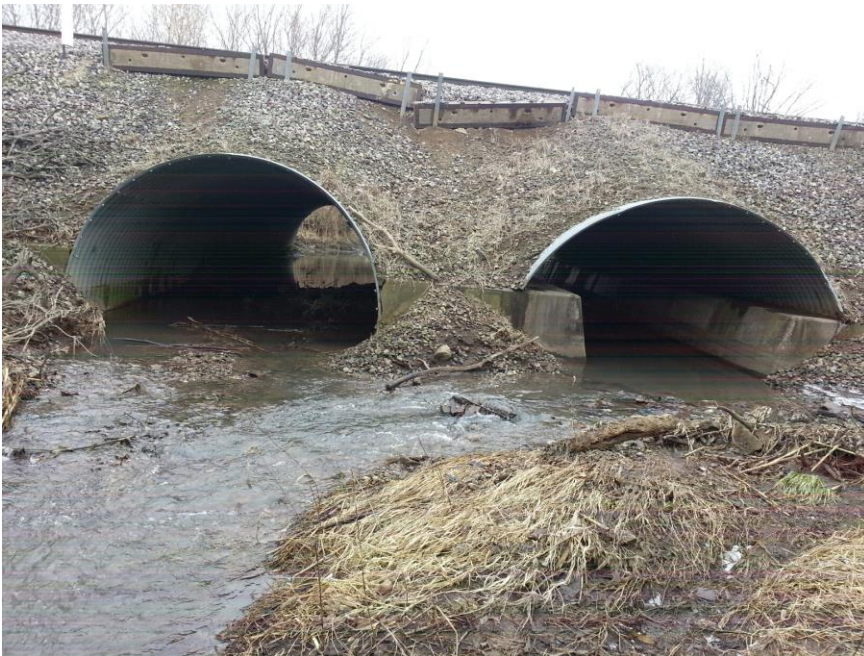
**Look January 23rd 2019 at downstream side of culvert under Norfolk
Southern Railroad along Grape Creek**

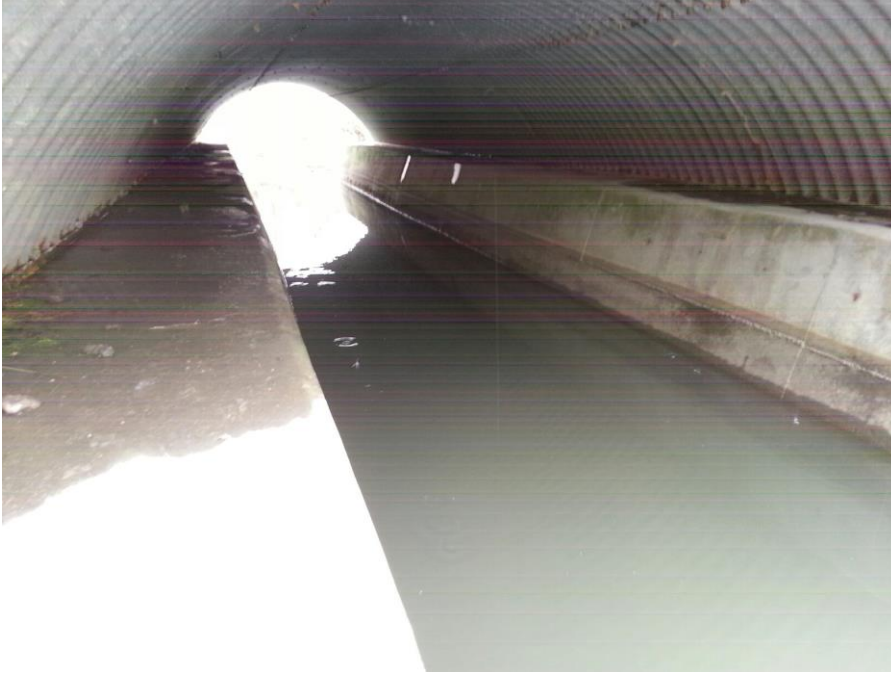
Look January 23rd 2020 at upstream side of west culvert under Norfolk Southern Railroad along Grape Creek

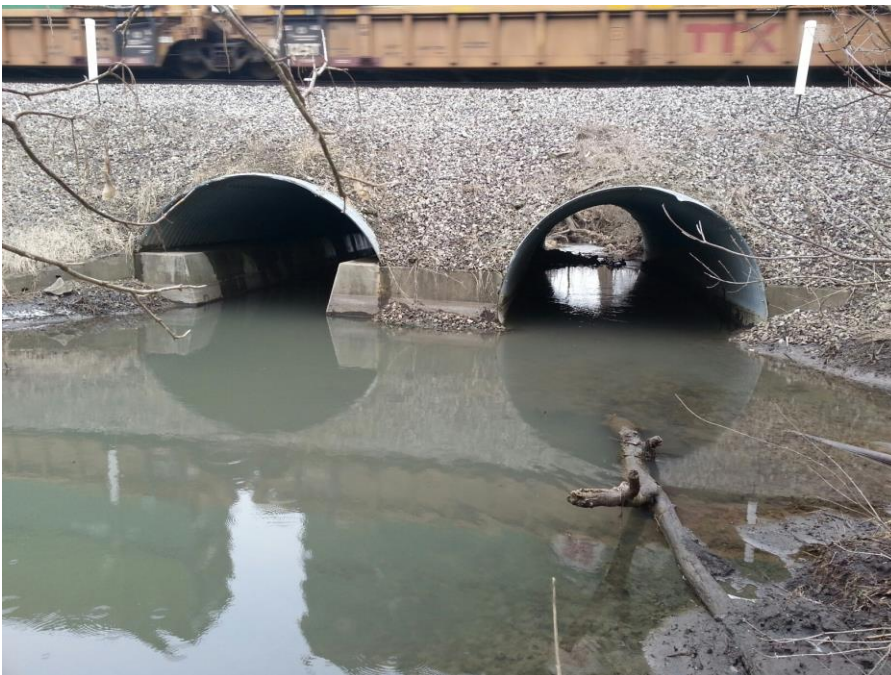
Look January 23rd 2020 at culverts under Norfolk Southern Railroad upstream side

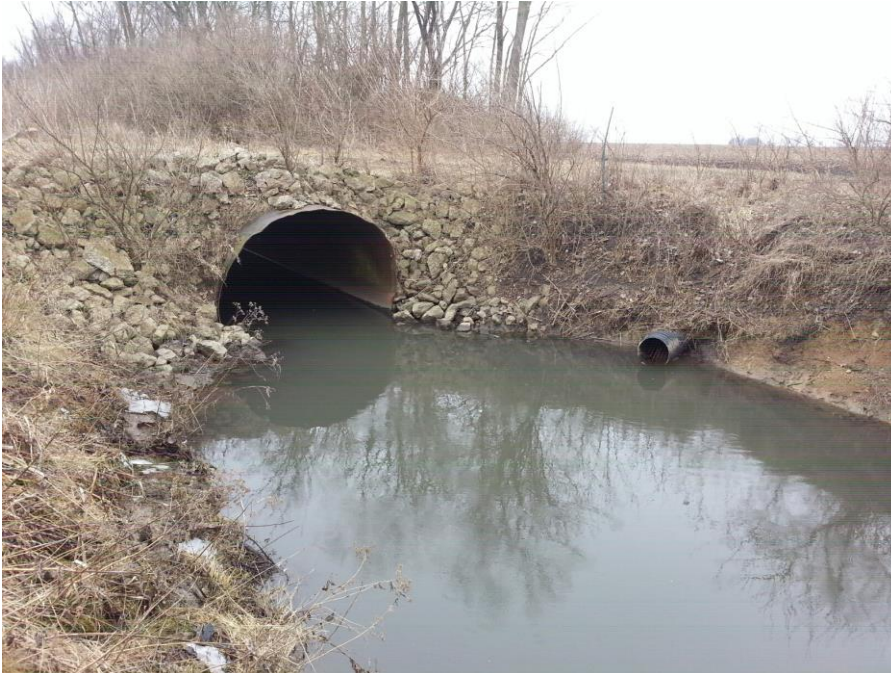
Look January 23rd 2019 at downstream side of steel culvert at farm field crossing upstream of West Ross Lane along Grape Creek

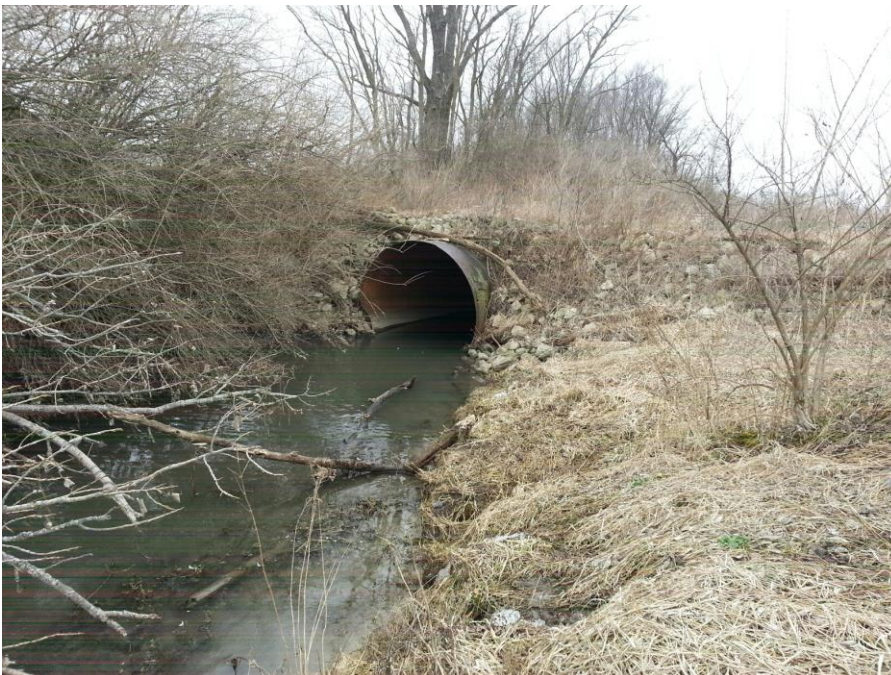
Look January 23rd 2020 at upstream side of steel culvert along Grape Creek south of West Ross Lane upstream of Tilton

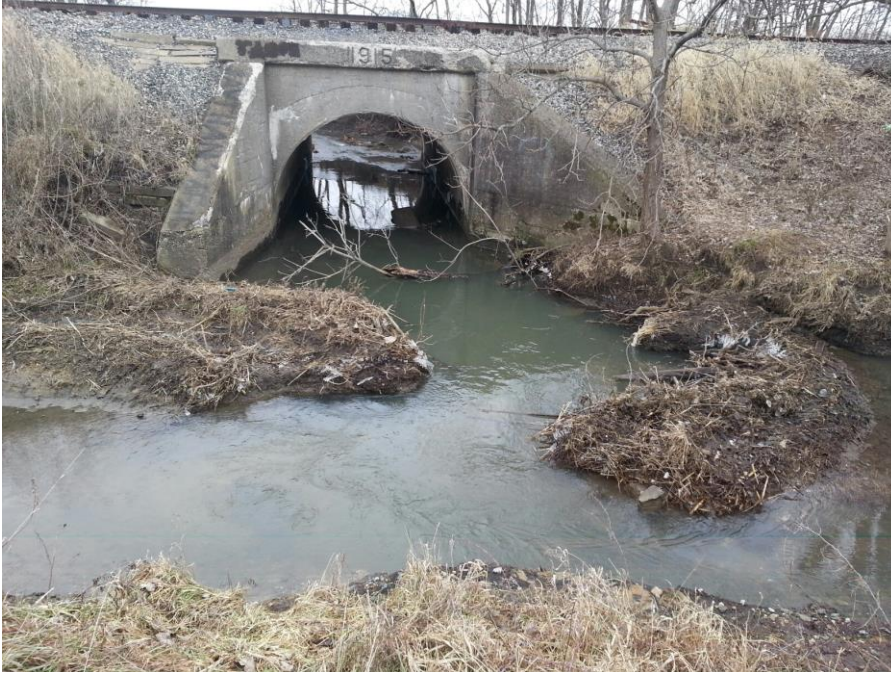
Look January 23rd 2020 at CSX railroad arched concrete culvert upstream side

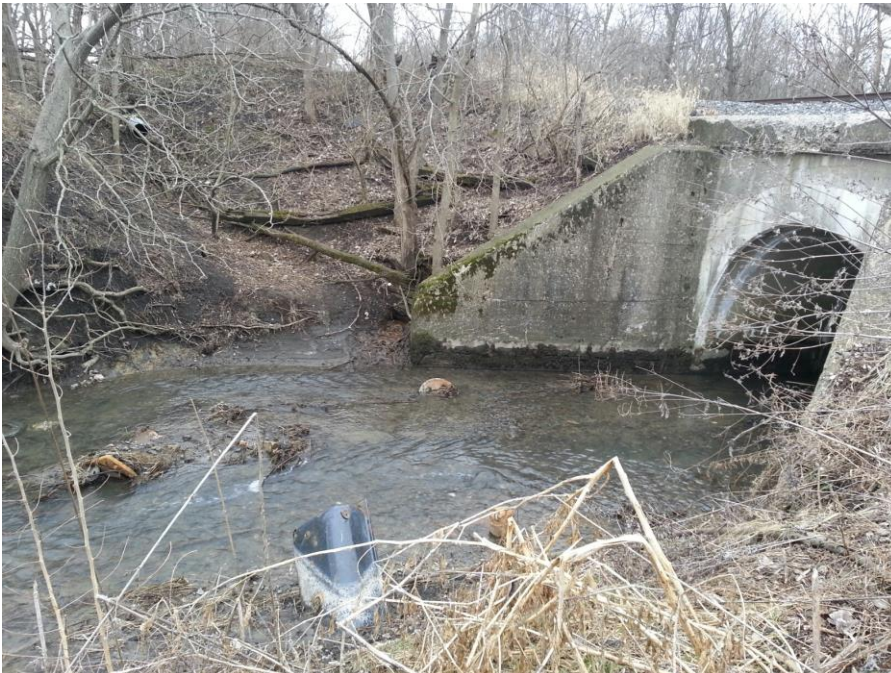
Look southwesterly at arch concrete bridge structure at CSX railroad over branch of Grape Creek. Notice storm sewer discharging from bank. Water is bleeding from behind abutment. Photo taken January 23rd 2020

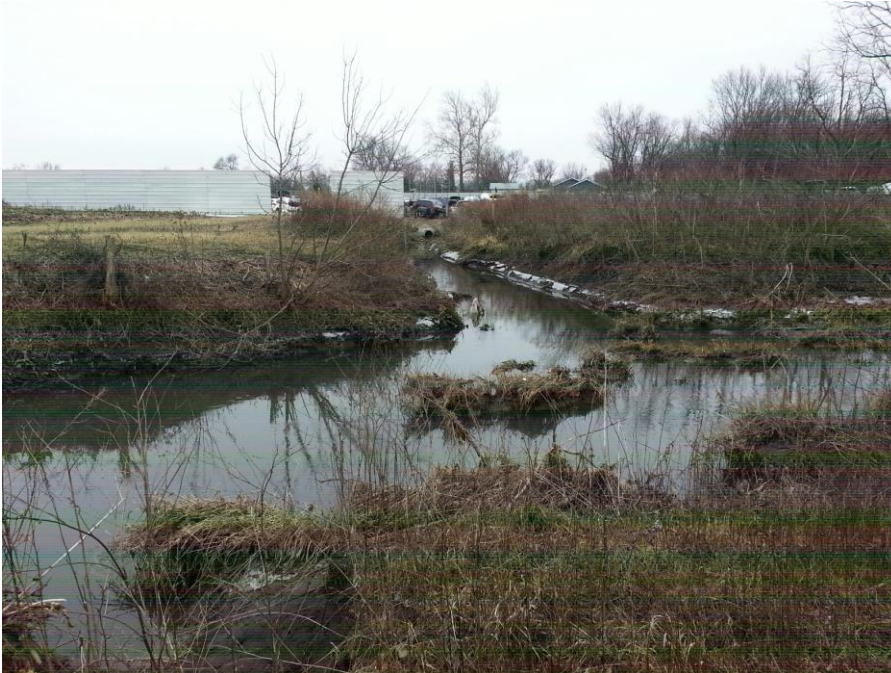
Look January 23rd 2020 towards discharge under auto salvage yard toward Grape Creek

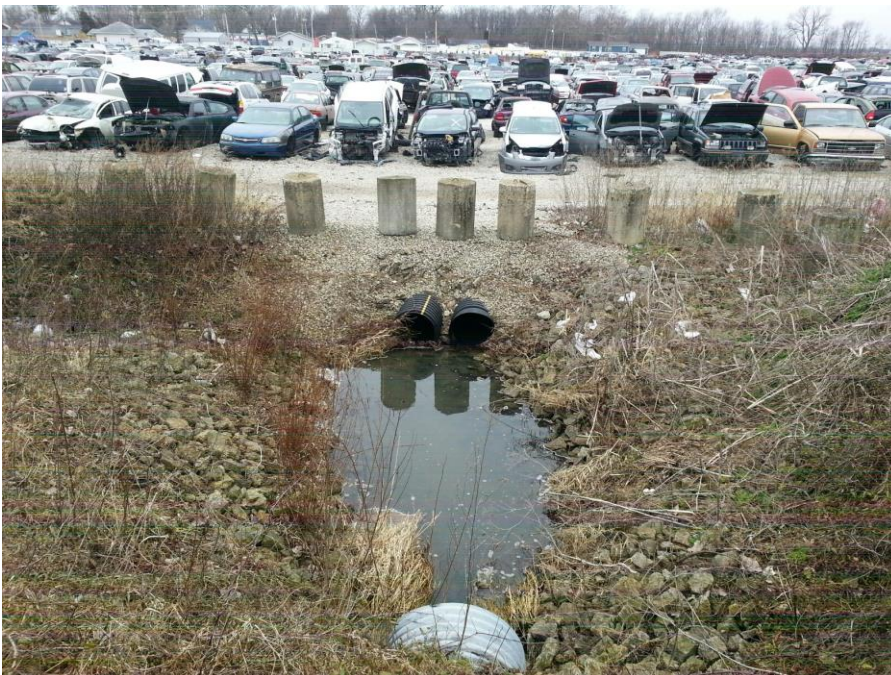
Look January 23rd 2020 toward downstream at two 24 inch diameter HDPE culvert under automotive salvage yard

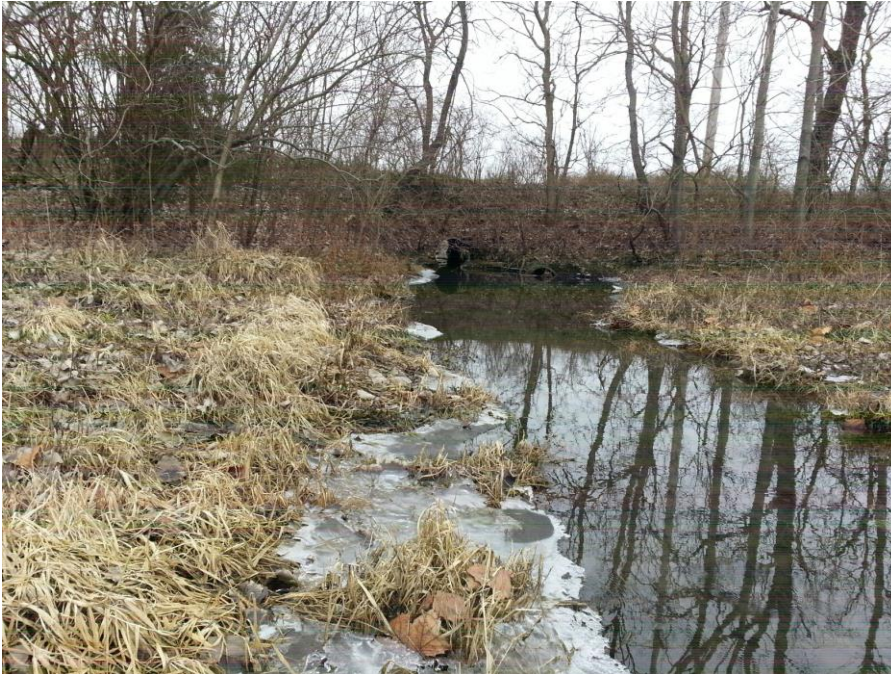
Look January 23rd 2020 toward downstream at culverts under abandoned railroad grade between WITY radio tower and auto salvage yard

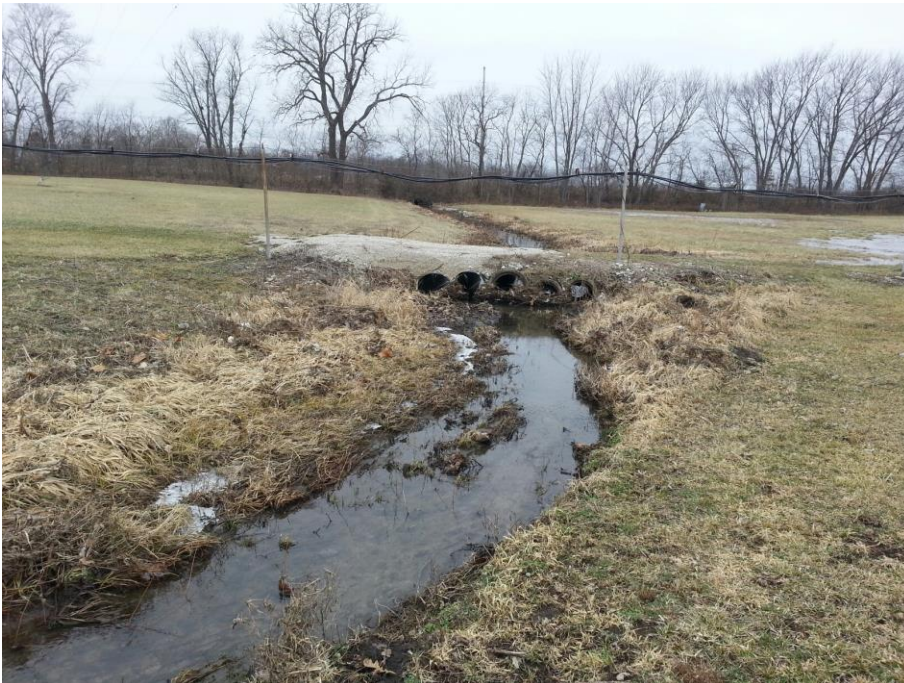
Look toward downstream at 5 culverts near WITY radio tower January 23rd 2020

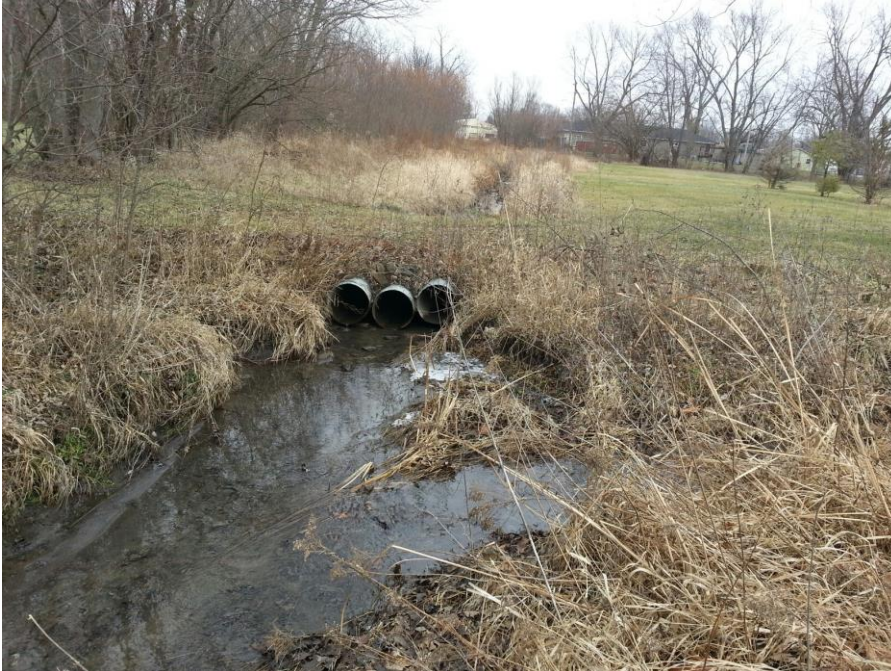
**Look toward east at 3 corrugated metal culvert pipes under access path
January 23rd 2019 upstream of WITY radio tower**

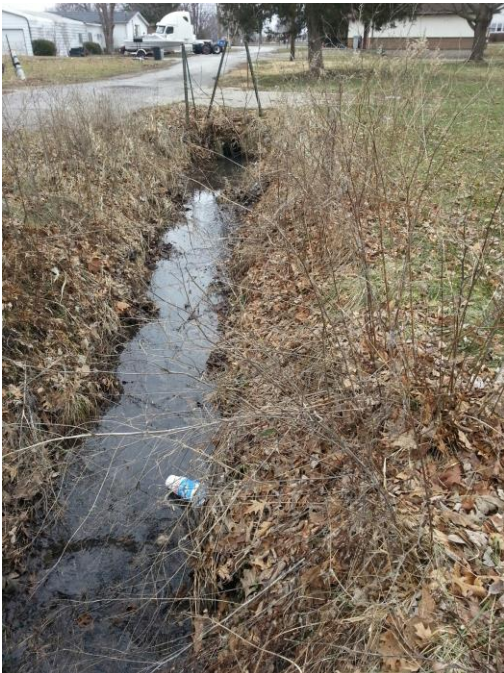
**Look toward upstream at 18 inch storm sewer structure discharging into
ditch north of West 5th Street January 23rd 2019. **Remove & eliminate litter.****

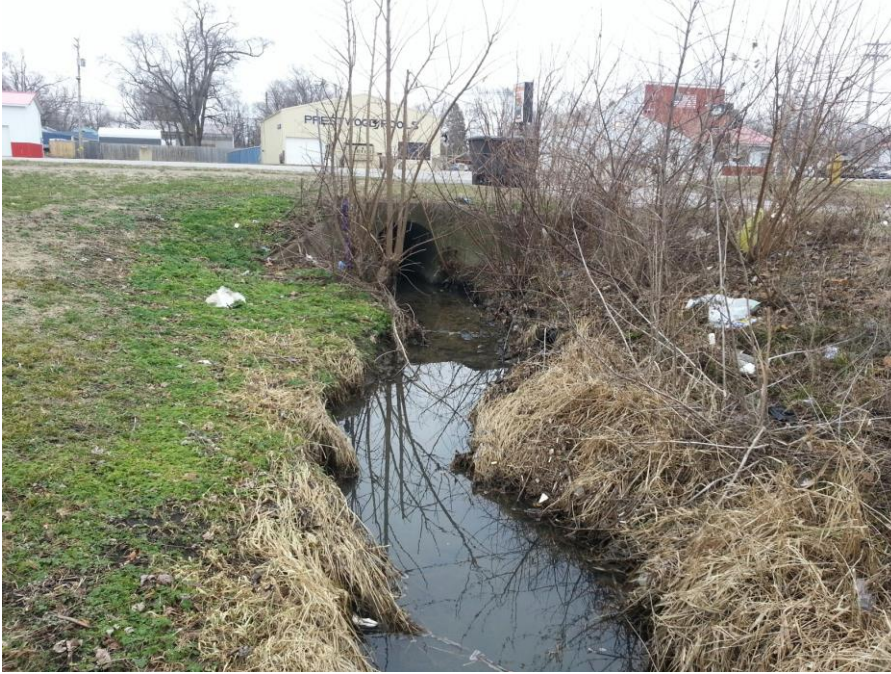
Look January 23rd 2020 towards the east at culvert discharging upstream of Tilton under Route 1 approximately 500 feet north of Spelter Avenue. Communicate with Illinois Department of Transportation to regularly police area and remove also dispose of litter and determine the source of litter and contain. Test quality of water discharging.

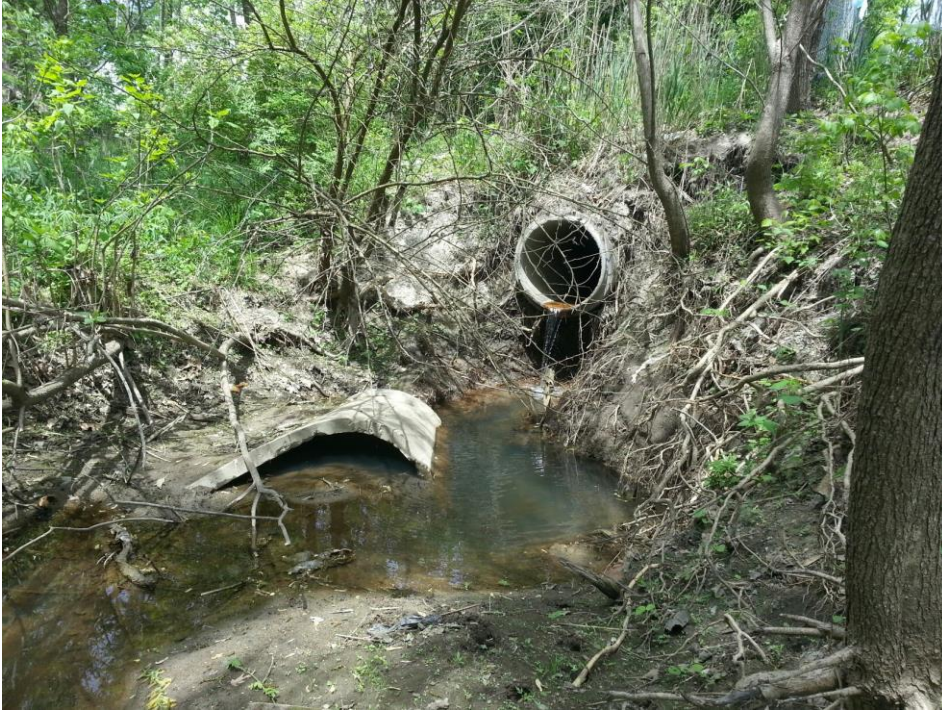
Photograph Northerly at 36" diameter discharge near Grape Creek behind Big R & Todd's Auto Body May 16st, 2018

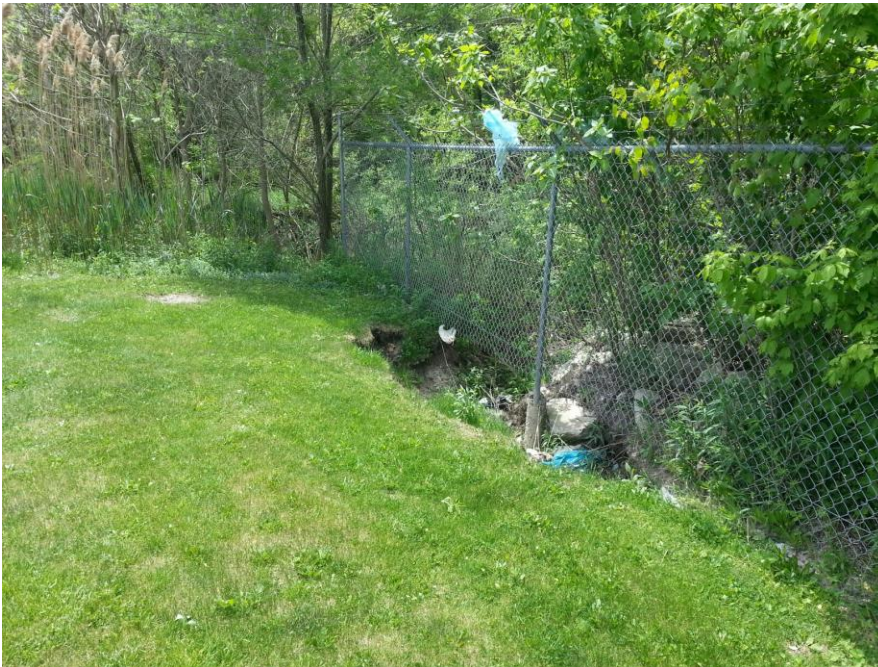
Photograph southerly at erosion along fence line between Big R & Todd's Auto Body near 36" storm sewer discharge May 16st, 2018

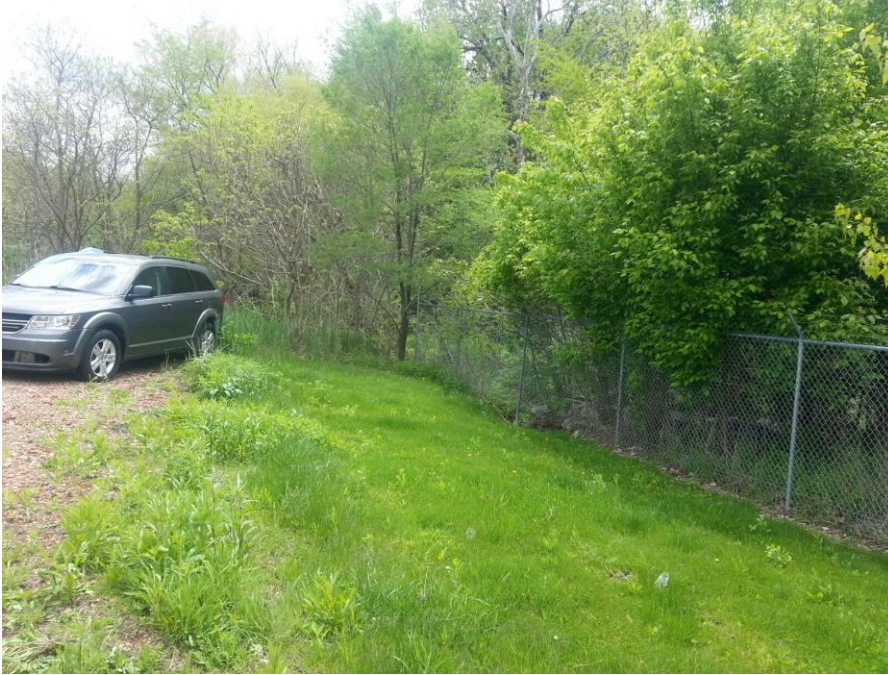
Look southerly May, 13th 2019 at proposed equipment access to discharge

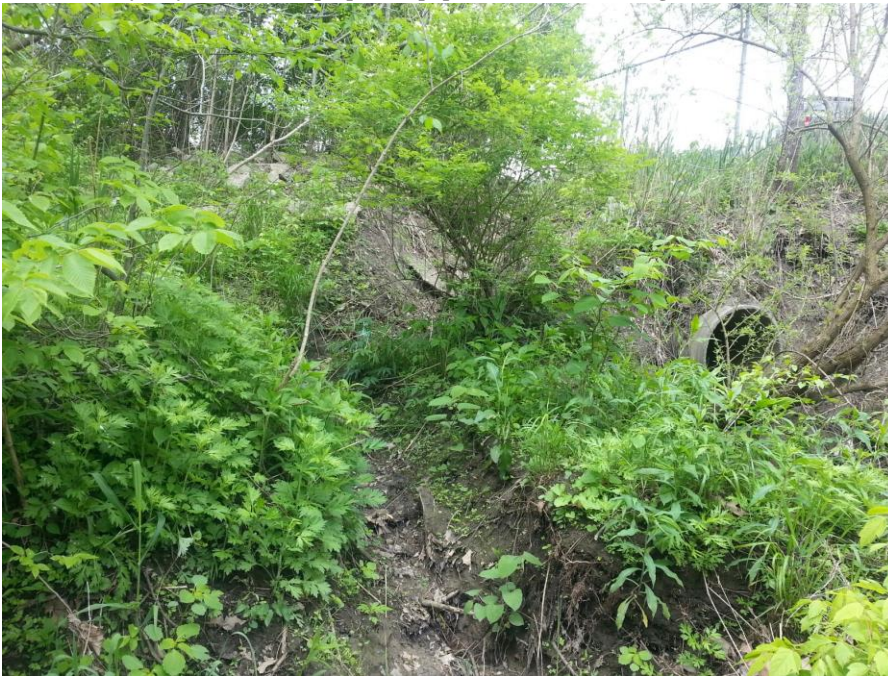
Look northerly May 13, 2019 at erosion rut proposed for fill with riprap grouted from the top to the bottom may minimize required vegetation clearing to access storm water discharge.

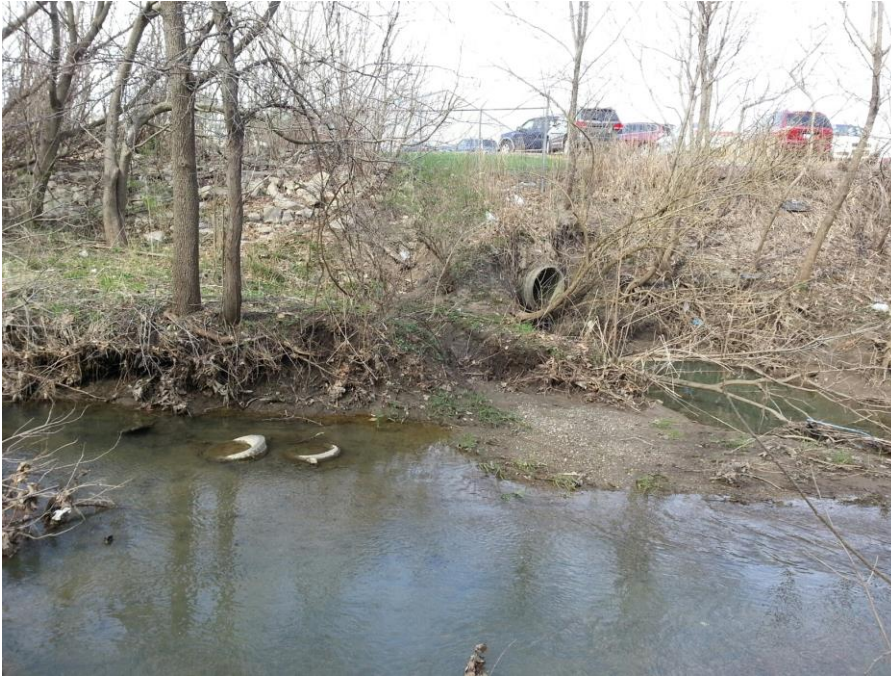
Look towards Northwest at erosion near 36-inch Southgate Drive storm sewer discharge April 10th 2019 from the south side of Grape Creek. Remove tires from stream and coordinate with Army Corp of Engineers requirements according to Nationwide Permit 7.

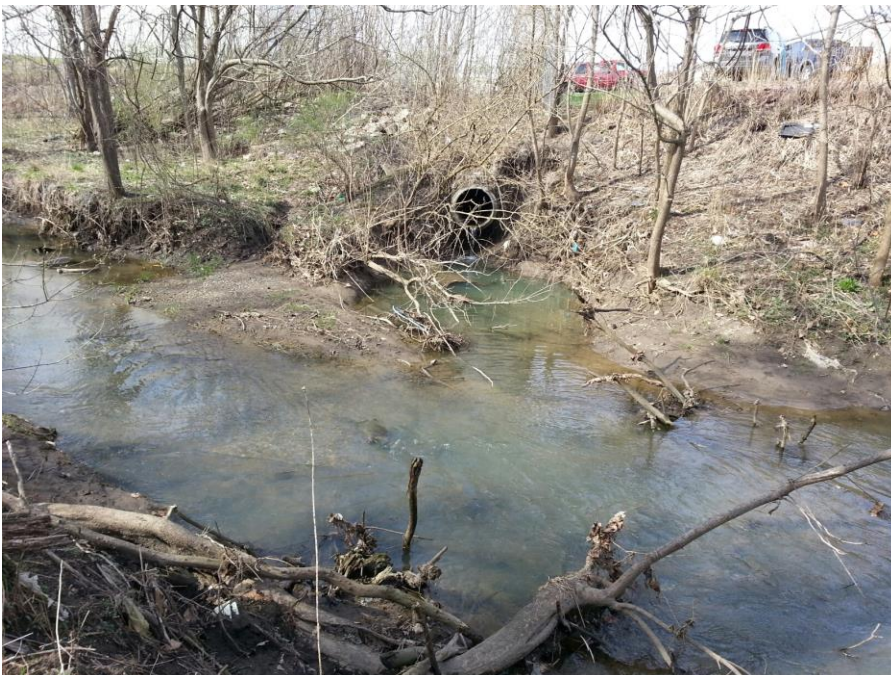
Look April 10th 2019 from the south side of stream towards the north across Grape Creek at erosion near 36 inch diameter storm sewer discharge from Southgate Drive. Coordinate with Army Corp of Engineers requirements according to Nationwide Permit 7.

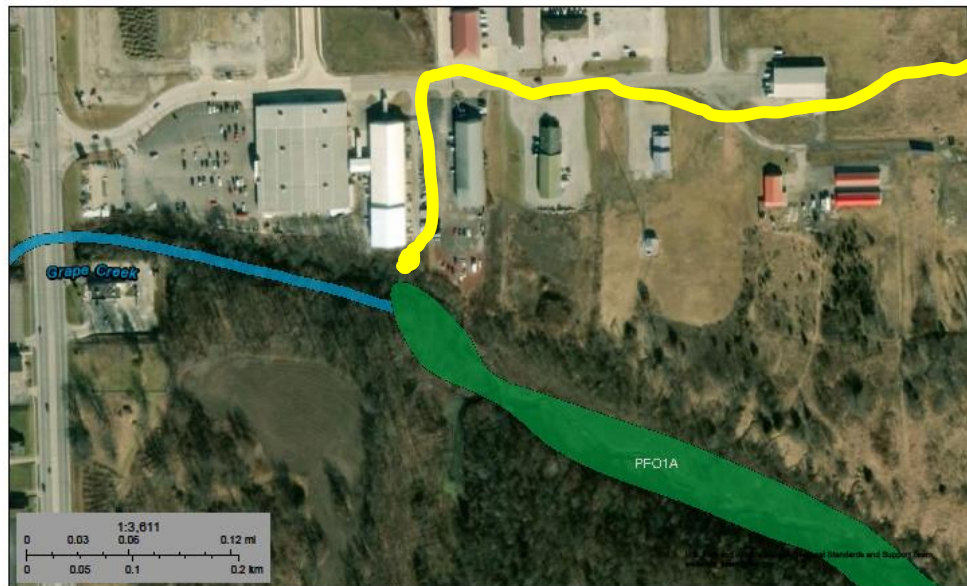
**LOCATION OF
EROSION AT
STORM
SEWER
DISCHARGE**

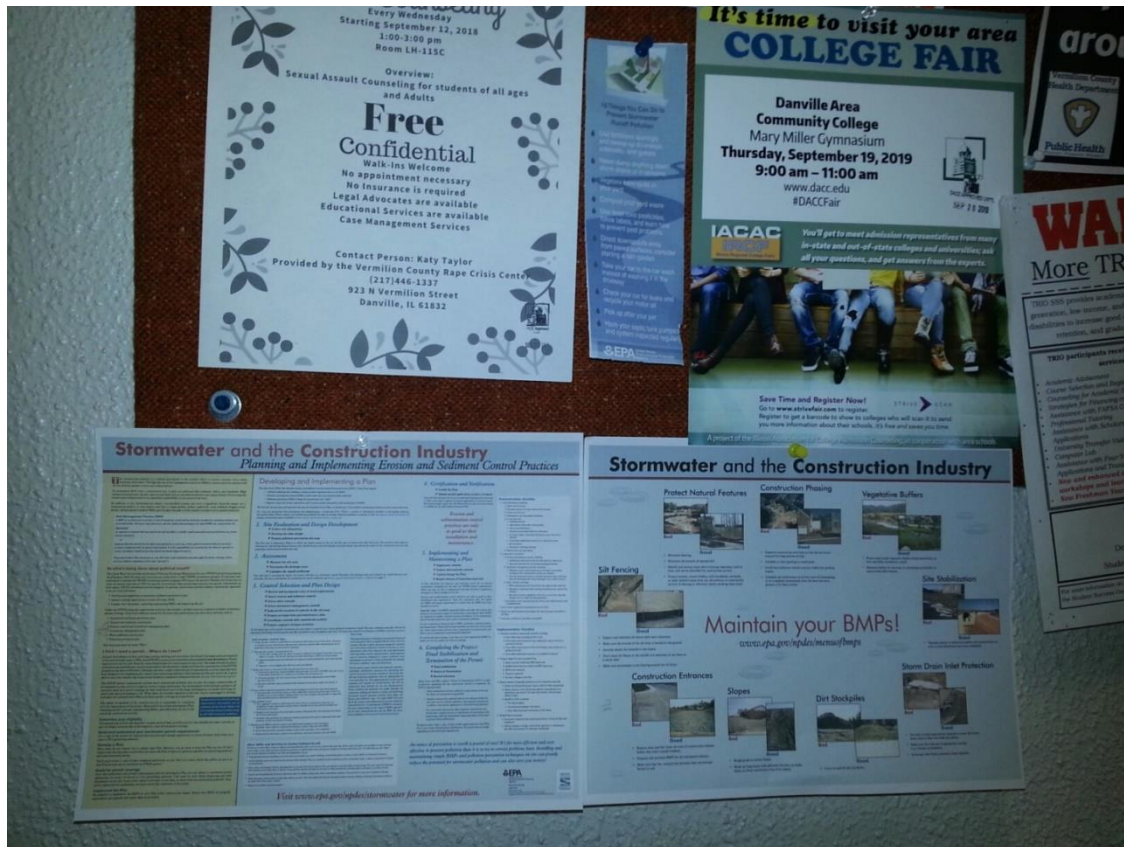
Look North September 13th 2019 at stormwater pollution prevention Flyers posted on bulletin board in the clock tower building north entrance at Danville Area Community College
